# Worker Crushed To Death by Falling Steel Coil

**Incident Number: 05KY015**

## **Kentucky Fatality Assessment and Control Evaluation (FACE) Program**

**Subject: Worker Crushed To Death by Falling Steel Coil**

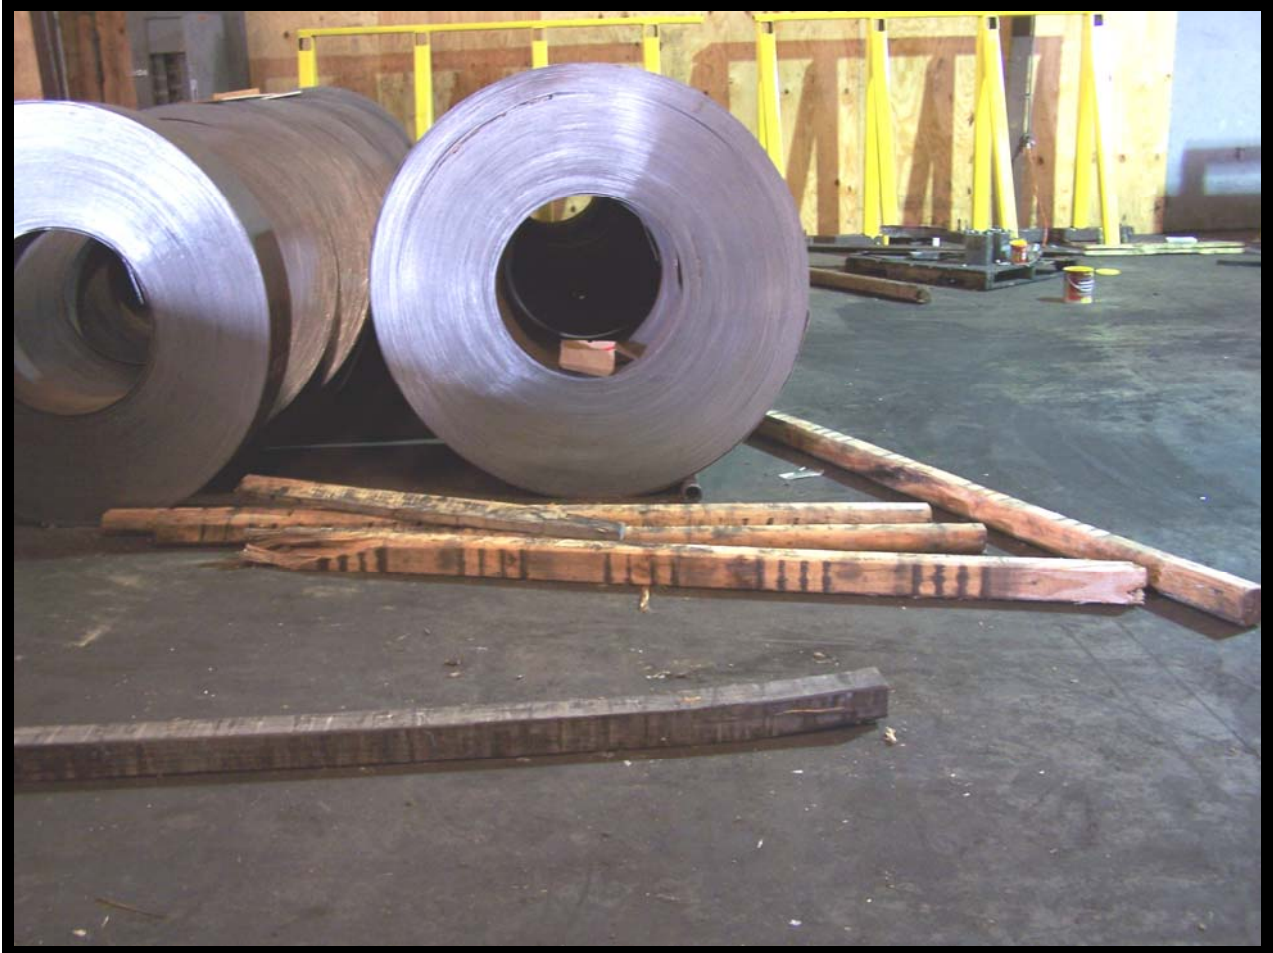
Photograph showing coils of slitted steel with boards to be used as chocks.

Since the incident, procedures on moving and storing steel coils have been changed. Now, coils of steel stacked on edge are chocked and there are boards placed between the coils, whereas previously they were not. This allows the chain to be placed through the middle of the coil without having to sit the coil on its narrow edge, thus reducing the risk of the coil falling over. 29 CFR 1910.176(b) states "for secured storage of materials, they must be stacked, blocked,

chocked or interlocked so that they are stable and secured against movement, sliding or collapse”.

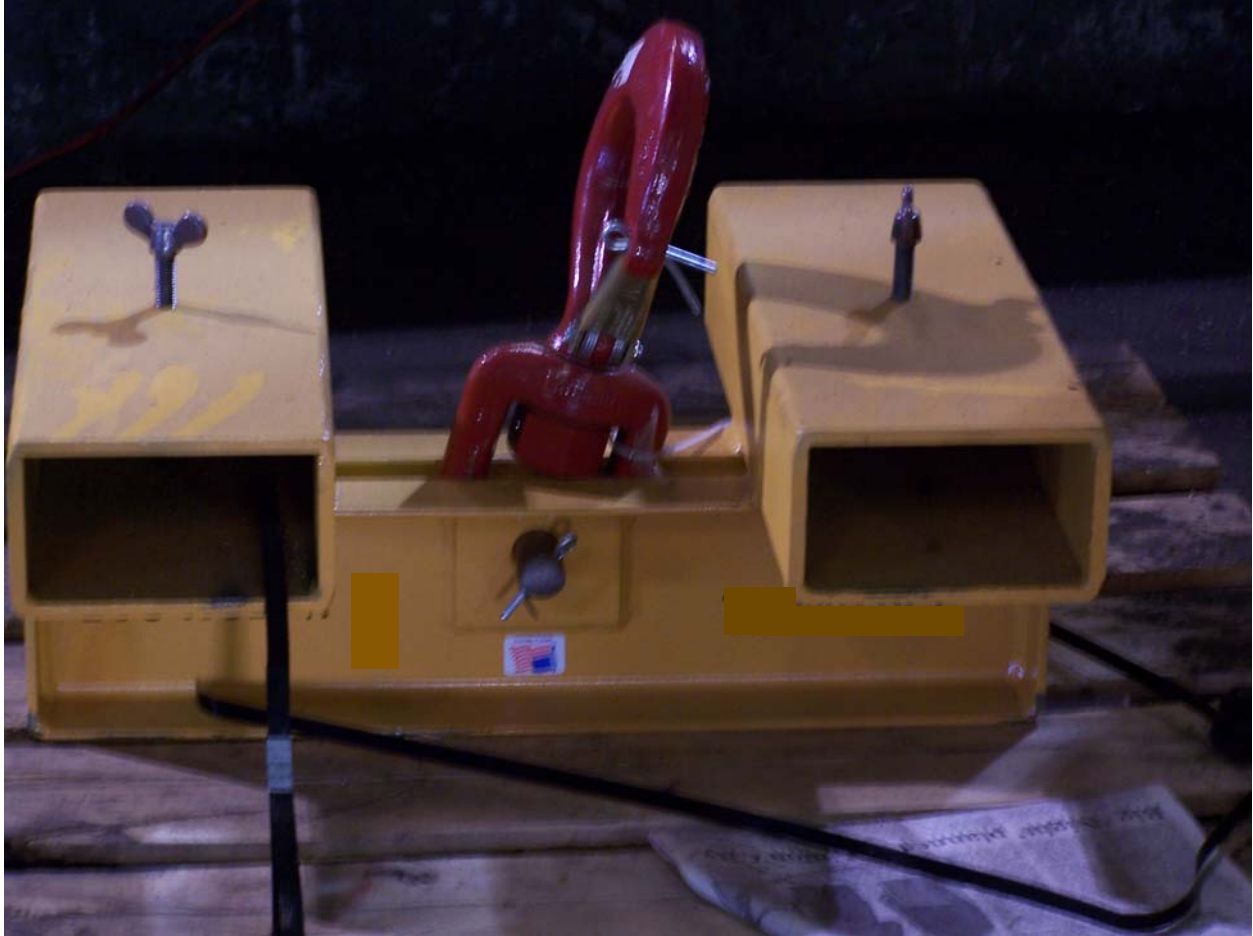
To accommodate the size of the steel coils, the homemade device was placed at a 36 inch load center instead of the 24 inch load center. The forklift was designed for a 24 inch load center. Placing the device at 36-inches on the forks changed the forklift center of gravity, load distribution, and carrying capacity. This load distribution change and handmade device were not approved by the forklift manufacturer. Equipment had been modified by the workers at the plant to enable them to transport the coils of steel to different locations within the facility. The modifications made to the forklift changed its center of gravity, load distribution, and carrying capacity from the manufacturer's original design. 29 CFR 1910.178(q)(6) prohibits modifications not approved by the manufacturer. Also, 29 CFR 1910.178(o)(2) prohibits handling loads greater than the capacity of the forklift. After the incident, a device, approved by the forklift manufacturer and KY OSH, was purchased which allows a chain to be attached safely to the forks of the forklift.

Picture of device workers should have been using with the forklift to transport coils of steel.

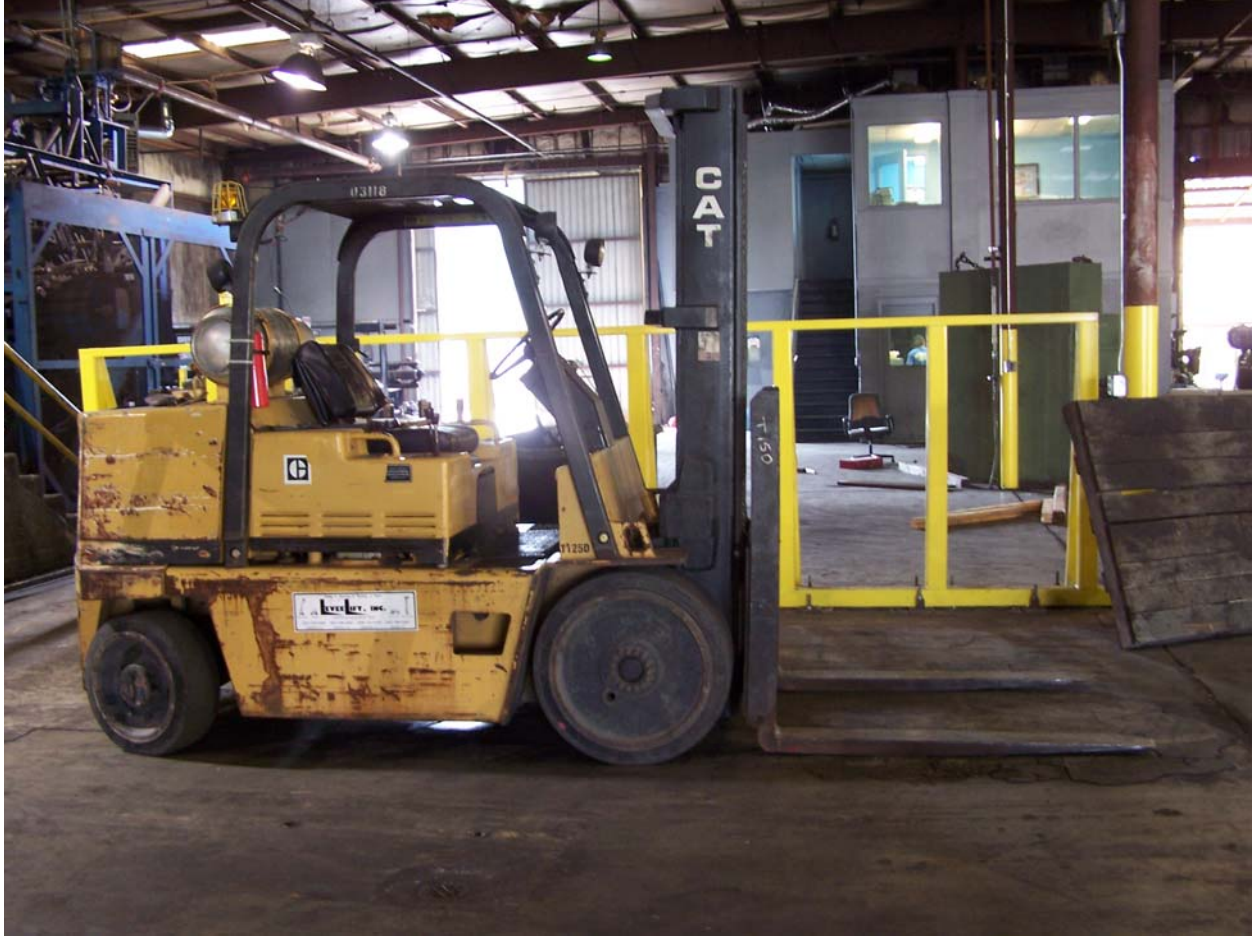
Picture of forklift used to transport steel coils. The holding area for the coils is on the other side of the yellow barrier.

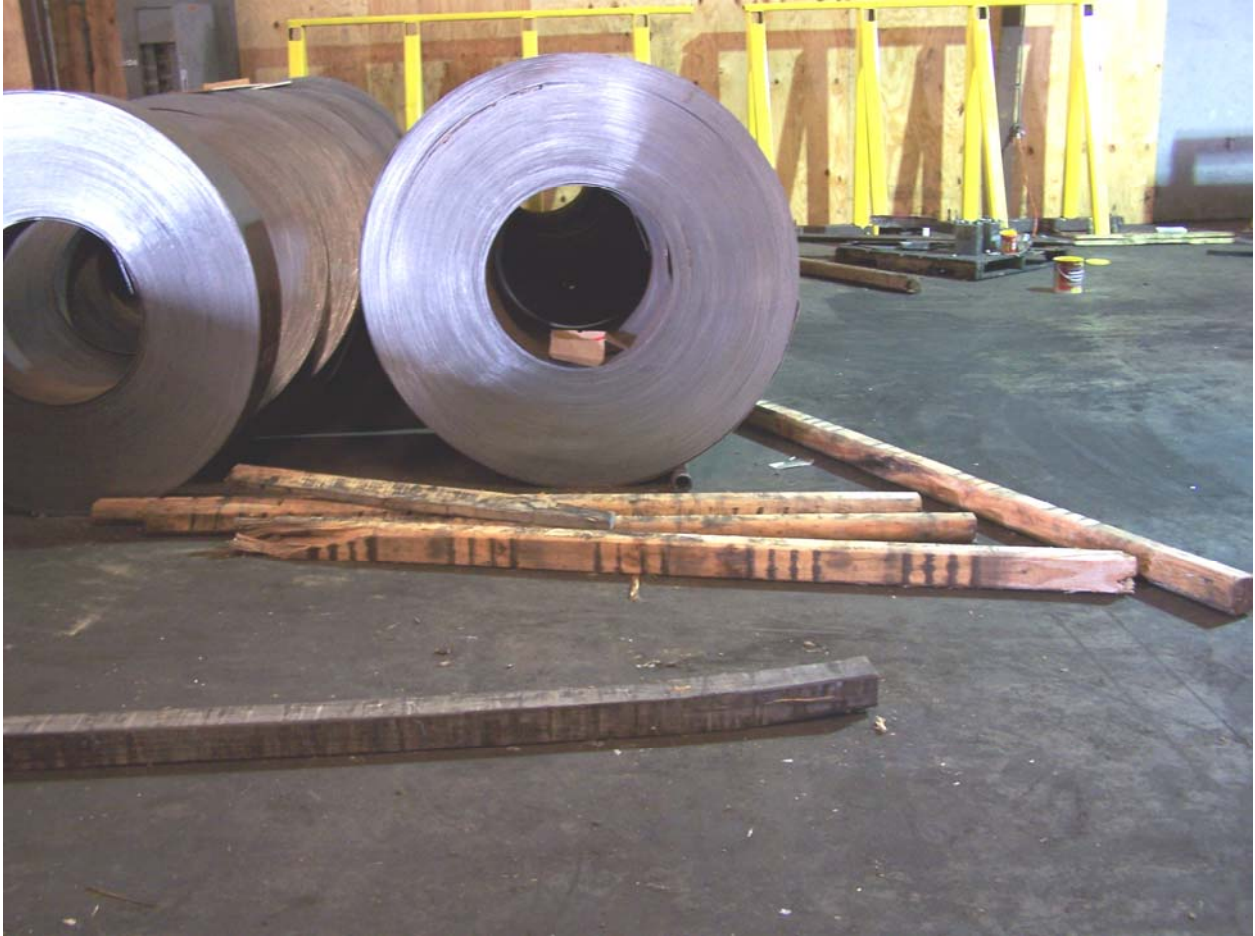
Picture of coils of slitted steel in the storage area waiting to be transported to the holding area before being taken to the pipe mill.
