Fatality Assessment and Control Evaluation Project

Public Health
KY FACE # 02KY041
Date: March 11, 2003

SUBJECT: Two Laborers Die From a Scaffolding Fall
Inside a Water Tank

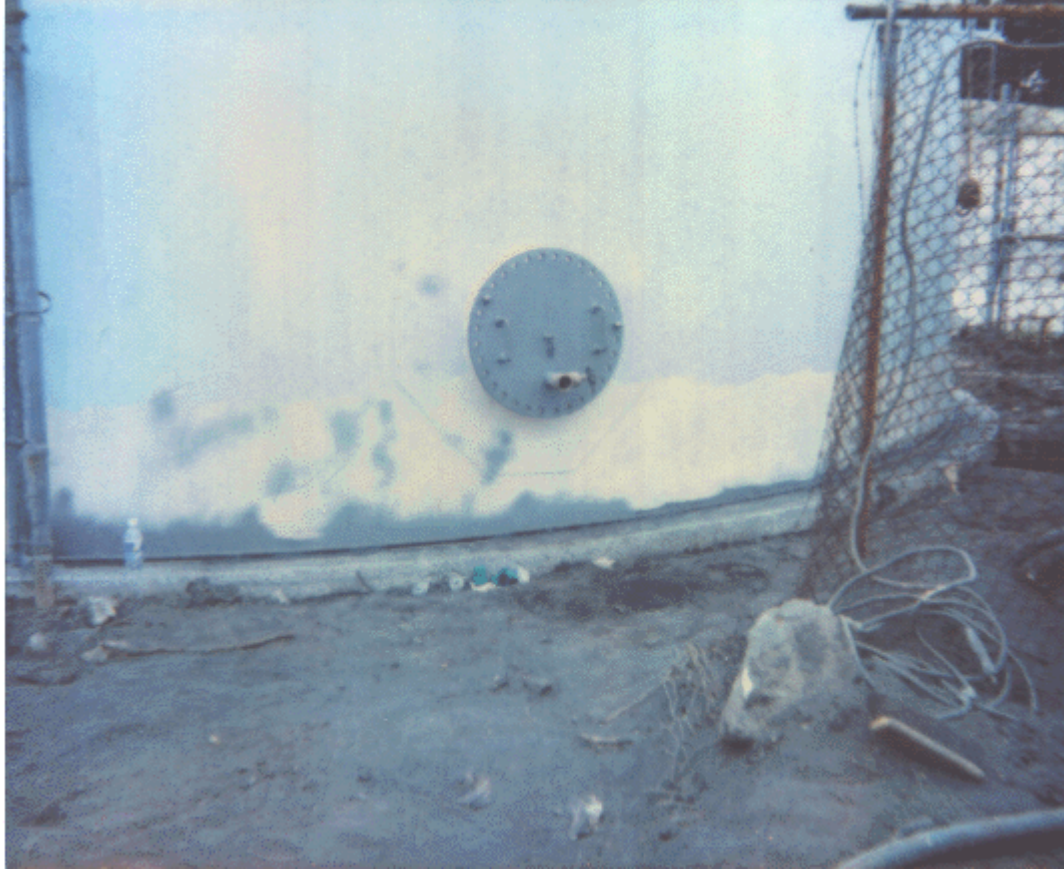
Picture of access / egress portal to water tank. The diameter of the access / egress is 24 inches and is 21 inches from the top of the concrete base, which is 5 inches deep.
