Traffic Technician Dies From Fall While Changing Traffic Signal Bulb

Incident Number: 03KY028

Kentucky Fatality Assessment and Control Evaluation (FACE) Program

**Subject: Traffic Technician Dies From Fall While Changing
Traffic Signal Bulb**

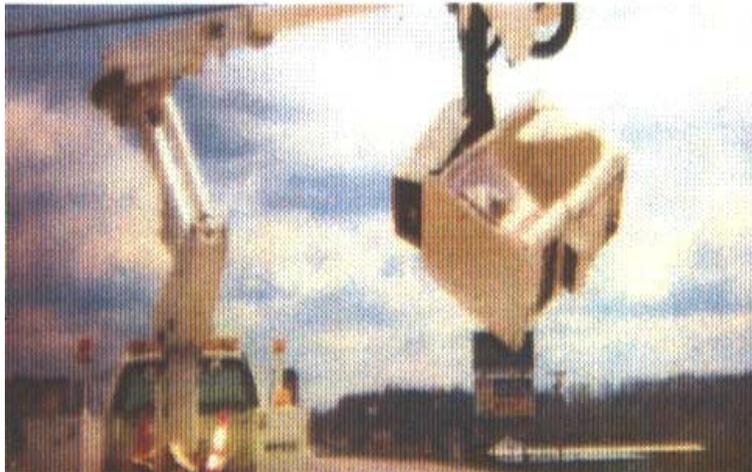
Picture of the bucket after the incident. (Photograph courtesy of employer)

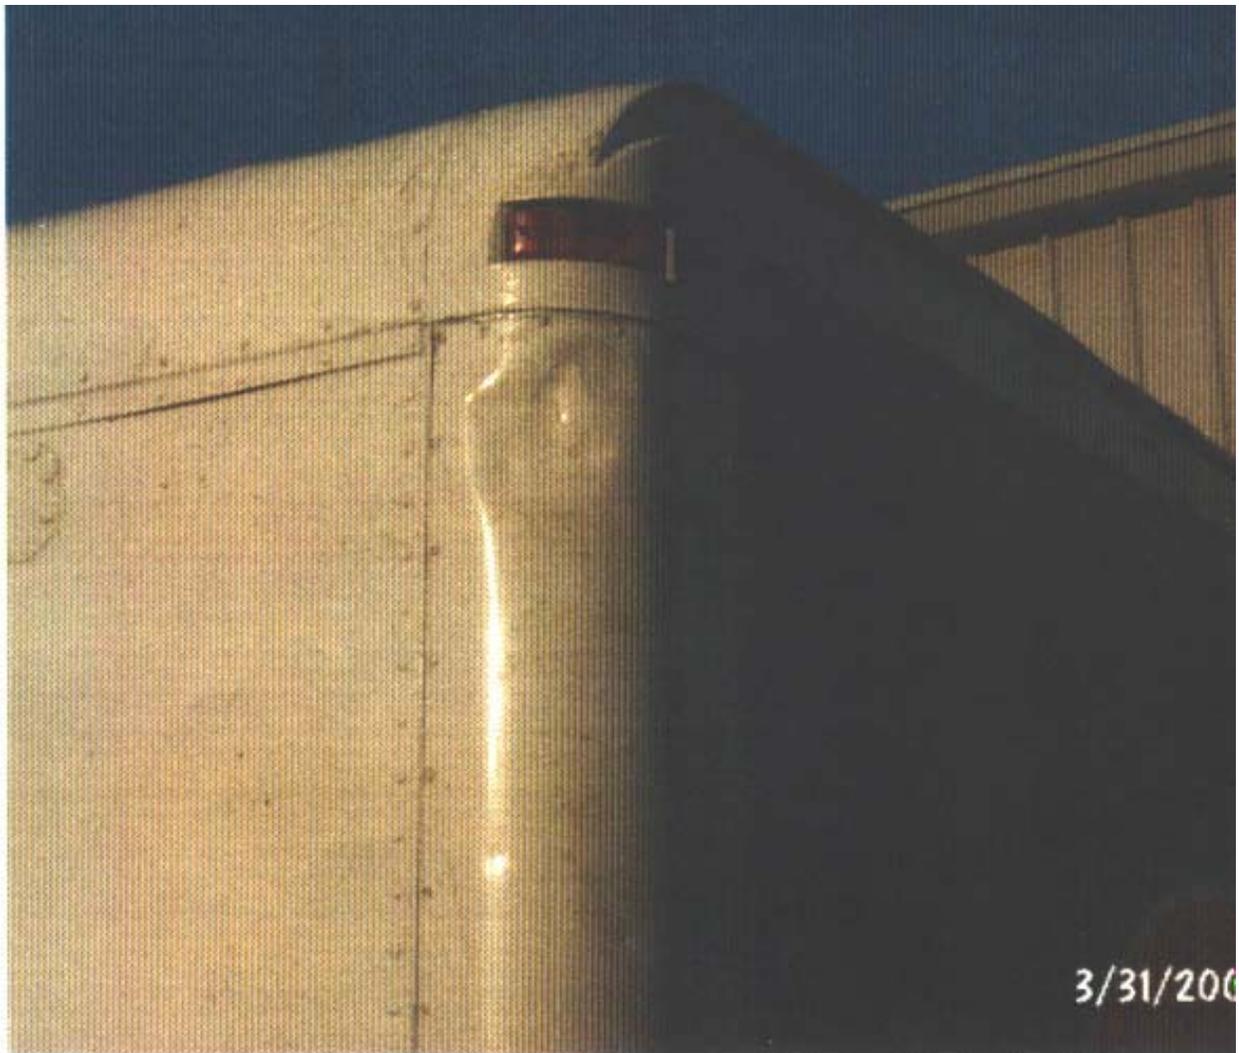
stopped for the red light. When the light changed to green the truck driver, seeing the technician in the bucket, thought he could clear the bucket and proceeded through the intersection. When the driver drove underneath the bucket, the driver heard something hit the top of the cargo section of the truck. The driver of the cargo truck stopped the vehicle and got out to find the technician lying on the pavement. The impact of the truck hitting the bucket had caused the bucket to break away from the boom, resulting in the technician falling 10 feet to the ground. Another driver traveling behind the truck saw the technician fall from the bucket. An off-duty police officer was sitting in the northbound lane at the red light and observed the traffic technician changing the bulb. The officer noticed there were no cones or a flagger to direct traffic around the truck. As the light changed to green, the officer proceeded through the intersection when he noticed commotion in the southbound lanes. The officer observed that the truck and bucket had collided and called emergency services to the scene at 10:59 am. A nurse driving by the incident also stopped and rendered aid to the technician until emergency services arrived. Emergency services arrived within minutes and transported the technician to the nearest hospital. At approximately 10:55 am, the technician was airlifted to the nearest trauma hospital in a neighboring state. He never regained consciousness and died four days later from his injuries.

Picture of the dent caused by the cargo truck hitting the bucket with the traffic technician in it.
(Photograph courtesy of employer)

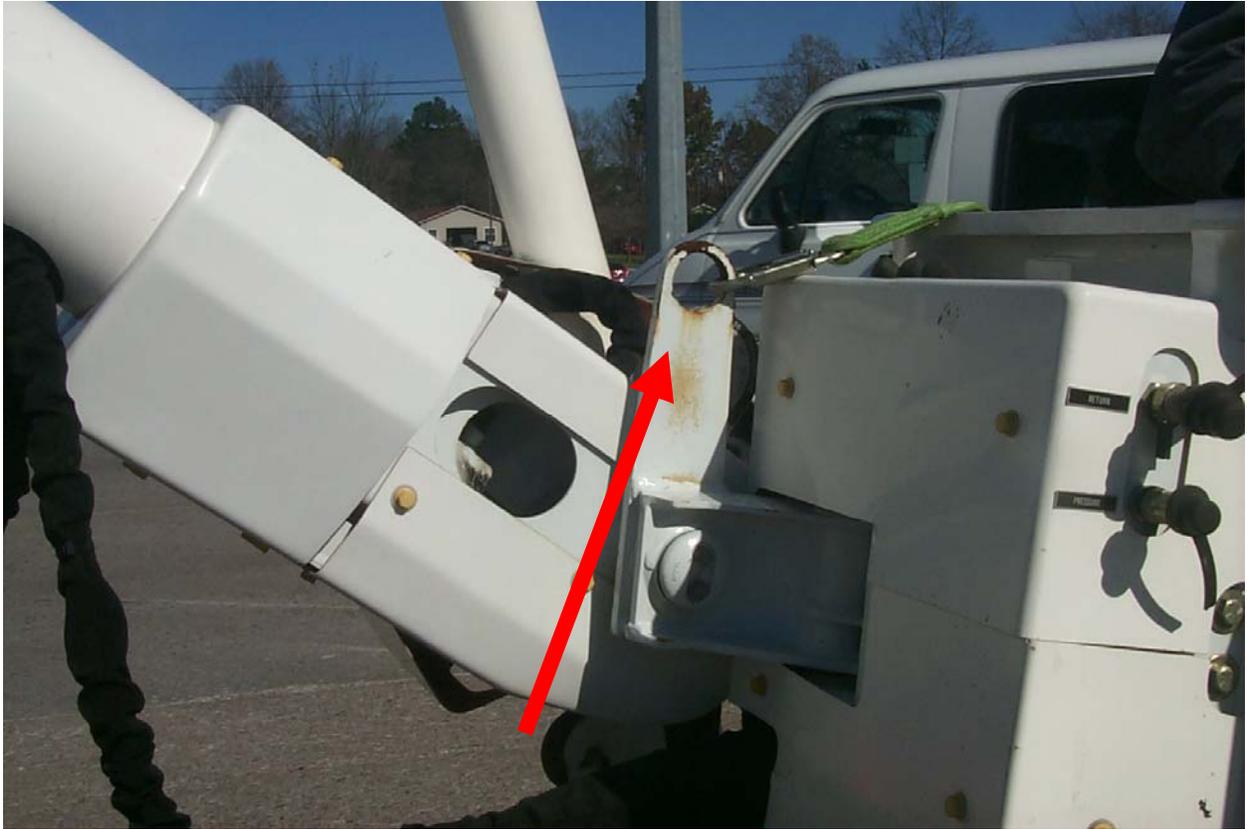
Employers have a responsibility to provide a safe working environment for all their employees. Employees have a responsibility to themselves, their fellow employees and to their employer to use all applicable safety training and personal fall protection equipment provided by the employer. The safety harness was not worn at the time of the incident. There were two other harnesses in the truck provided by the truck manufacturer which had not been used and only needed adjustment to fit the user. A safety harness should have been worn and tied off to the eyehook on the boom.

Photograph depicts the attachment of the boom to the bucket and the eye hook for harness attachment

Recommendation No. 1: Employees should use personal fall protection equipment in an aerial lift bucket at all times.
