SURVEY AND VISUAL INSPECTION OF KEYSTONE BLOCK WALL  
AND EMBANKMENT SLIDE AT MIST LAKE PLAZA  
IN LEXINGTON, KENTUCKY

**Research Report KTC-98-6**

**March 1998**

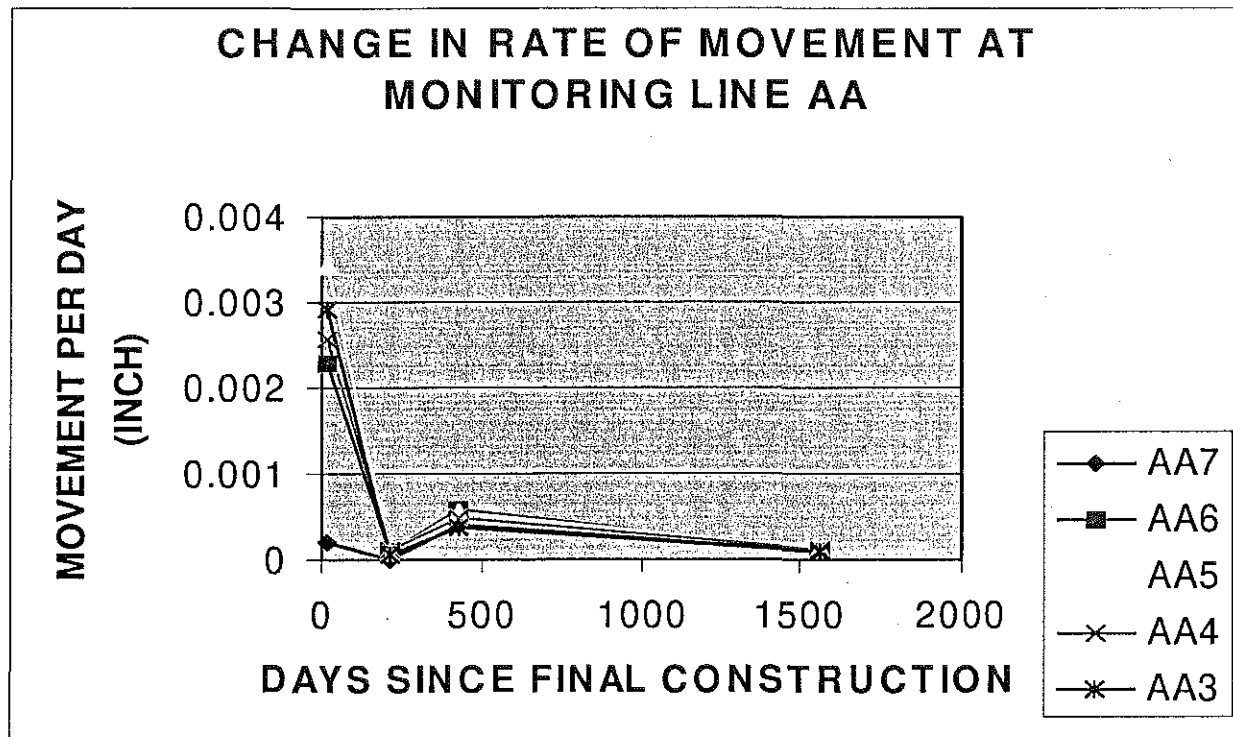
Figure 3. Monitoring Line AA

Readings taken by Black Engineering (Appendix A) indicate that the lower portion of the wall at Station A and Station B has moved forward 8 to 9 inches. It is apparent that a considerable amount of this movement had occurred during and shortly after construction. Approximately 1 to 2 inches of additional forward movement occurred between August 1994 and September 1997. To evaluate the rate of movement, data were analyzed back to May 22, 1993 when the wall was completed. The difference between readings has been plotted in Figures 3 through Figure 7. The Figures indicate that the rate of movement appears to have decreased significantly.

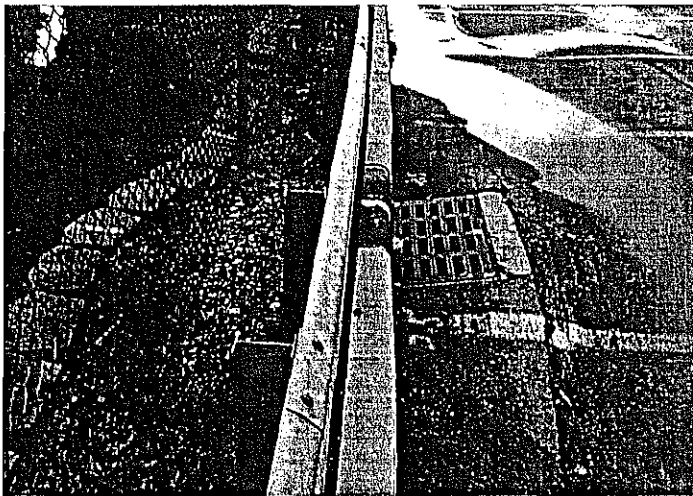
From visual observations, it is apparent that forward displacement has occurred just north of monitoring line C, directly behind vertical catch basin No. SD4 (Storm Drain No. 4) (see location in Appendix B). Figures 8 and 9 show the displacement in the Keystone Wall around SD4. It is apparent that settlement in the fill around the catch basin has caused some forward displacement in the face of the wall structure. It was apparent, at the time of the last survey of the wall face, that monitoring line C was not close enough to record any of this movement. An additional monitoring line was installed at this location on September 24, 1997. Additional monitoring will provide better information on current rates of movement in the various wall segments.

**Figure 8.** Showing change in wall alignment behind SD4.

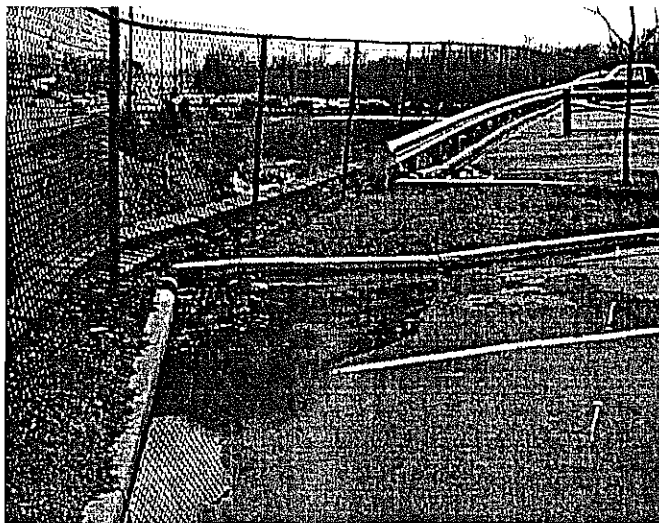
A significant amount of settlement also appears to be occurring on the north end of the wall at SD5 and SD6. This is shown in Figure 13 and Figure 14.

Figure 13. Settlement Observed Around SD6.

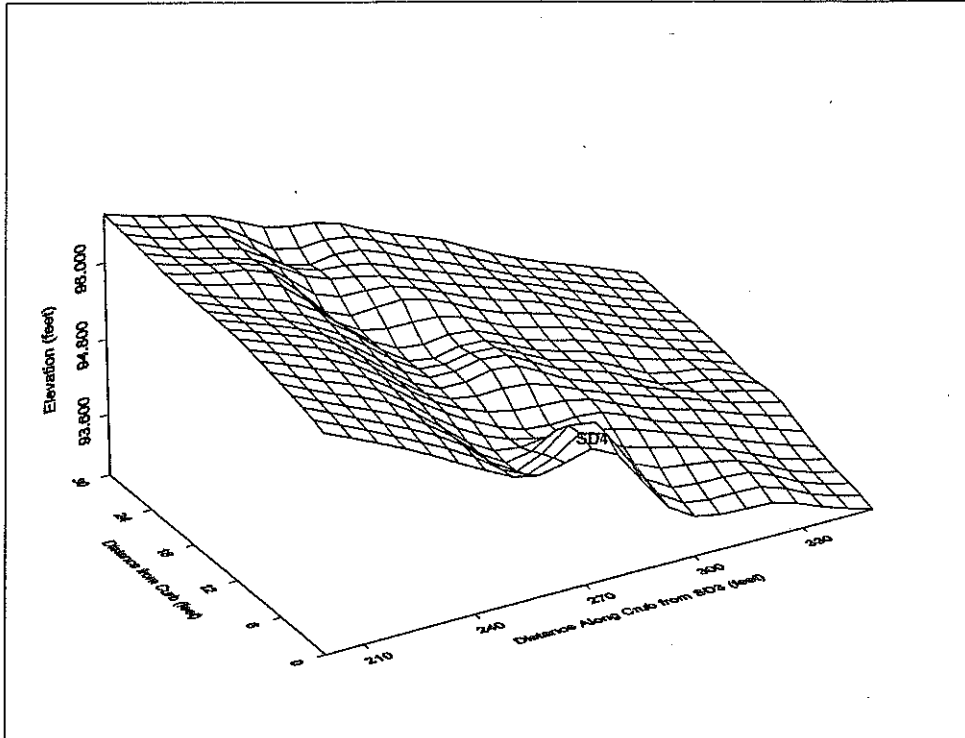
**Figure 14. Observed Around SD4.**
