TRUCK ROUTE ACCESS EVALUATION

Kenmor Stone and Ruth Brothers Quarry  
Olive Hill  
Site # 2620

Report No. KTC-98-27

Kentucky Transportation Center and the Department of Civil Engineering  
University of Kentucky

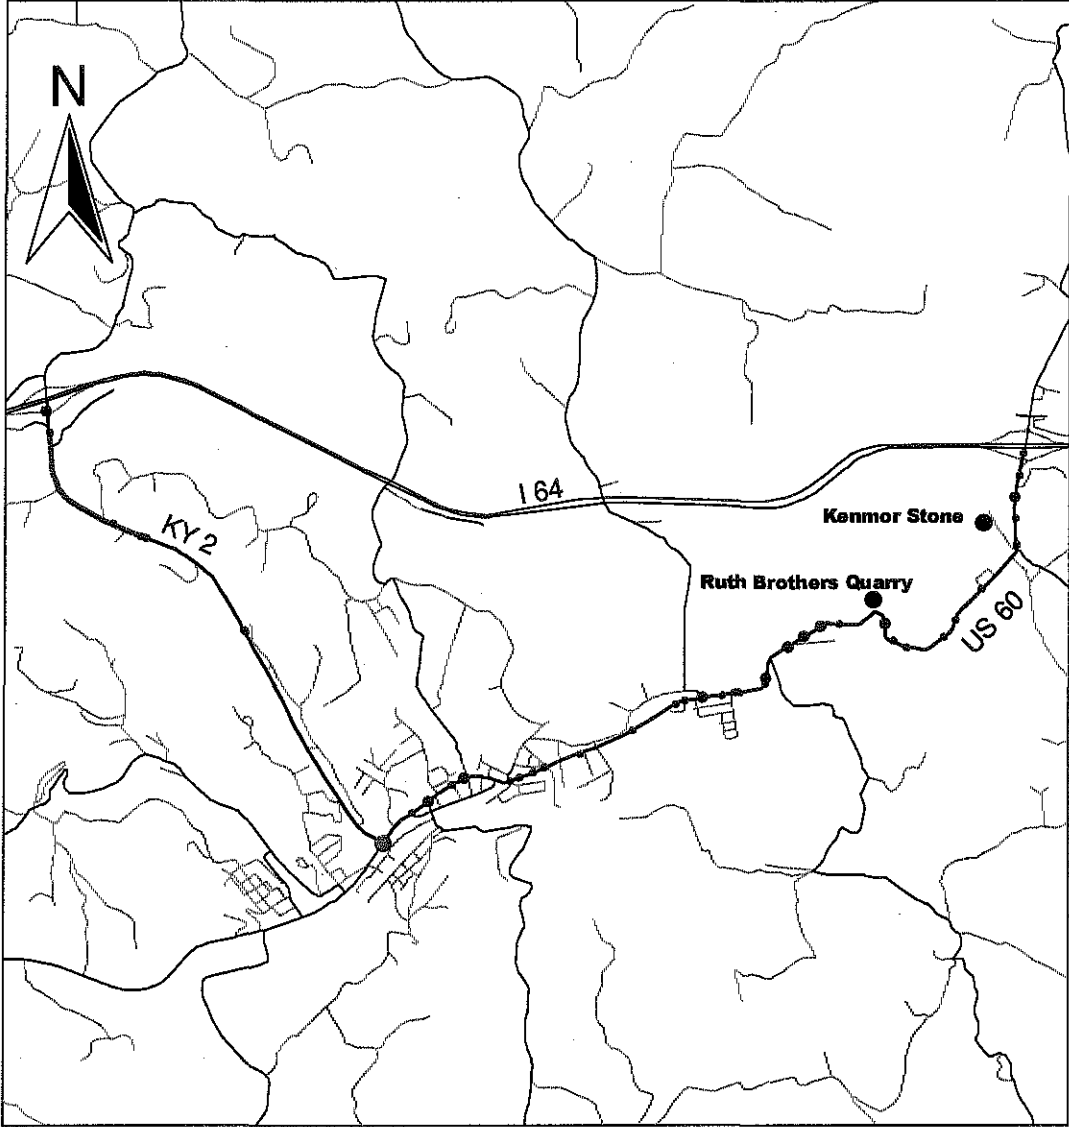
**Figure 2: Accident Locations (1994-1996)**

The section of KY 2 near I-64 (between milepoints 2.0 and 2.8) had a critical rate factor (the ratio of the actual accident rate to the critical accident rate) of 1.0 indicating that the truck accident rate is equal to the critical rate for that particular highway type. The section with a critical accident rate is shown in green in Figure 2.

Figure 2 also shows the locations of all accidents during the years 1994, 1995 and 1996. The figure shows that a majority of the accidents were on US 60, with a significant number occurring at intersections. This indicates that there are safety concerns along US 60. Most accidents on KY 2 were at the I-64 interchange or the intersection with US 60.

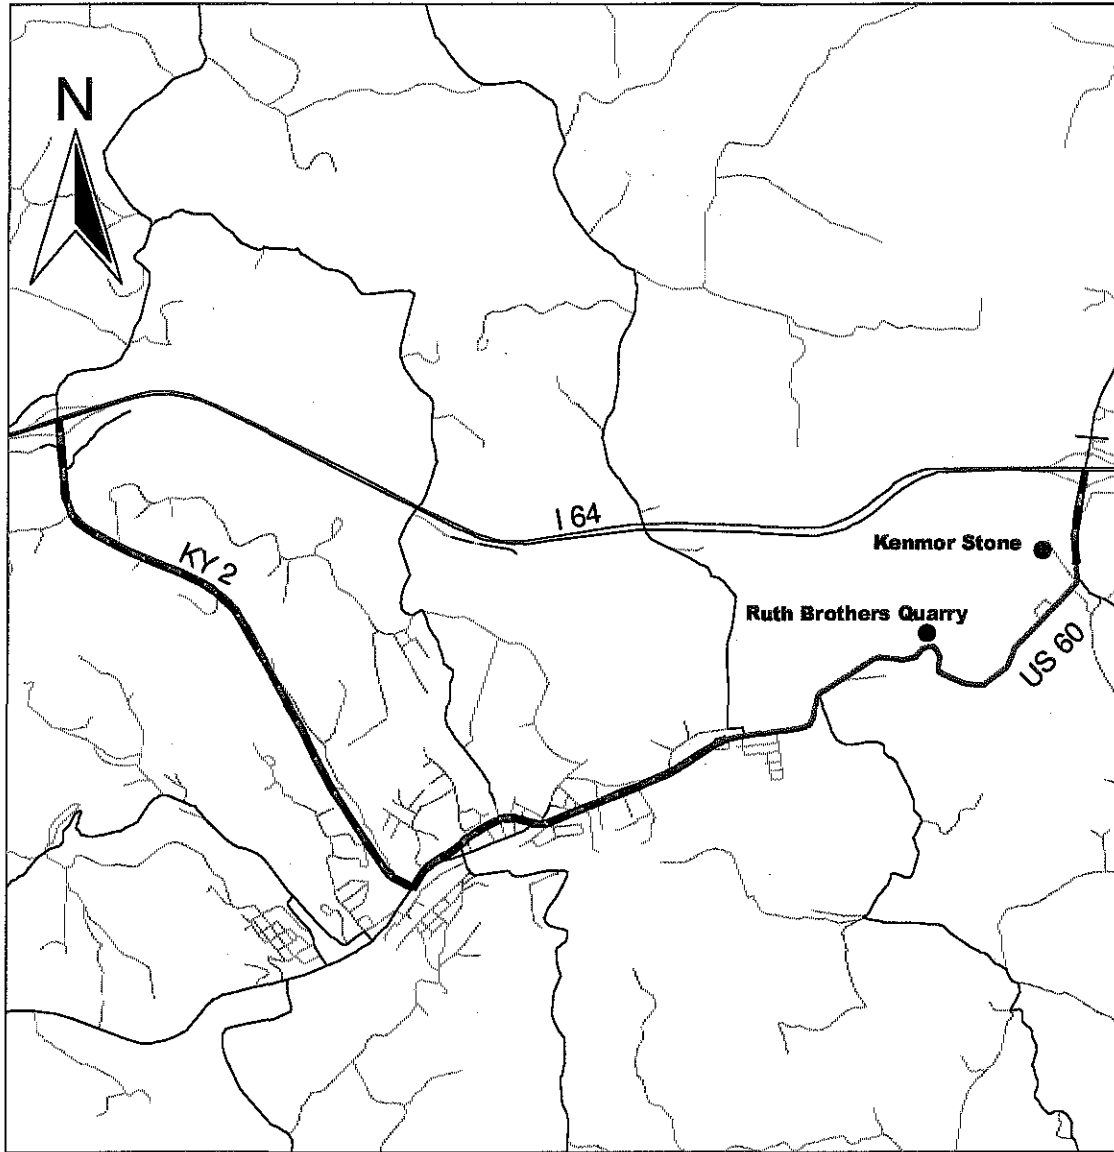
**Figure 3: Lane Widths**

Figures 3 and 4 illustrate the sections of the routes having different widths of lanes and shoulders. A 2.3 mile section of US 60 which includes the Ruth Brothers entrance has “adequate” 11 foot lanes. All other sections of both routes have “preferred” 12 foot lane widths. The eastern route includes 0.4 miles of US 60 with “adequate” 10 foot gravel shoulders. The remaining 1.5 miles have “less than adequate” 3 foot shoulders. The western route includes 0.8 miles of “less than adequate” 3 foot shoulders and 0.9 miles with no shoulder on US 60. The remaining 0.9 miles of US 60 and all of KY 2 have “adequate” 10 foot gravel shoulders. Sections of US 60 on both routes had inadequate clear zone with the most common problems being trees and drainage ditches. There were no significant clear zone problems found on KY 2. The pavement on both routes was generally good.

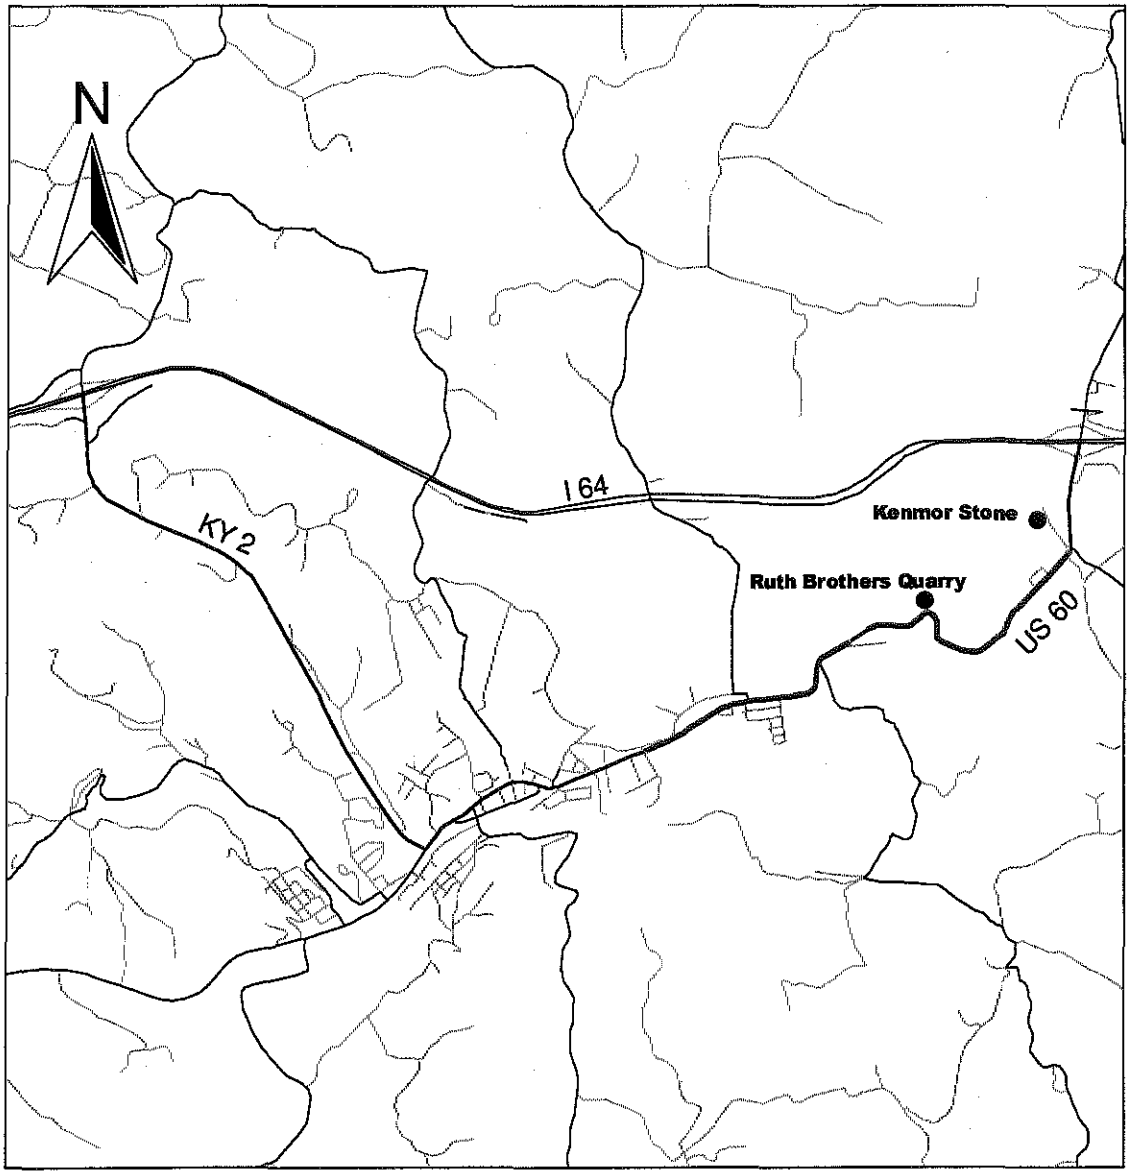
**Figure 5: Problematic Grades**

Grades are considered problematic if they cause trucks to slow down excessively. The locations of problematic grades (evaluated using AASHTO speed reduction tables) are shown in Figure 5. The eastern route includes three “less than adequate” grades. The western route also has three “less than adequate” grades on US 60 and one that was rated “adequate.” The most significant grade on US 60 (near Olive Hill) is not considered a problem because a climbing lane is provided. There is also a rather long hill on KY 2, north of Olive Hill that is not a problem because a climbing lane is provided for most of the hill.

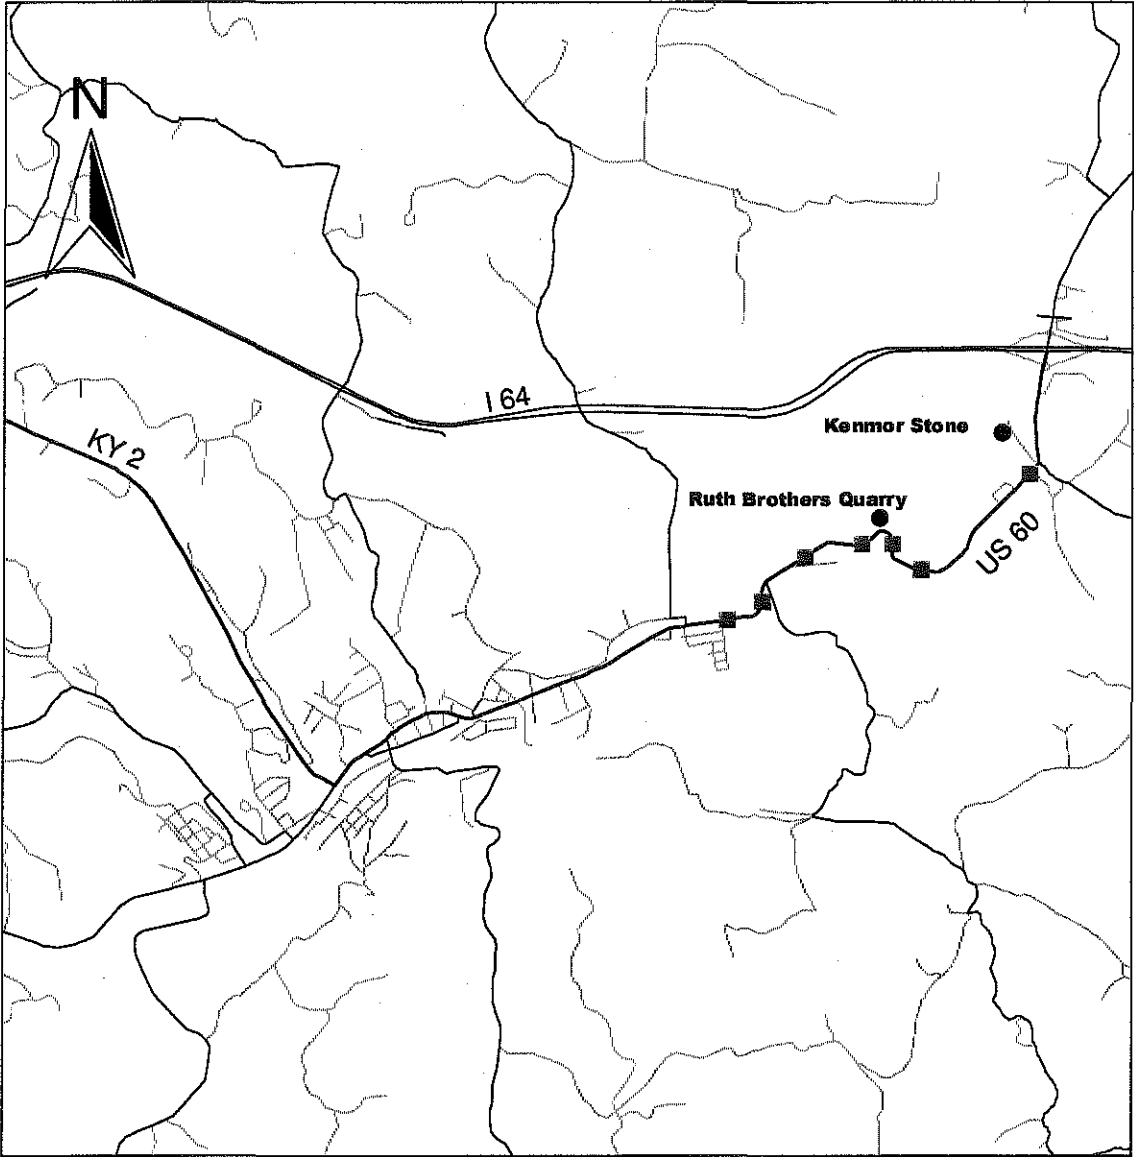
**Figure 7: Curves Where Safe Speed May be a Problem**

There are also some sections of US 60 where safe speed on a curve can be a problem as measured using a ball bank indicator. These curves are shown in Figure 7. The eastern route has two curves rated “adequate” and one rated “less than adequate.” A fourth curve has an advisory speed sign in one direction for an “adequate” rating, but does not have a similar sign for the other direction which gives it a “less than adequate” rating. The western route includes one curve receiving an “adequate” rating and two curves with a “less than adequate” rating.

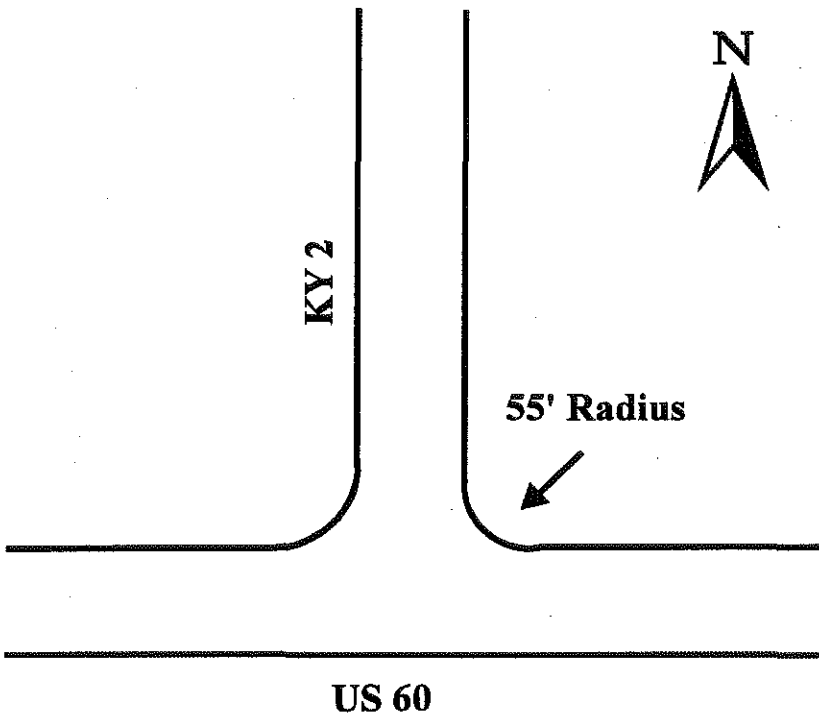
**Figure 8: Approximate Turning Radius at US 60 and KY 2**

The turning radius from US 60 onto KY 2 was approximated in the field. This location is shown in Figure 8. The turn (55 foot radius) was rated “less than adequate” because trucks are not able to complete the turn without encroaching on opposing traffic or starting the turn in the westbound through lane rather than the turn lane.

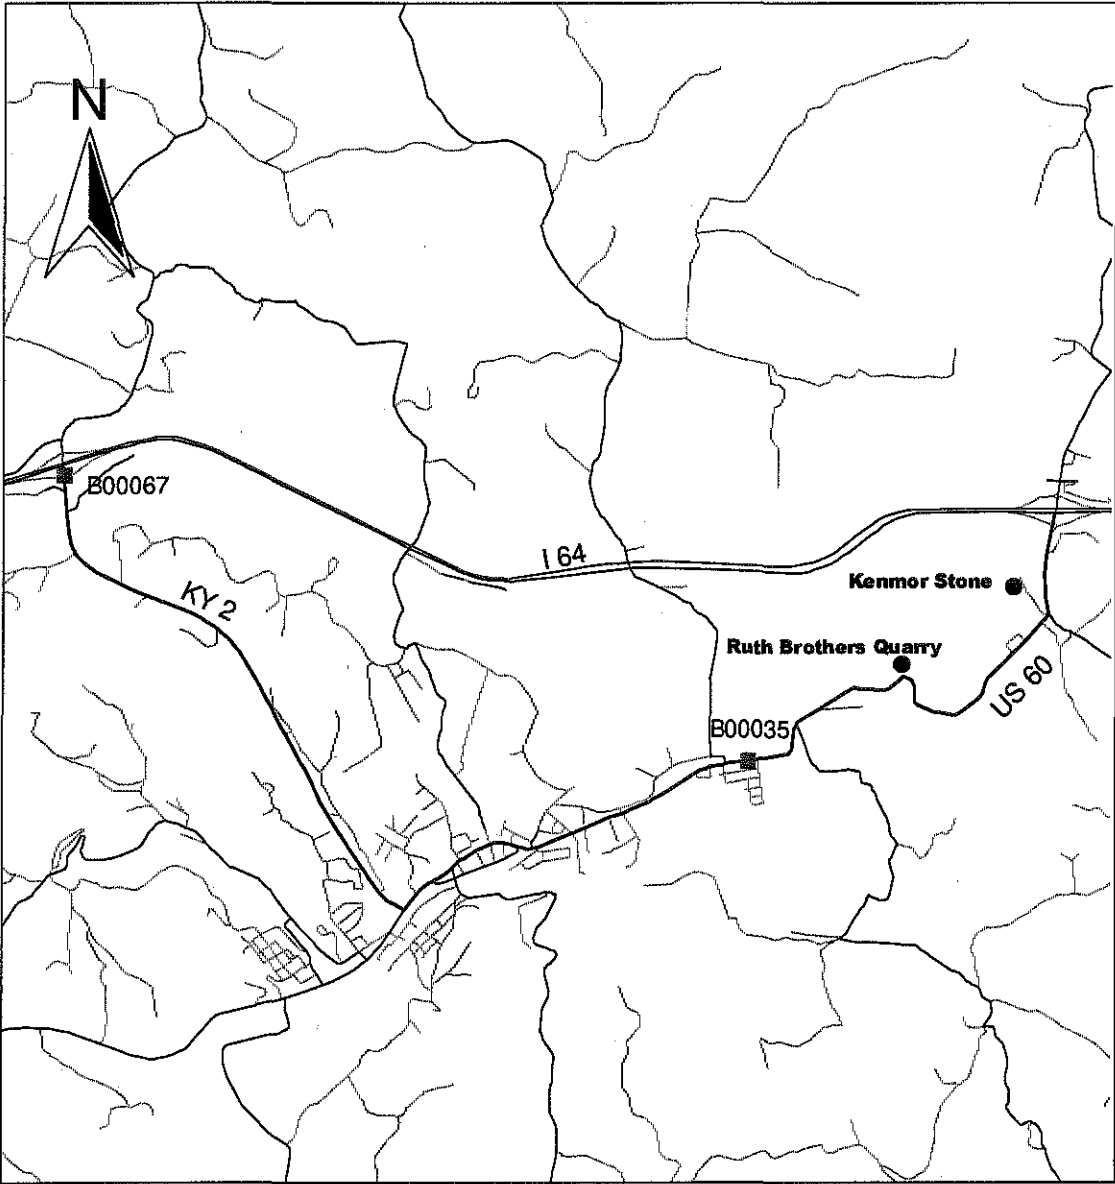
**Figure 9: Bridge Locations**

The location of the bridge on US 60 near milepost 11 is shown on Figure 9. The bridge has a sufficiency rating (provided by the Division of Operations at the KYTC) of 60.7 (out of a possible 100) which is considered “adequate.” The bridge is relatively narrow and obstructs the clear zone. The only other bridge along these routes is on KY 2 at the interchange with I-64. This bridge has a sufficiency rating of 81.6 which is “preferred.”

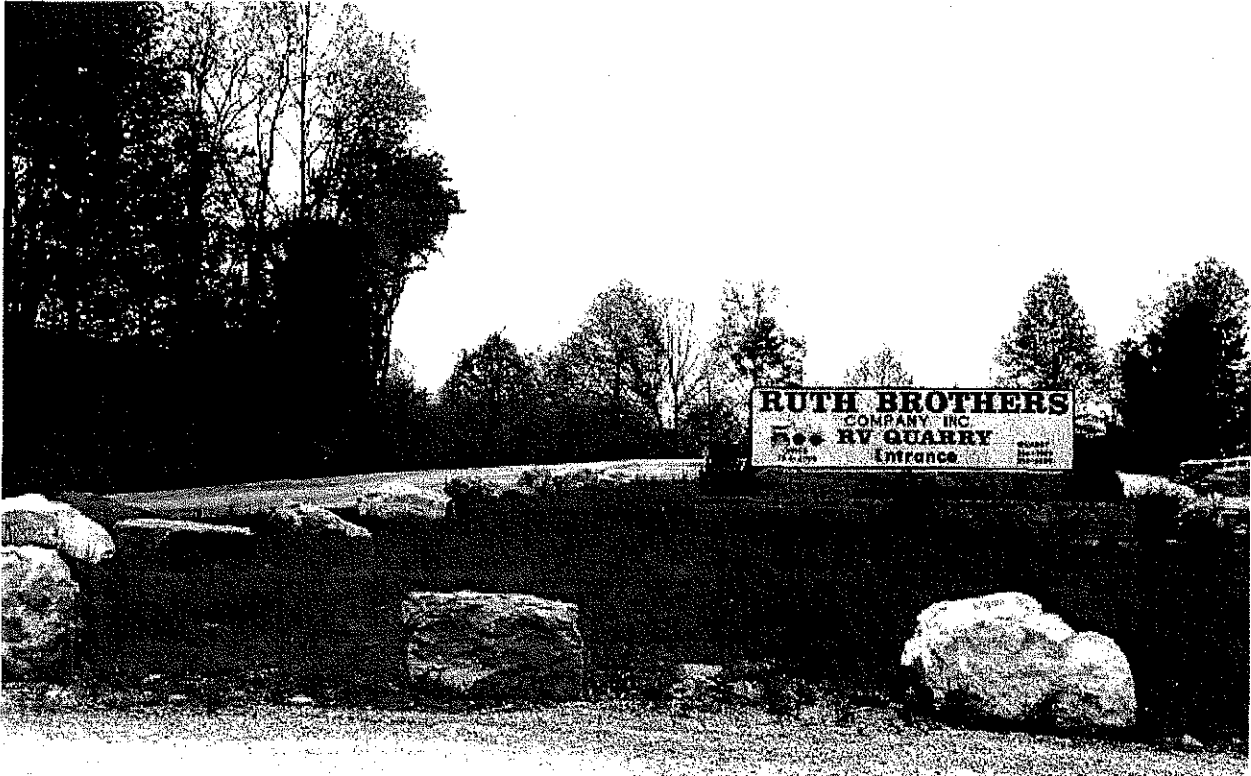
**Figure 10: Sight Distance at Quarry Entrance**

The sight distance was measured at the entrance of the Ruth Brothers Quarry where a sharp curve (shown in the background of Figure 10) limits the sight distance for truck turning left to travel east on US 60. The 300 foot distance is considered “adequate” because there are warning signs on US 60 indicating a truck entrance.
