TRUCK ROUTE ACCESS EVALUATION

Centennial Resources, Inc./B. Four, Inc.

On US 62 in Hopkins County

Report No. KTC-99-11

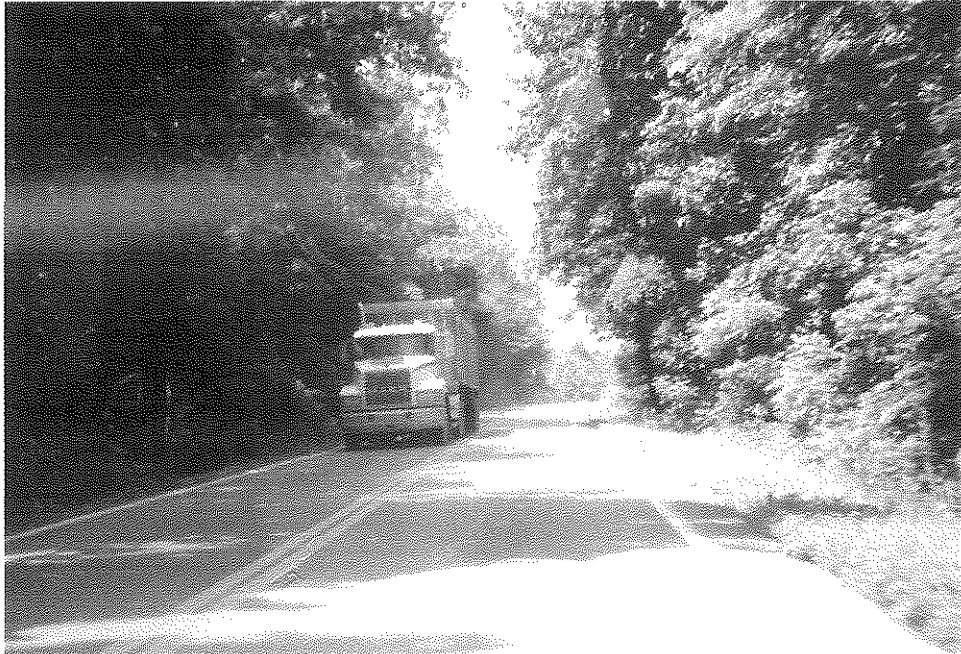
**Figure 2: Typical US 62 Cross Section**

Figures 4 and 5 illustrate the lane and shoulder widths along the route. The typical 10-foot lane widths on US 62 are considered “less than adequate”. The two-foot paved shoulders on US 62 are also considered “less than adequate”.

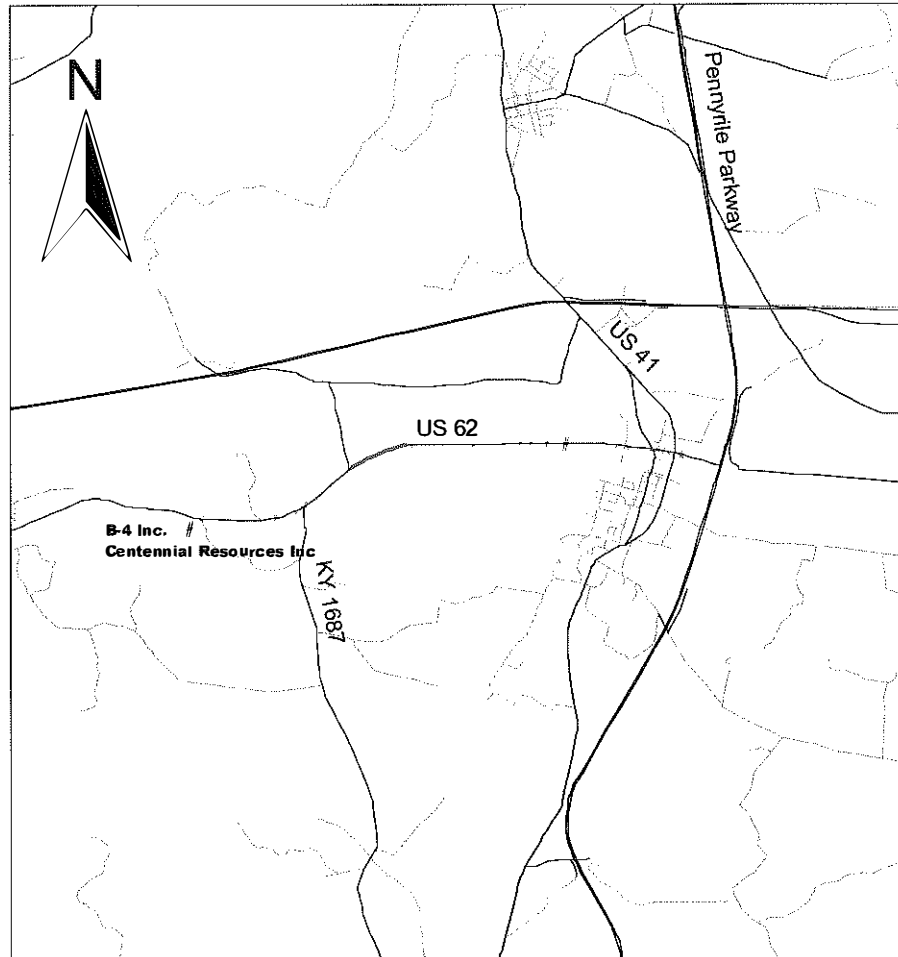
**Figure 3. Accident Locations (1995-1997)**

Figure 3 shows the locations of accidents during the years 1995, 1996 and 1997. The largest number of accidents occurred around the Pennyriple Parkway interchange. A summary of the accidents on US 62 between the Pennyriple Parkway interchange and coal facility is shown in Table 2 for the same three-year period. Eight of the 48 accidents involved a truck (17 percent), and this percentage was close to the 14 percent of heavy trucks on this route. The accident history does not show a pattern of types or locations of truck accidents so there has been no documented problem related to truck traffic.

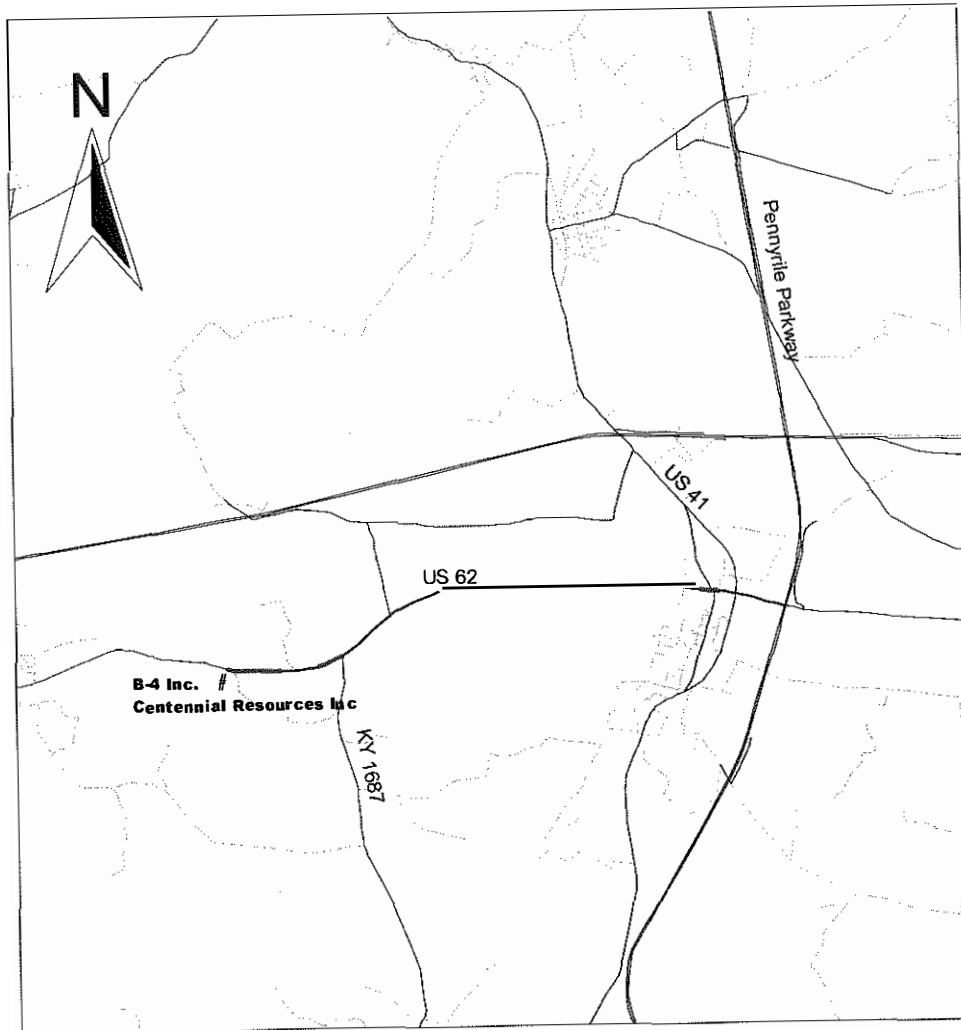
### **Figure 6: Grade Adequacies**

Grades are considered problematic if they cause trucks to slow down excessively. There were three grades which could potentially cause a truck to slow (Figure 6). Trucks exiting the facility enter US 62 on a steep upgrade for about 1,000 feet (Figure 7). There is an upgrade for trucks approaching the facility starting at KY 1687 and extending for about 0.3 mile. There is also an upgrade westbound approaching the bridge at milepoint 14.9.

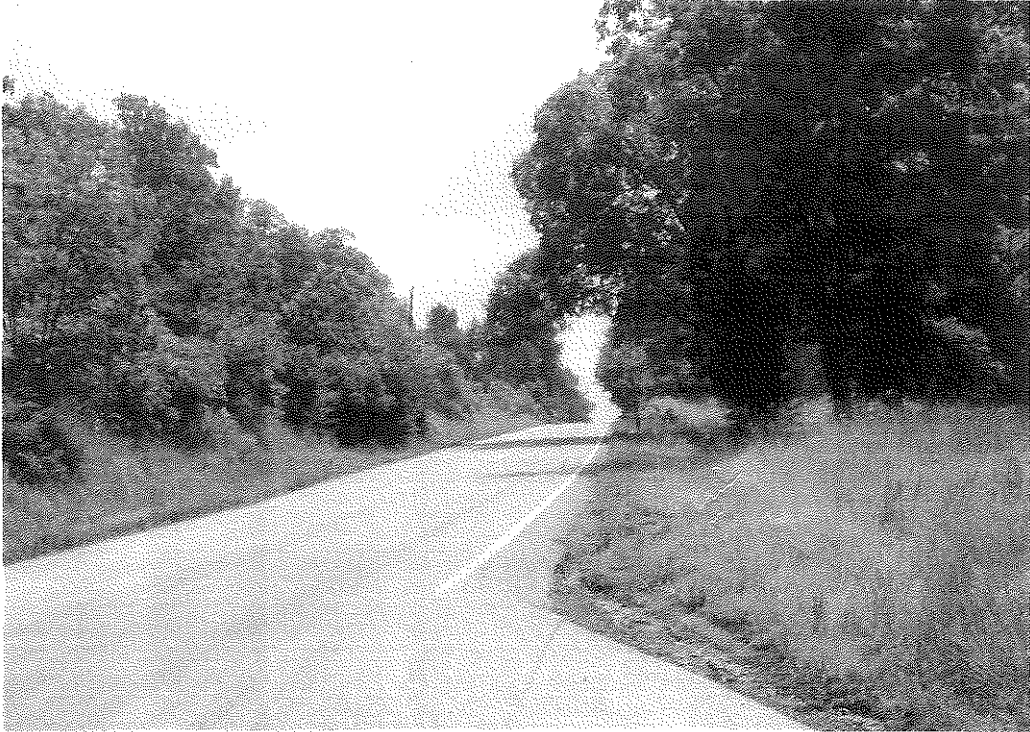
**Figure 7: Exit from Facility**

No sight distance problems were observed at any entrance or side street. The only possible problem would be for drivers exiting the facility observing westbound vehicles (Figure 7).

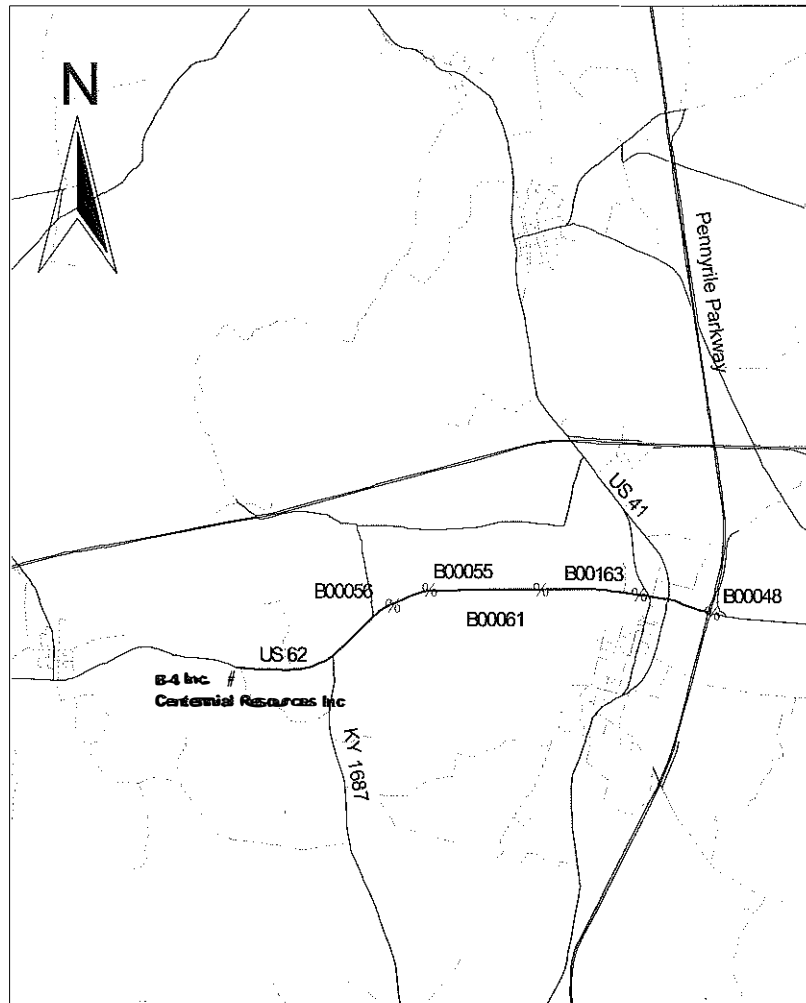
**Figure 8: Bridge Locations**

There were five bridges on this route (Figure 8). The bridge at the Pennyriple Parkway (milepoint 15.7) has a sufficiency rating (provided by the Division of Operations of the KYTC) of 81.4 (out of a possible 100 points) which is considered “preferred”. The other major bridge, which is over a railroad and stream (at milepoint 14.9), had a rating of 75.3 which is considered “adequate” (Figure 9). The other ratings were 80.3 (“preferred”) for the bridge at milepoint 12.3, 73.7 (“adequate”) for the bridge at milepoint 12.9, and 76.7 (“adequate”) for the bridge at milepoint 14.0.

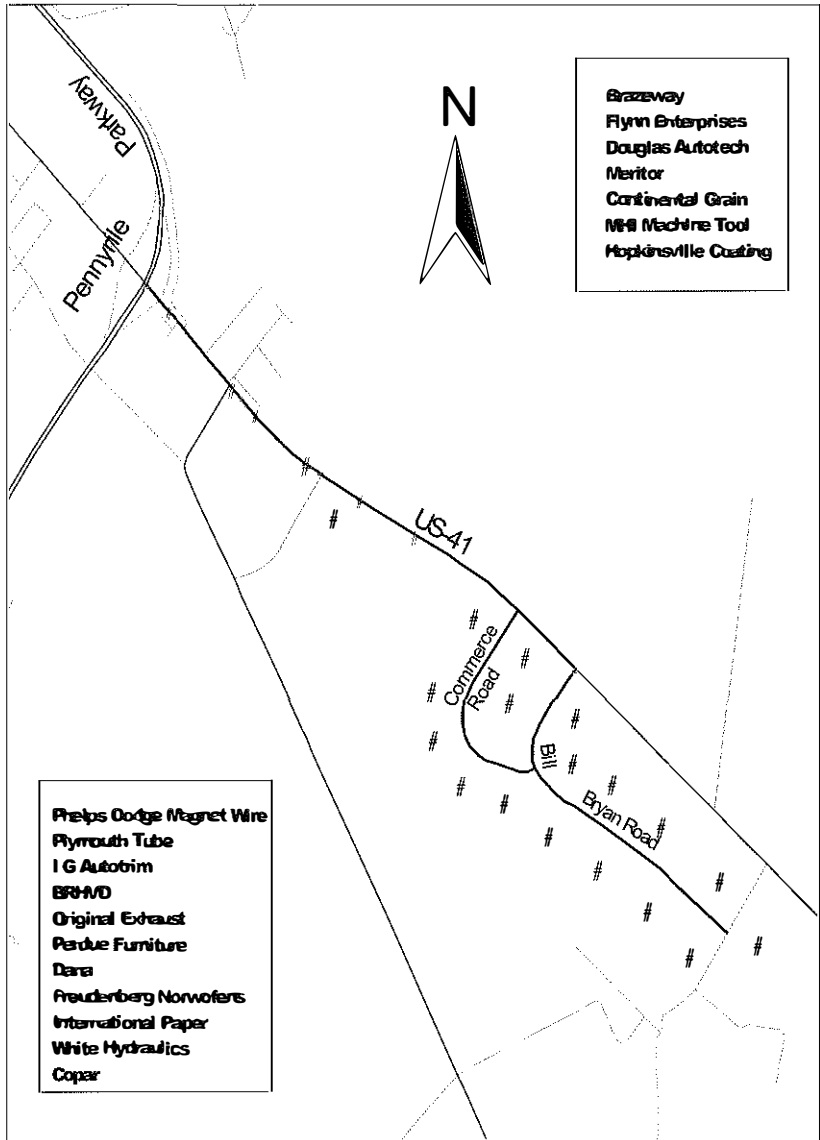
**Figure 4: Accident Locations (1994-1996)**

Figure 4 shows the locations of accidents during the years 1994, 1995 and 1996. The largest number of accidents occurred around the Pennyriple Parkway interchange. A summary of the accidents on US 41 between the Pennyriple Parkway interchange and Bill Bryan Road is shown in Table 2 for the same three year period. Only two of the 30 accidents involved a truck (6.7 percent), and this percentage was less than the 12 percent of heavy trucks on this route. The accident history does not show a problem related to truck traffic.

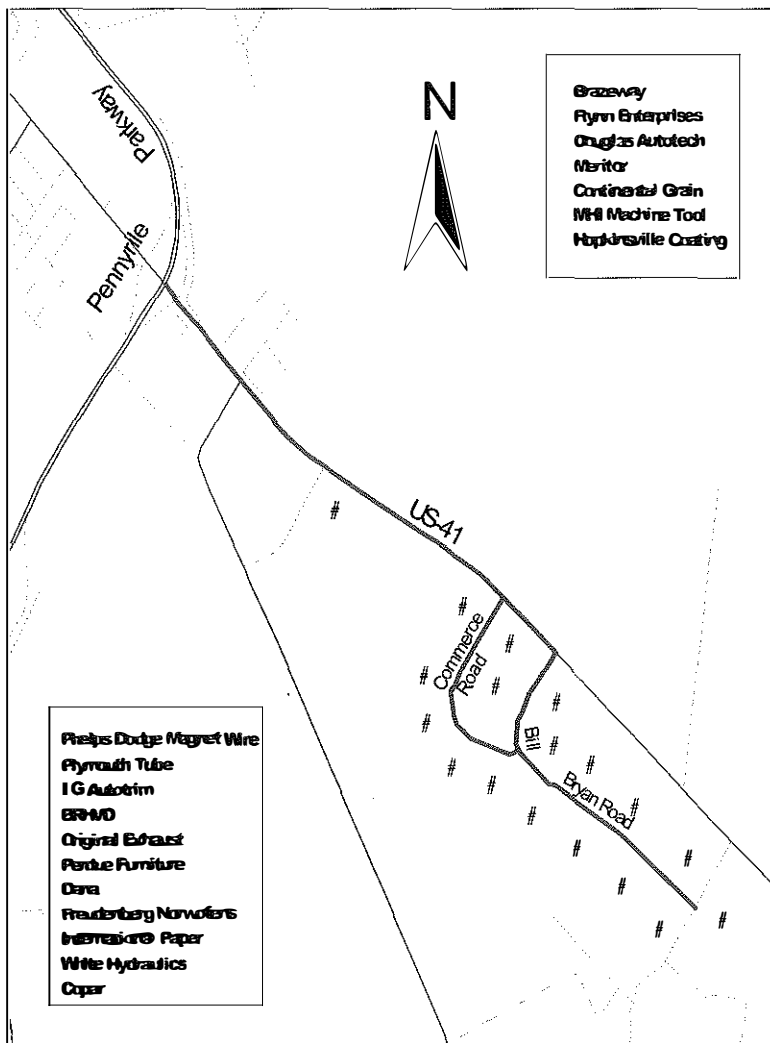
**Figure 5: Lane Widths**

Figures 5 and 6 illustrate the lane and shoulder widths along the route. The 12-foot lane widths provided on US 41 are considered “preferred” and the roadway widths on the road in the industrial park gave a lane width of over 12 feet (also “preferred”). The 10-foot gravel shoulders on US 41 are considered “adequate” while no shoulders were provided on the industrial park road (considered “less than adequate”).
