TRUCK ROUTE ACCESS EVALUATION

Seaboard Farms
Graves County
Site #2623

Report Number KTC-99-12

February 1999

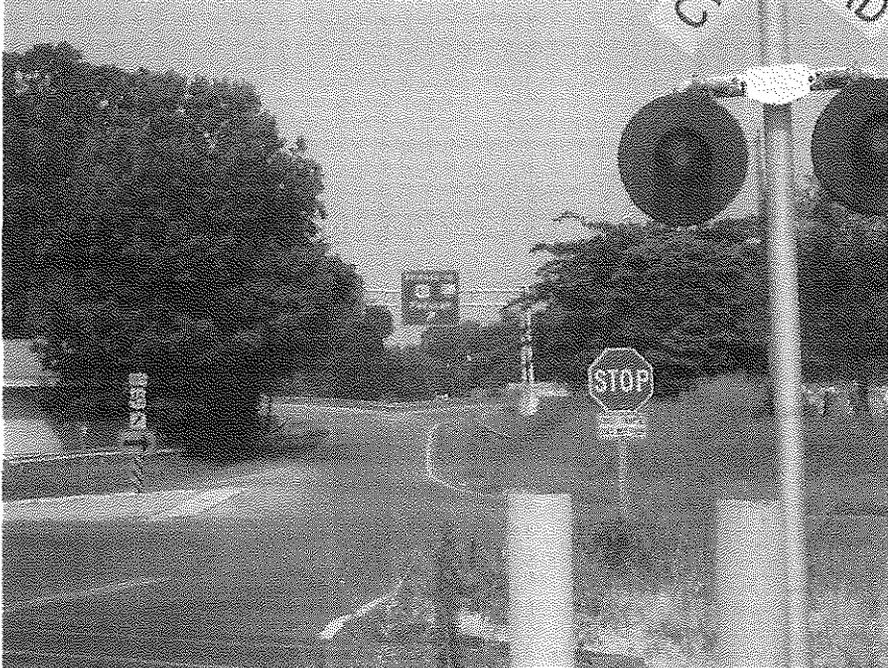
Figure 2: Entrance to US 45B (as seen from Macedonia Road)

There is one route used for access to the NHS, the Purchase Parkway in this case. Trucks leave the facility by Macedonia Road and travel west through the intersection of US 45 and Macedonia Road onto US 45B (bypass) as seen in Figure 2. Once on the bypass, the first ramp to the right allows trucks to proceed north to either the ramp for the westbound Purchase Parkway or US 45B runs directly into the eastbound Purchase Parkway at milepost 0.958. Trucks traveling to the facility can proceed directly south on the Purchase Parkway (turns into US 45B) if they are southbound, or remain on the parkway if they are eastbound. At the intersection of US 45B and US 45, trucks turn left and proceed northeast on US 45 for approximately 0.2 miles (as seen in Figure 3). US 45 is a two-lane, one-way road (from US 45B to the intersection of Macedonia Road). Trucks then turn right onto Macedonia Road, cross the railroad tracks, and then turn left into the Seaboard Farms entrance approximately 200 feet from the intersection. Total route length is approximately 0.5 miles for outgoing trucks and 0.65 miles for incoming trucks. The average daily traffic (ADT) on US 45 is 6,100 vehicles per day (from 1996 KYTC traffic counts) and the ADT on US 45B is 7,274 vehicles per day (from 1998 KYTC traffic counts).

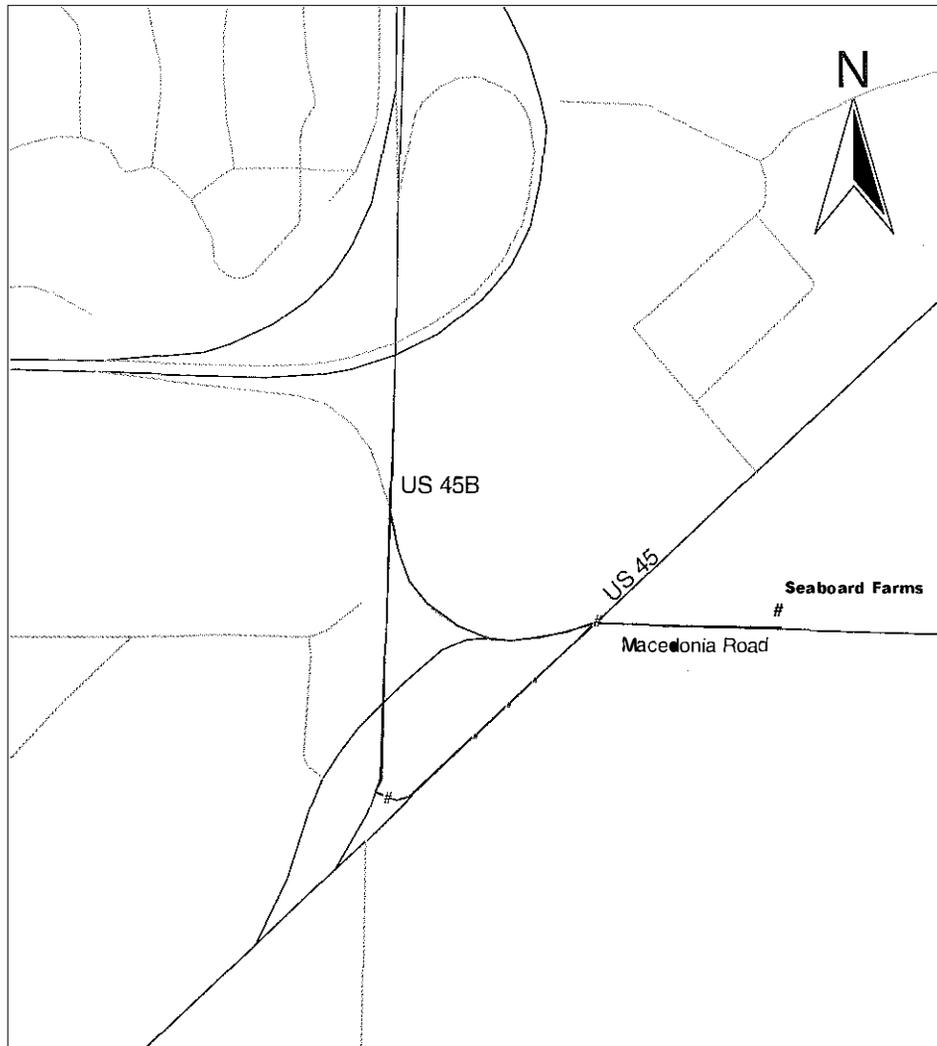
Figure 4: Accident Locations (1995 - 1997)

Figure 4 shows the locations of accidents during the years 1995, 1996, and 1997. A summary of the accidents along the truck route (for all roads, not just state-maintained roads) is shown in Table 2 for the same three-year period. Just 1 of 21 accidents on the route involved a truck. Thus, truck accidents are assumed to not be a problem for the route. However, the relatively high numbers of accidents occurring at the intersections of US 45 and US 45B (8 accidents) and US 45 and Macedonia Road (8 accidents) suggest that there are some concerns for these intersections from a recent accident history point of view. More discussion of the intersection of US 45 and Macedonia Road can be found in Section 3.4 and of the intersection of US 45 and US 45B in Section 3.8.

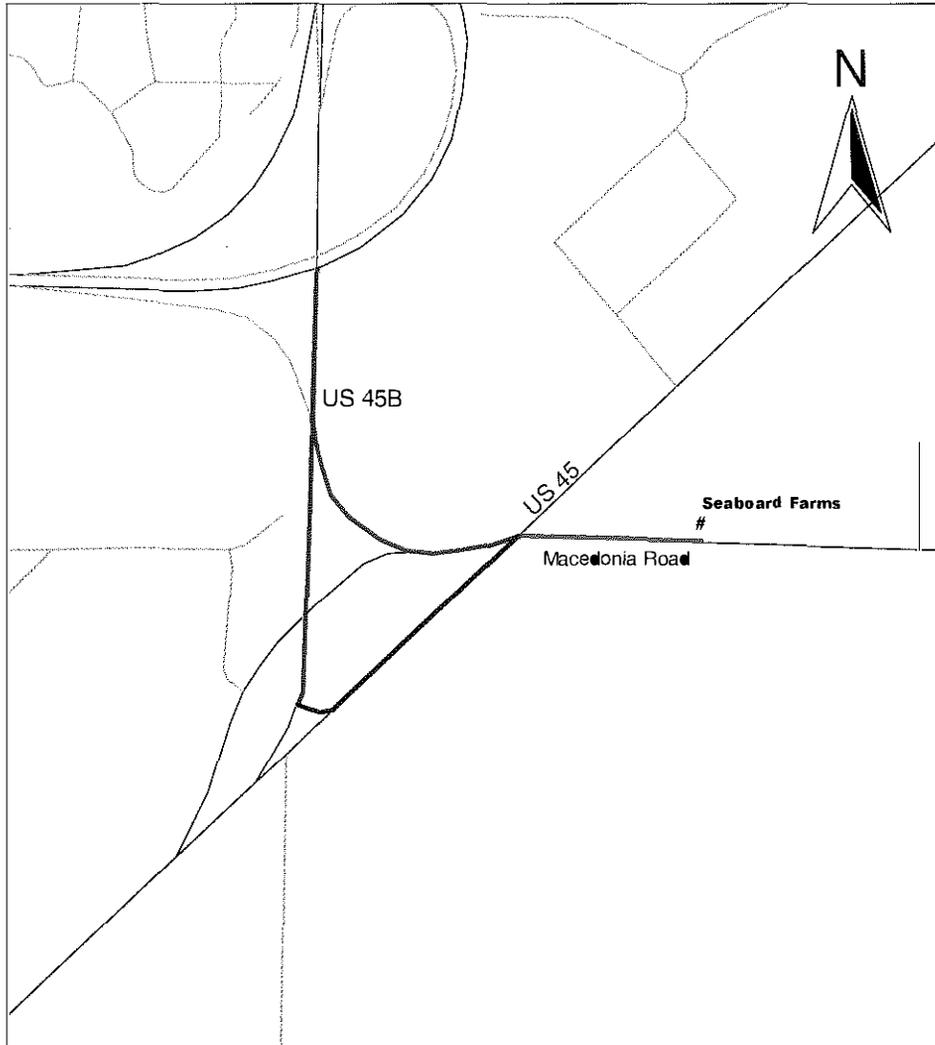
Figure 5: Lane Widths

Figures 5 and 6 illustrate the sections of the route with different lane widths and shoulder types, respectively. Macedonia Road has only 10-foot lanes and 2- to 4-foot turf shoulders, both of which are “less than adequate”. US 45 has “adequate” 11-foot lanes and “less than adequate” 2- to 4-foot turf shoulders. US 45B has “preferred” 12-foot lanes (the ramp portions have 16-foot lanes) and the southern portion (milepost 0 – 0.69) has “less than adequate” 5-foot turf shoulders. The northern section (milepost 0.69 – 0.96) has “adequate” 10-foot turf shoulders.

The intersection of US 45 and Macedonia Road could be improved by widening the lanes on Macedonia so that trucks have more space available to turn into. However, with the railroad crossing so close to the intersection, this may not be feasible. Consideration should be made for placing warning signs on US 45B so that drivers are aware of the turning bay deficiencies. In order to correct the lane width and shoulder problems along this route, complete reconstruction would be necessary. However, the problems associated with lane and shoulder widths are not severe enough to warrant such action.

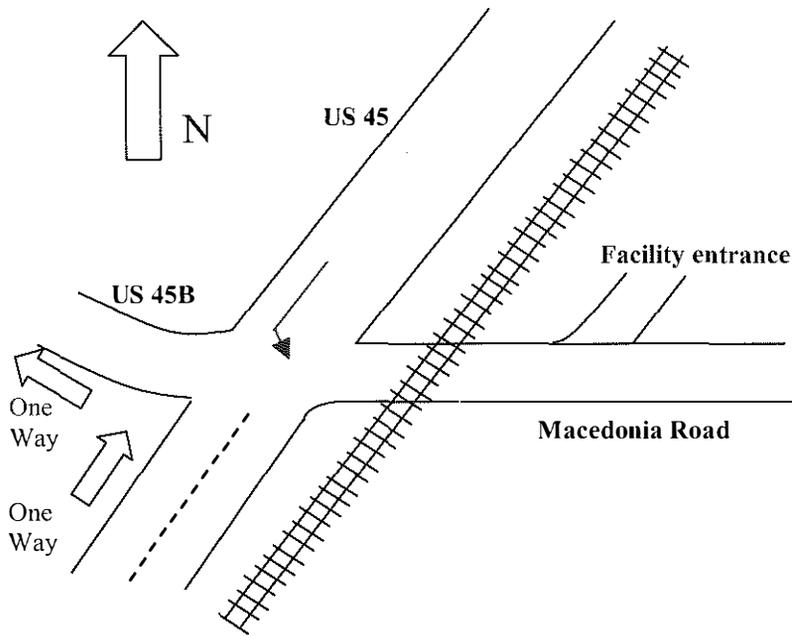
Figure 7: Intersection of US 45 and Macedonia Road

One left-turning radius (shown in Figure 7) was observed as being problematic for trucks. The intersection of US 45 and Macedonia Road has a sharp left-turning radius for trucks (turning left from southbound US 45). During the site visit for data collection, trucks were observed encroaching into opposing lanes in order to make the turn onto Macedonia. This intersection is not problematic for right-turning trucks. However, it is still “less than adequate” for the purposes of this study.

There is one at-grade railroad crossing along this route. The crossing is on Macedonia Street immediately west of its intersection with US 45 (see Figure 7). There are no problems with sight distance at this crossing and warning lights (but no gates) are present. The crossing surface is in good condition. One potential problem with this crossing is its proximity to the stop-controlled intersection of US 45. When a train is passing over the crossing, traffic can back up on US 45 and/or Macedonia Road. A semi-trailer can not be waiting at the stop bar at the end of Macedonia because the trailer would back up onto the tracks. However, given the character of the area and the long tangent available for sight along the tracks, trucks should have adequate warning before a train enters into the area. Thus, the crossing is not problematic and is considered to be “preferred”.

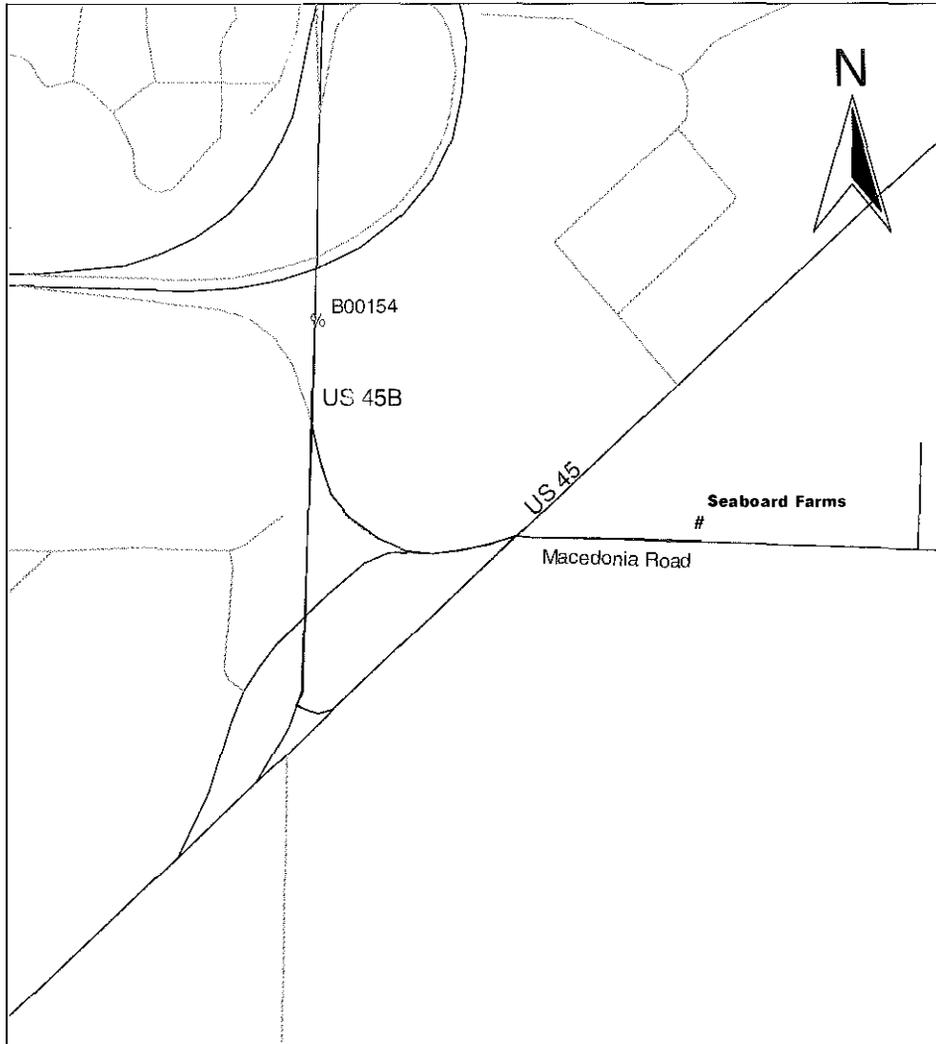
Figure 8: Bridge Location

There is one bridge on US 45B, shown in Figure 8. The Kentucky Transportation Cabinet’s Division of Operations maintains a database of bridge sufficiency ratings that are based on the serviceability (as well as other factors) of the structure. This bridge, located just south of the Purchase Parkway, received a sufficiency rating of 76.1 which is considered “adequate”.

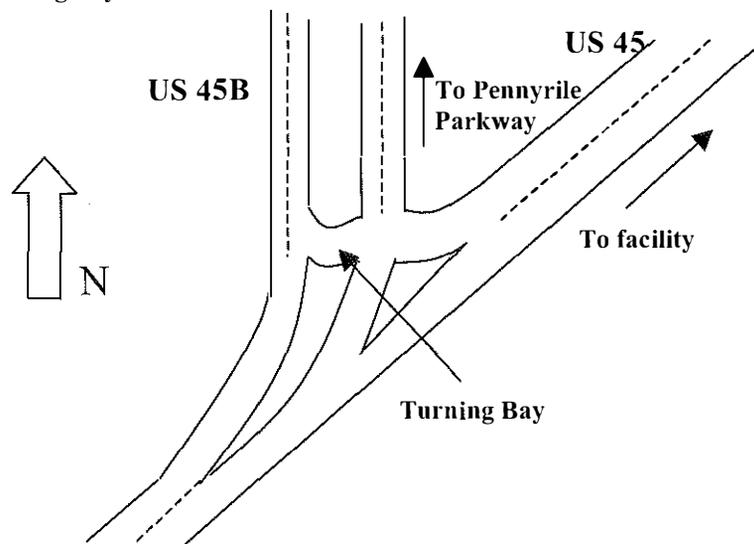
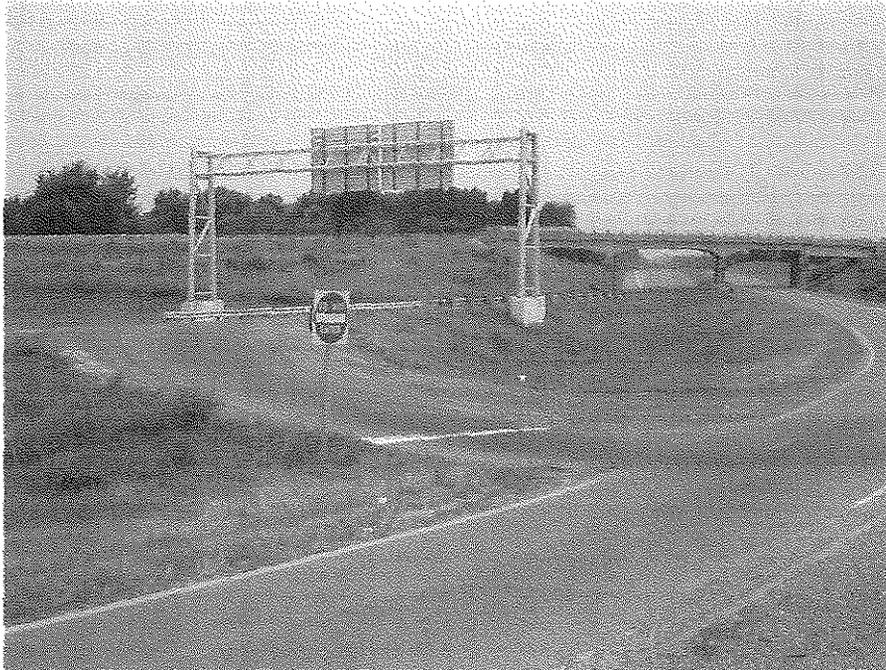
There are no inadequacies in clear zone along the route’s length. Pavement along all route sections was in good condition, with the exception of the turning bay from US 45B to US 45. Pavement along the northern side of the turning bay is in poor condition.

The phone survey indicated that trucks sometimes miss the exit from US 45B onto the southbound Purchase Parkway and try to turn back northbound (back onto US 45B) at the intersection with US 45. The left turning bay (pictured in Figures 9 and 10) at this intersection requires very sharp turns to make such a maneuver. In addition, the turning bay does not provide adequate room for storage of trucks making left turns from US 45B onto US 45. The bay is approximately 45 feet in length, which requires that trucks have portions of their trailers remaining in the left lane of US 45B since there is no turn lane or storage queue.

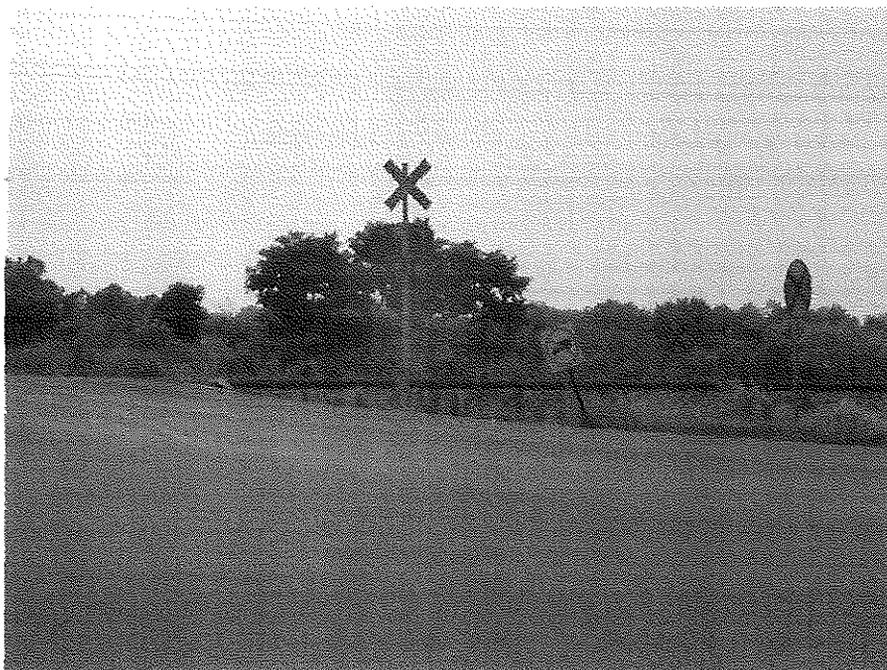
Figure 11: "No Trucks" Sign as Seen from Southbound US 45

Another route feature worthy of mention is shown in Figure 11. The “No Trucks” sign at the intersection of Macedonia Road and US 45 indicates that Macedonia is closed to through-truck traffic, but the sign can only be seen from southbound US 45. It is believed that the only trucks utilizing Macedonia are traveling to Seaboard Farms’ mill. Truck usage of the route should be clarified and appropriate signs should be installed.
