Research Report  
KTC-96-24

**VISUAL INSPECTION OF NEW RAMP PAVEMENT  
AT BLUEGRASS AIRPORT  
LEXINGTON, KENTUCKY**

David L. Allen  
Chief Research Engineer

October 25, 1996

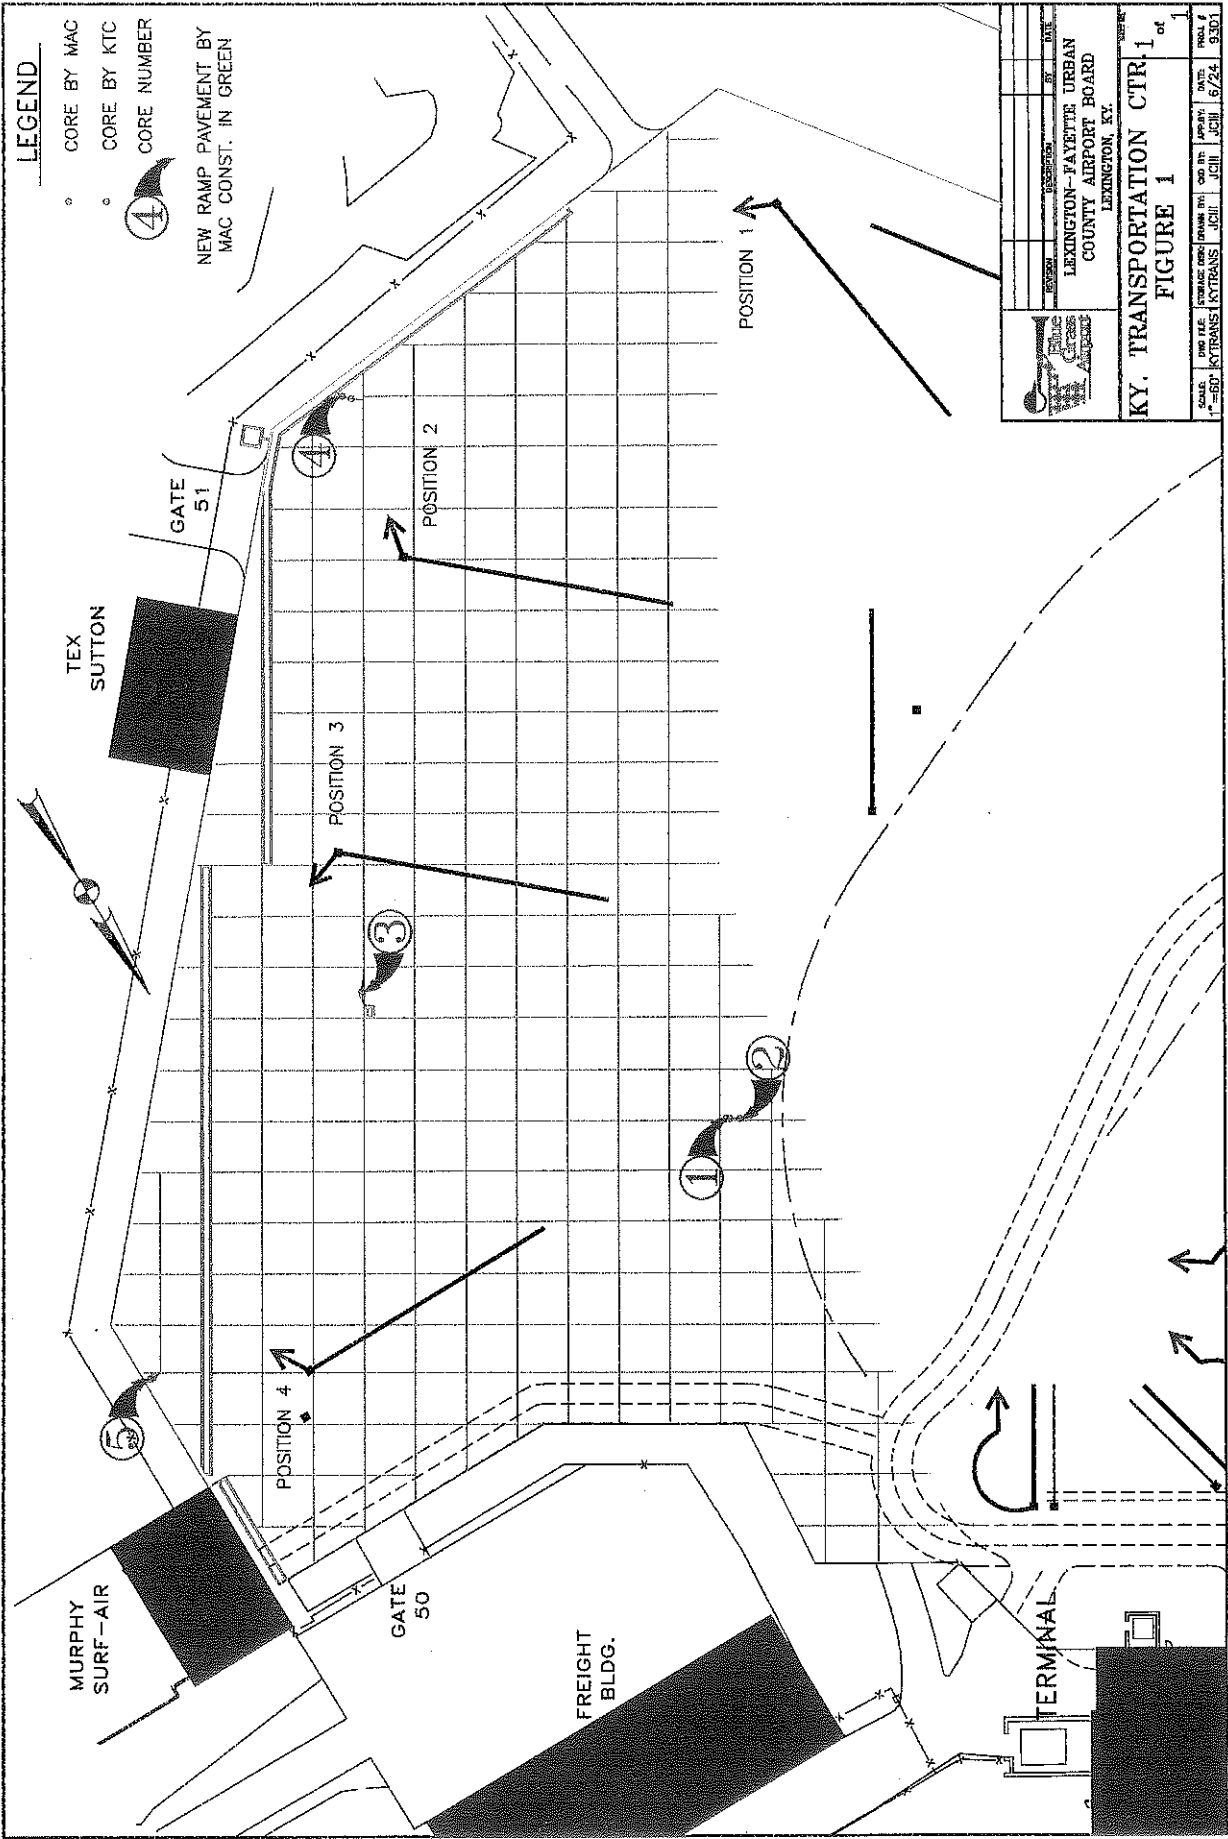
LEXINGTON-FAYETTE URBAN COUNTY AIRPORT BOARD LEXINGTON, KY.	
<b>FIGURE 1</b> of 1	
DATE: 1/24/24 DRAWN BY: JCH CHECKED BY: JCH SCALE: AS SHOWN	DATE: 1/24/24 DRAWN BY: JCH CHECKED BY: JCH SCALE: AS SHOWN

Five two-inch diameter cores were obtained on June 3, 1996. The locations are noted on Figure 1. Four of the five cores were cut where the panels were cracked and had been sealed with epoxy. Core 2 was taken in a location where there was no crack. Figures 2 through 5 show the condition of the extracted cores. Cores 1, 3, 4 and 5 were in very poor conditions. Core 2 was in good condition, with one horizontal crack that was apparently caused by the coring process.

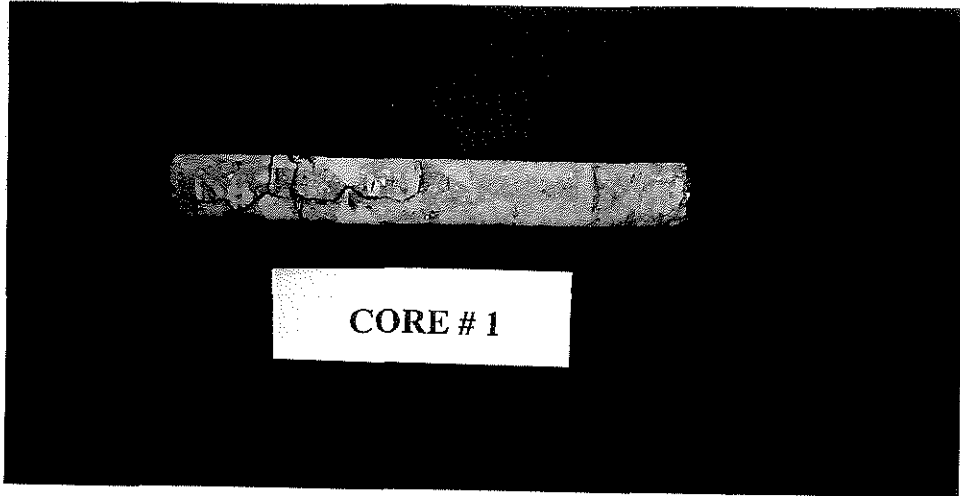
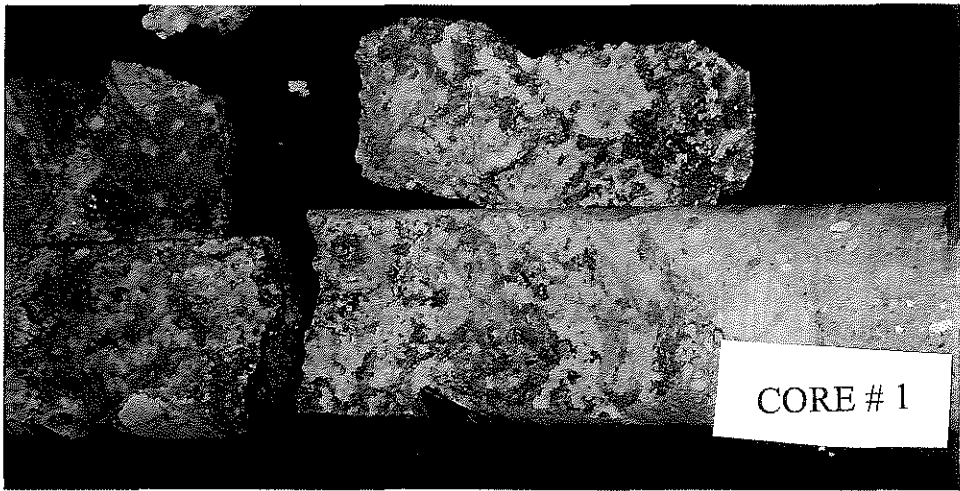
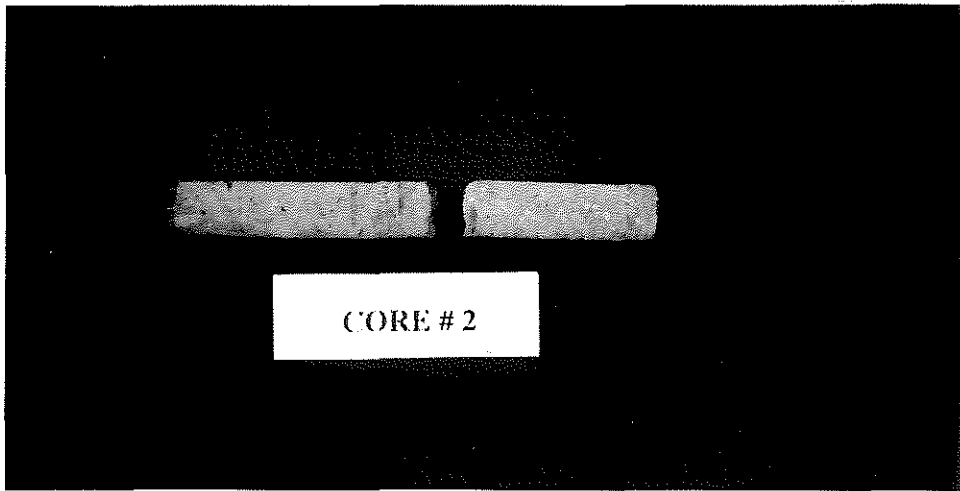
Fig. 2

All of the cores that had vertical cracks and had been sealed with epoxy fell apart except Core 5. However, it came apart along two horizontal cracks. Figures 2 and 3 show that the epoxy apparently did not provide much adhesion or tensile strength across the cracks. From Figure 2, it appears the epoxy did not completely fill all of the cracks, leaving portions of the surface area of the crack without side-to-side bonding and without an effective seal against water.

1. All apron slabs that have cracked (including those that attempts have been made to seal with epoxy) should be replaced or partial slab replacement should be performed. If partial slab replacement is chosen, there should be straight saw cuts through the entire width of the slab ("dog leg" cuts should not be permitted). The portion of the slab to be replaced should not have a length-to-width ratio of greater than 2:1.

2. If an entire slab is to be replaced, dowel bars should be used on all four edges of the slab. If a partial slab is to be replaced, the saw-cut edge should be fitted with reinforcing steel bars grouted into the original portion of the slab, and should be of sufficient length to develop full bond. This is an attempt to make the new replacement portion of the slab act as a unit with the original part of the slab. The remaining three edges of the new replacement portion of the slab should be doweled with the adjacent slabs.

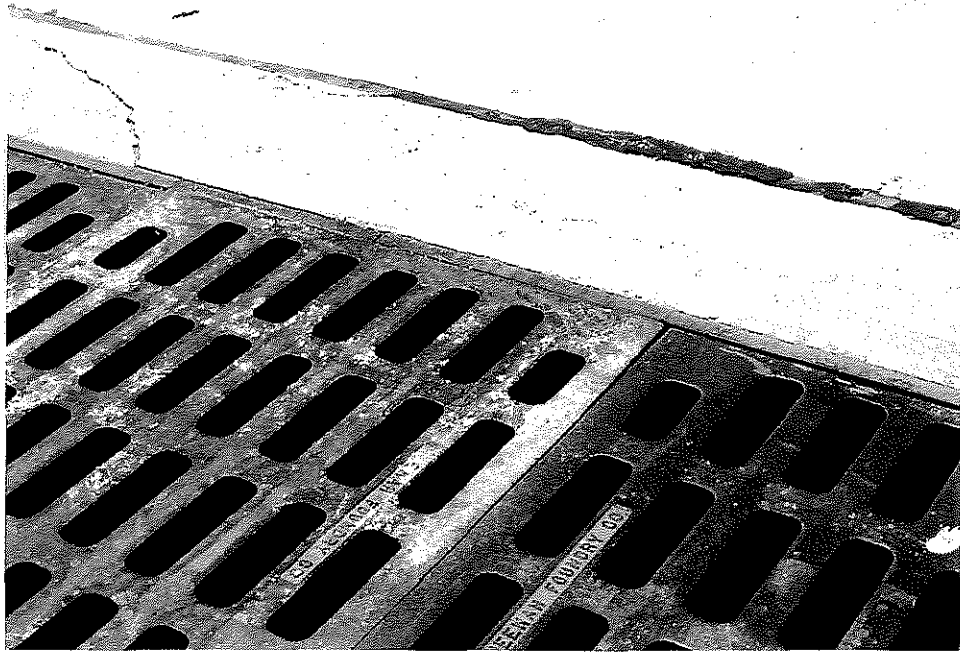
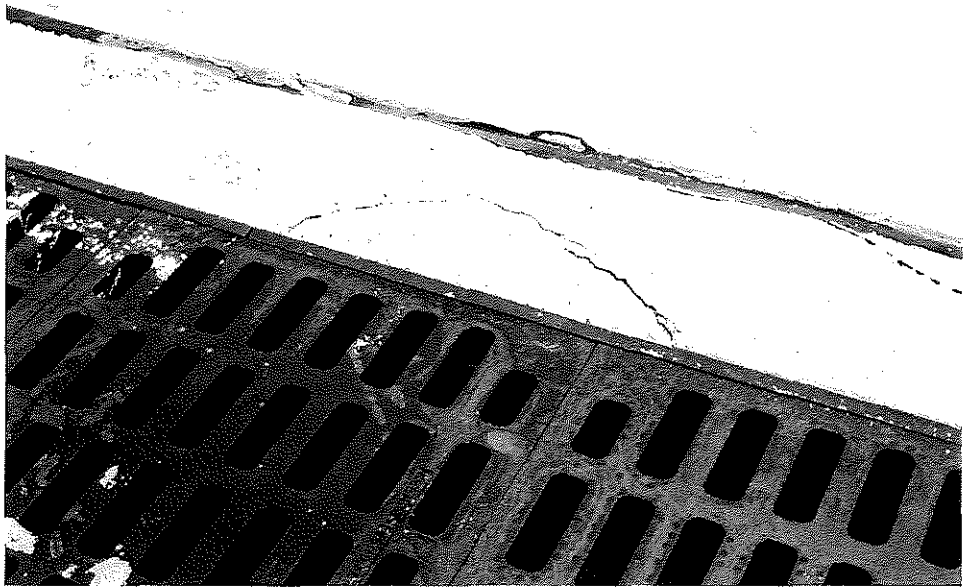
Fig. 5

As shown in Figure 1, there are two concrete drainage trenches located on the south and southeast sides of the apron. Both trenches are covered with steel grating as shown in Figure 5. The steel grating rests on a steel angle frame that was cast in place in the concrete wall of the trench (noted in Figure 7). It appeared that all or most of the 2-foot by 2-foot sections of steel grating were wedged extremely tightly into the steel angle frame. Some of the individual sections of the steel grating had spot welds at the corners in an apparent attempt to make the grating fit more tightly into the steel frame. It appears the grating has little or no room for temperature expansion because of the tight fit in the steel angle frame.

It appears the compressive strength of the concrete has been exceeded at several places along the trenches, because of the temperature expansion of the steel grating. Figure 5 shows two of these locations. The half-moon-shaped cracks should be noted in those photographs and they are, in all probability, the result of the failure of the concrete caused by the attempted expansion of the steel grating. Those half-moon cracks exit the concrete wall of the trench (on the inside of the trench) approximately one to two inches below the bottom of the steel angle frame.

3. The half-moon cracks along the edges of the drainage trenches should be repaired. The steel grating should be removed and the top portion of the wall of the trenches should be jack hammered down to the top level of the reinforcement steel of the wall. Vertical reinforcement steel should be drilled and grouted into the remaining portion of the trench wall. The wall should then be repoured up to the original grade elevation. This would include recasting the steel angle frame in place as the concrete is being repoured. A sufficient gap should be allowed between the steel angle frame and the steel grating to permit temperature expansion of the steel grating in the future.

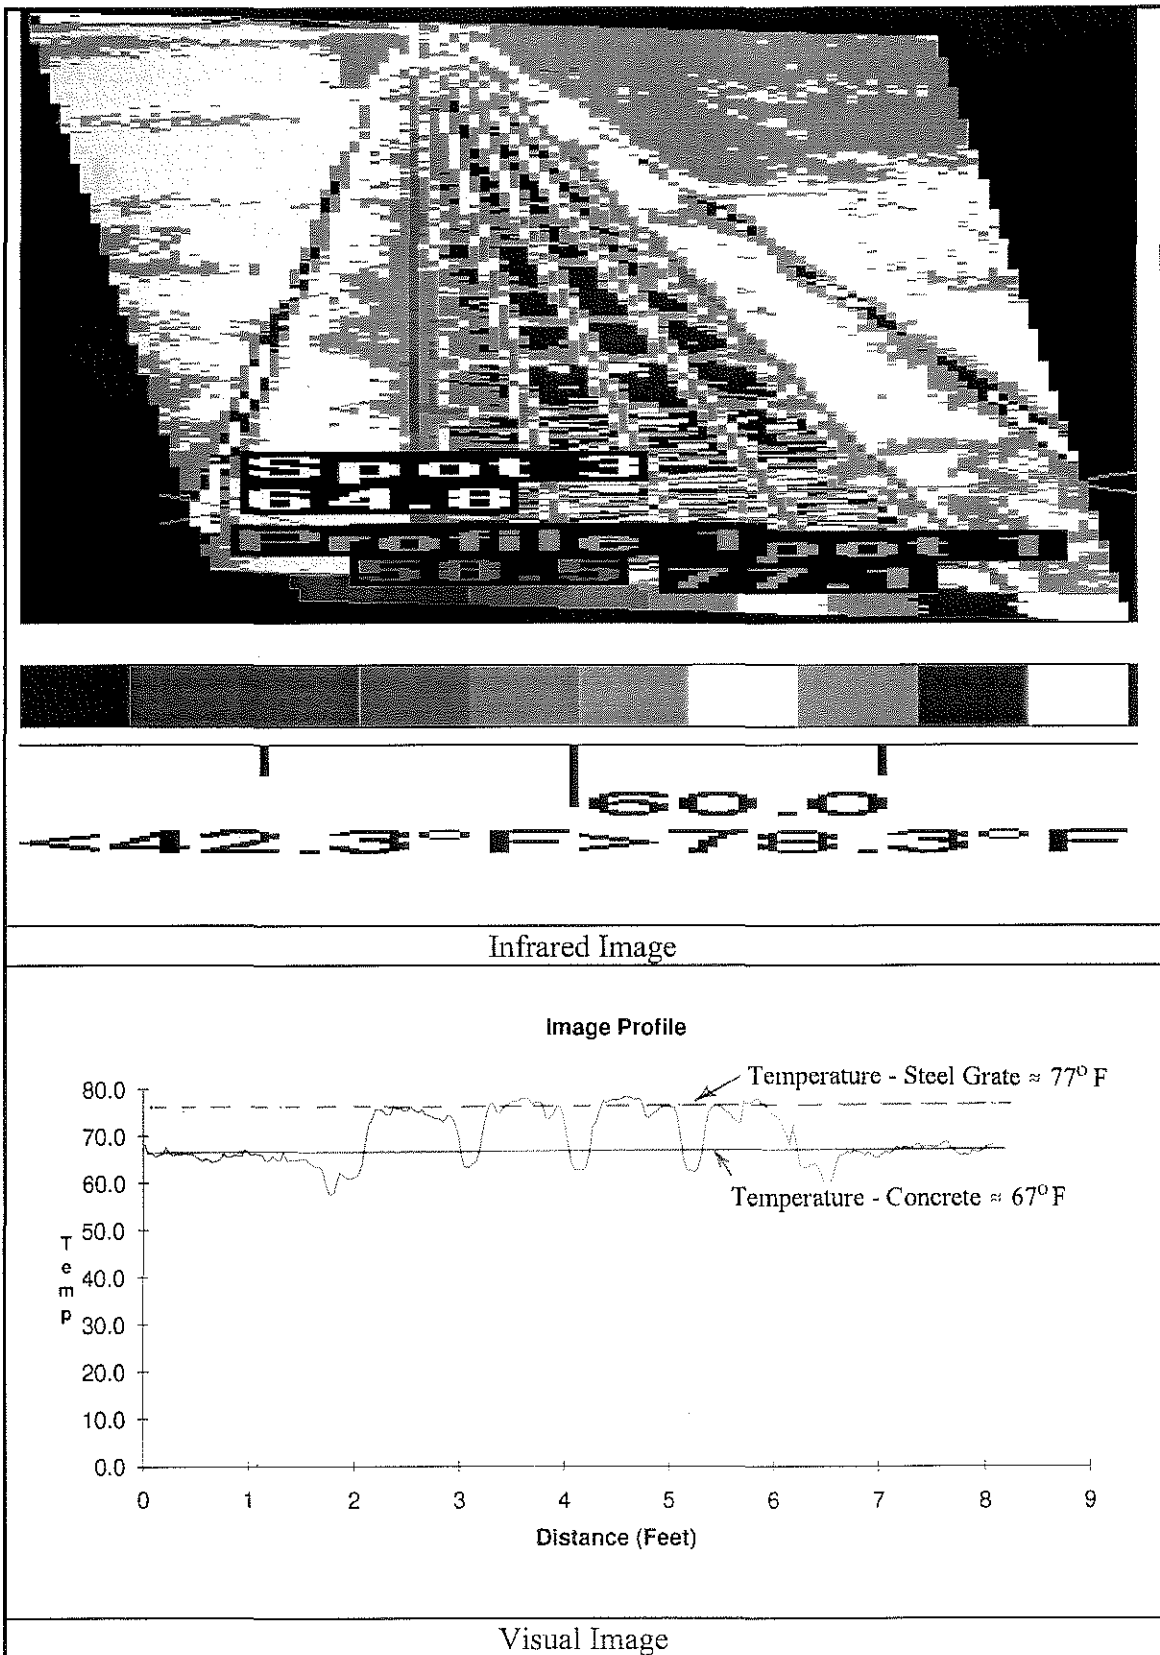
Fig. 6

Figure 6 is an infrared thermogram of one of the drainage trenches and the adjacent concrete. Because of the dark color of the steel grating, it absorbs more solar energy and heats more quickly and to a higher temperature than the lighter-colored, surrounding concrete. The bottom portion of Figure 6 is a temperature profile across the grating and the adjacent concrete. The day this was taken was mostly sunny, and from the temperature profile it appears the steel grating was approximately 10° F warmer than the surrounding concrete. The coefficient of thermal expansion for steel

is approximately  $7.2 \times 10^{-6}/^{\circ}\text{F}$ , and the average coefficient of thermal expansion of concrete is approximately  $5.5 \times 10^{-6}/^{\circ}\text{F}$ . Therefore, it appears the steel grating would be trying to expand more than 10 times an equivalent width of concrete. Because of the tight fit of the steel grating in the steel angle frame, it appears that there is insufficient room in the frame for the steel grating to expand. This would put considerable compressive stresses on the top portion of the concrete wall of the trench.
