TRUCK ROUTE ACCESS EVALUATION

Central Kentucky Asphalt
Off of KY 1723
Site #2634

Report No. KTC-98-34

September 1998

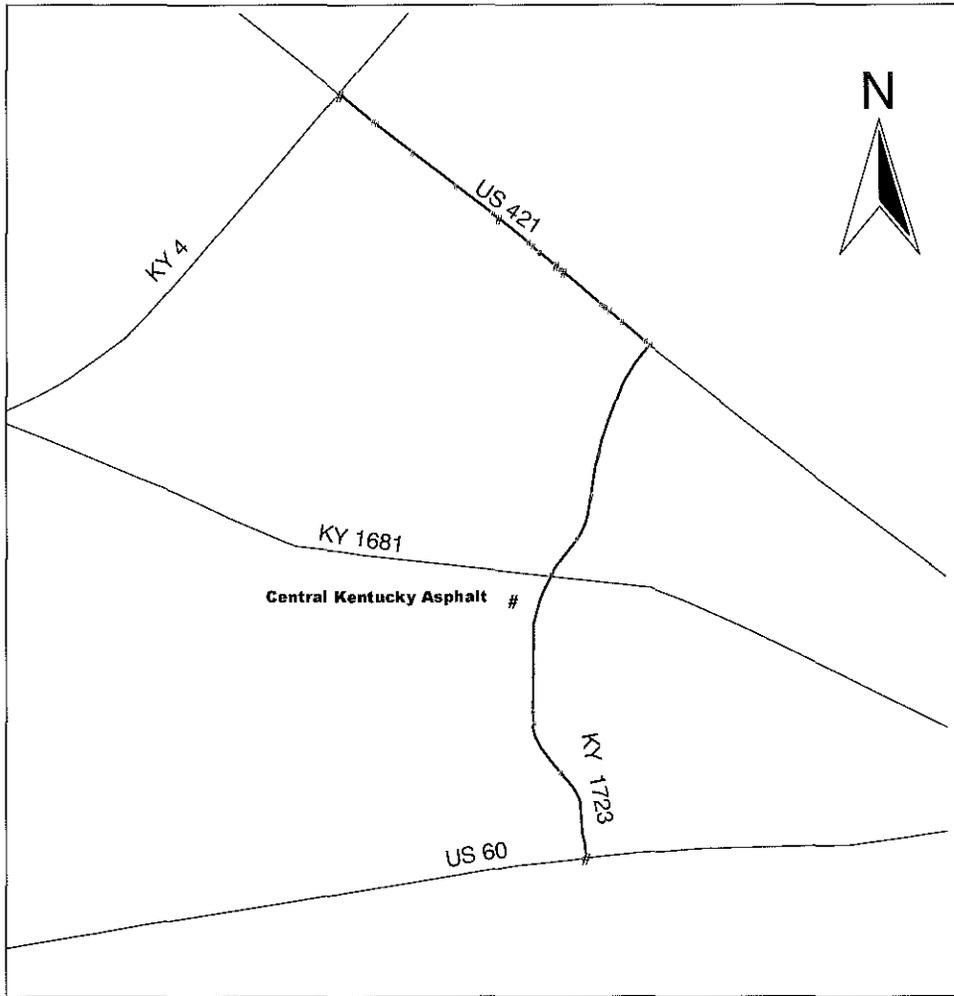
Figure 4: Accident Locations (1994-1996)

Figure 4 shows the locations of accidents during the years 1994, 1995, and 1996. A summary of the accidents along the first (KY 1723 south) and second (US 421 west) truck routes (for all roads, not just state-maintained roads) is shown in Tables 2 and 3 for the same three-year period. The number of accidents along the KY 1723 south route is insignificant and only two included trucks. The 9.0% of accidents involving trucks along the US 421 west route is somewhat higher than either the percent trucks along KY 1723 (6.4%) or US 421 (4.9%). This suggests that there are some safety concerns from an accident history point of view that must be addressed along this route.

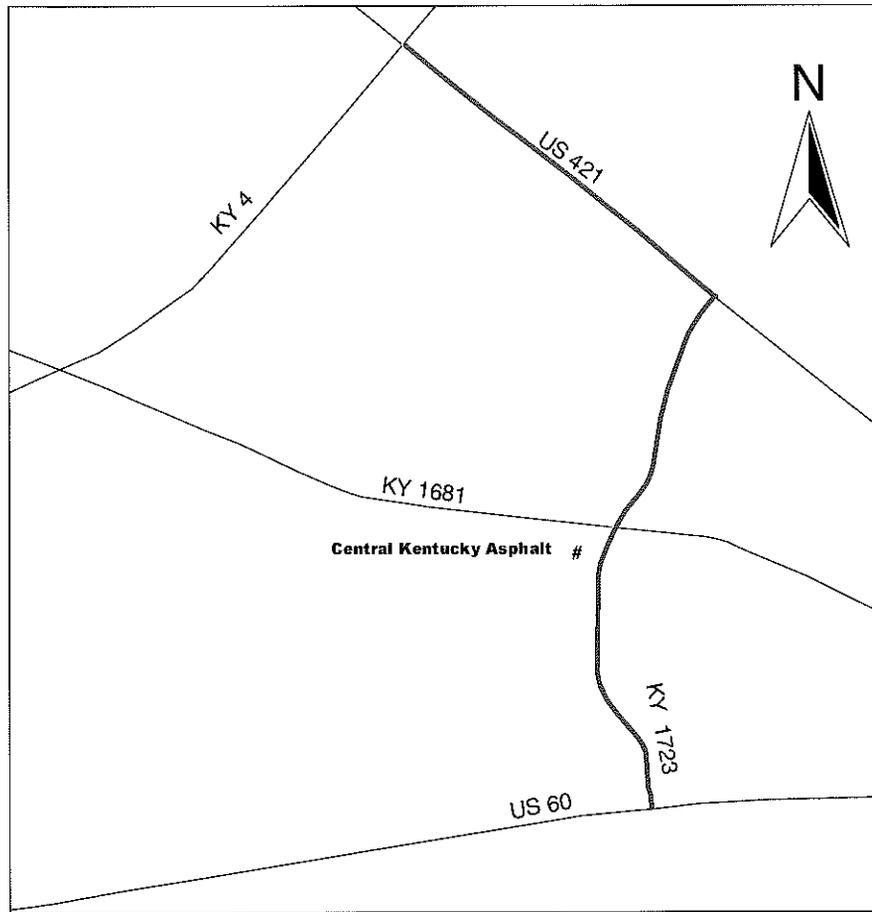
Figure 5: Lane Widths

Figures 5 and 6 illustrate the sections of the route with different lane widths and shoulder types, respectively. KY 1723 and US 421 are both comprised of 12 foot lanes which is considered to be “preferred”. The section of US 421 on this route (mileposts 1.042 – 1.254) begins with 10 foot stabilized shoulders which are considered “adequate”. The remainder of the route consists of “less than adequate” shoulders. KY 1723 begins at US 60 with a curbed shoulder for roughly 0.1 miles and continues with a 6 foot stabilized shoulder until the areas adjacent to the intersection of KY 1723 and US 421, where the shoulder is composed of a one-foot curb. All pavement along US 421 was in good condition, while some along KY 1723 was fair, especially in the area of the railroad crossing north of the intersection of KY 1723 and KY 1681 discussed in section 3.5.

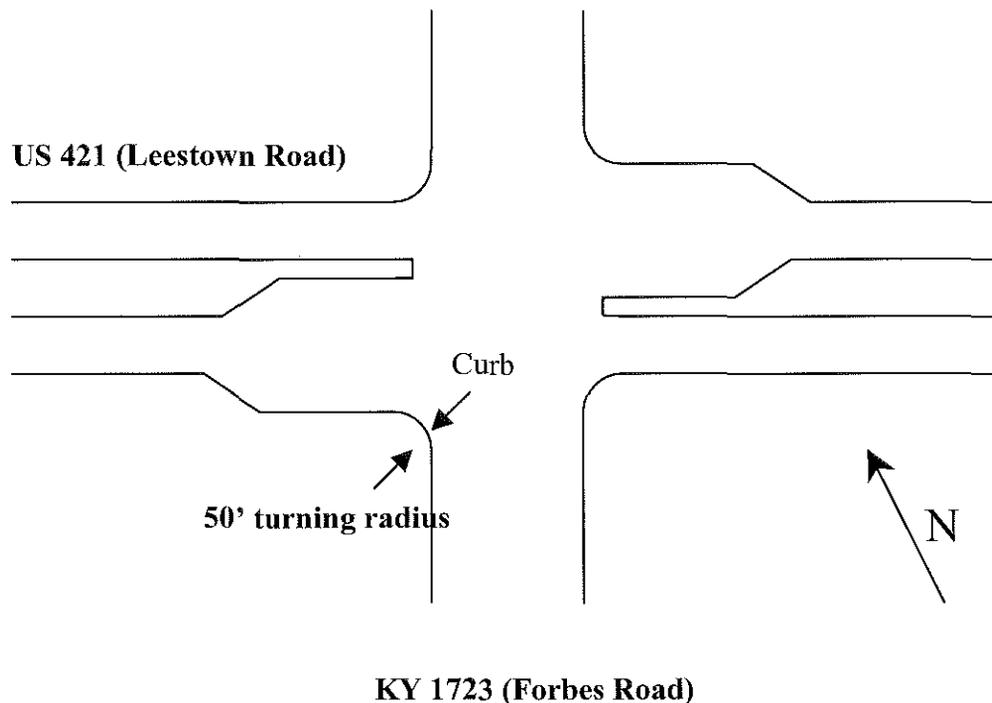
Figure 7: Intersection Diagram of KY 1723 and US 421 with turning radius problem

One turning radius was approximated with field measurements as observation demonstrated that offtracking was likely among larger trucks. Figure 7 demonstrates that trucks making a right turn at the intersection of US 421 and KY 1723 must negotiate a 50 foot turning radius which is bound by a curb on the inside. While site visits did not allow for the observation of the 53 foot trailers that the survey suggested as being the largest vehicles accessing the facility, markings on the curb indicated that trucks are running onto the curb in order to minimize encroachment into the opposing lanes of traffic. Some single unit trucks were observed making the turn with little or no encroachment; however, the roadway should be able to accommodate the largest truck travelling it. For this reason, this turning radius is rated “less than adequate”.

The problematic turning radius at the intersection of US 421 and KY 1723 could be remedied by widening the lanes or removing the curbed shoulder on KY 1723. The railroad crossing on the US 421 west route could benefit from resurfacing. The problems associated with shoulders can only be alleviated by reconstructing the routes. If truck volumes along the routes were to increase, then such action might be considered.

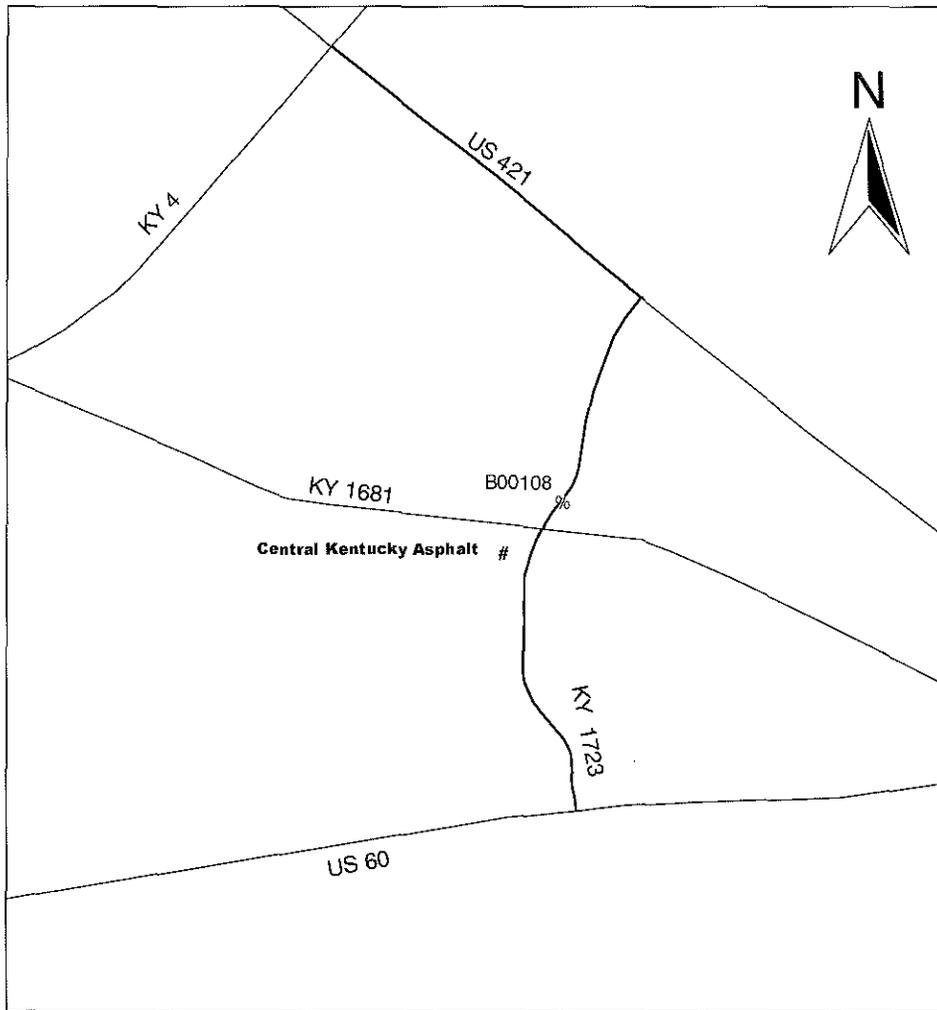
Figure 8: Bridge Location

The only bridge along this route is a roadway culvert located at approximately milepost 0.6 on KY 1723 (US 421 west route) and can be seen in Figure 8. The Kentucky Transportation Cabinet’s Division of Operations maintains a database of bridge

sufficiency ratings that are based on the serviceability (as well as other characteristics) of the structure. Roadway culverts such as the one found on KY 1723 are included in this database as they are considered to be a type of bridge. This structure received a sufficiency rating of 81.2, which is considered to be “preferred”.
