TRUCK ROUTE ACCESS EVALUATION

Fulton County
Hickman Riverport Area
Site No. 16

Report No. KTC-98-35

January 1998

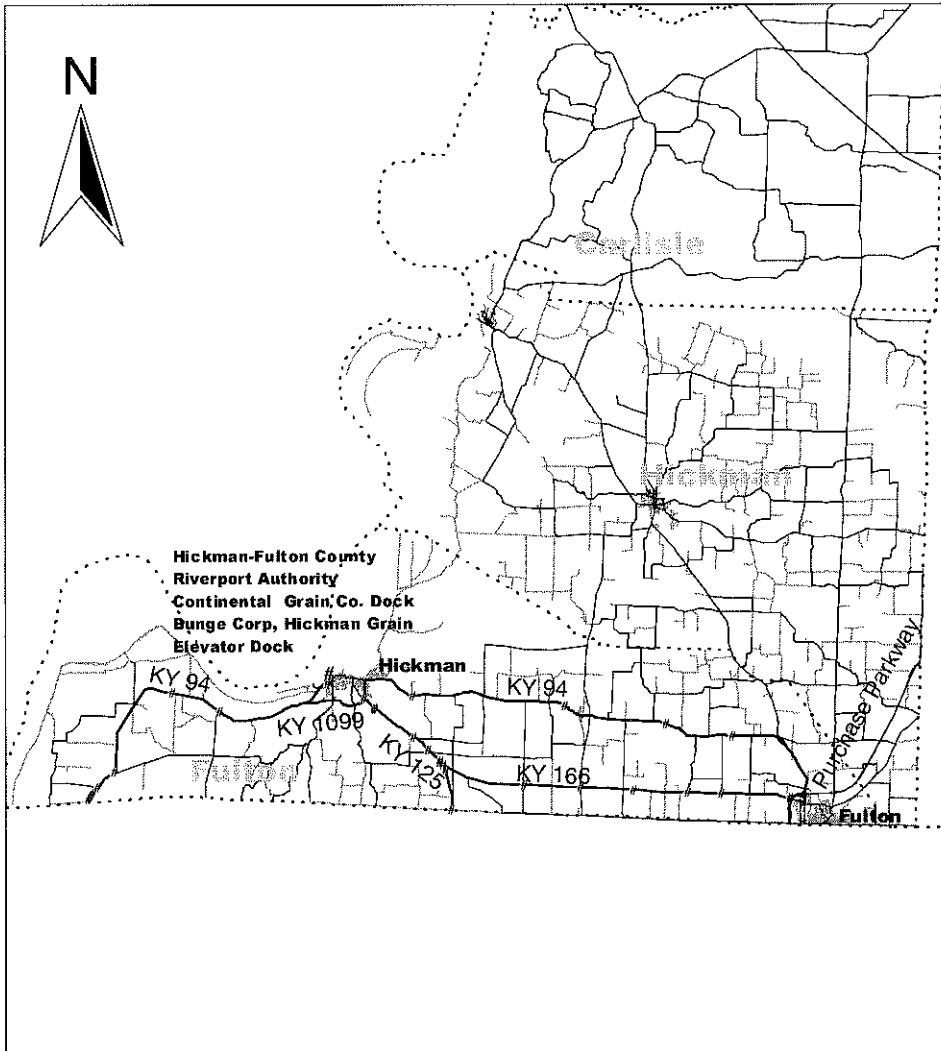
Figure 6: Location of Accidents (1995-1997)

Figure 6 shows the locations of accidents during the years 1995, 1996 and 1997. This map should be viewed with caution as only 45 of the 165 accidents during the three years had a milepoint reported in the state-accident database and could therefore be plotted here. A high number of accidents occurred in South Fulton on US 51 and KY 166 where overall traffic levels are higher than along other portions of these more rural routes (this intersection is listed for reconstruction in the Long Range Highway Plan). A large number of accidents occurred just north of the Tennessee border on KY 94. This section is discussed in section 3.5 and contains an intersection of two roads and a railway crossing on a sharp horizontal curve. Many accidents occurred near the intersection of KY 166 and KY 125. This non-ideal "Y" shaped intersection is described in section 3.4 which contains a drawing of the configuration. Overall, there was not a significant number of truck accidents as indicated in Tables 2 through 5. The tallies of accidents are presented for each route segment for the 1995 through 1997 three year period. Note that KY 309 did not have any accidents reported on it. Trucks represent between 8 and 11 % of the ADTs along these segments. Considering the magnitude of total accident numbers and the truck traffic percent, it would seem only KY 94 and US 51 between Hickman and the town of Fulton may require further investigation related to truck accidents and safety. The site visit revealed no apparent differences between this route segment and the others that would lead to higher accident levels. Furthermore, no sight distance or other safety hazards were noted.

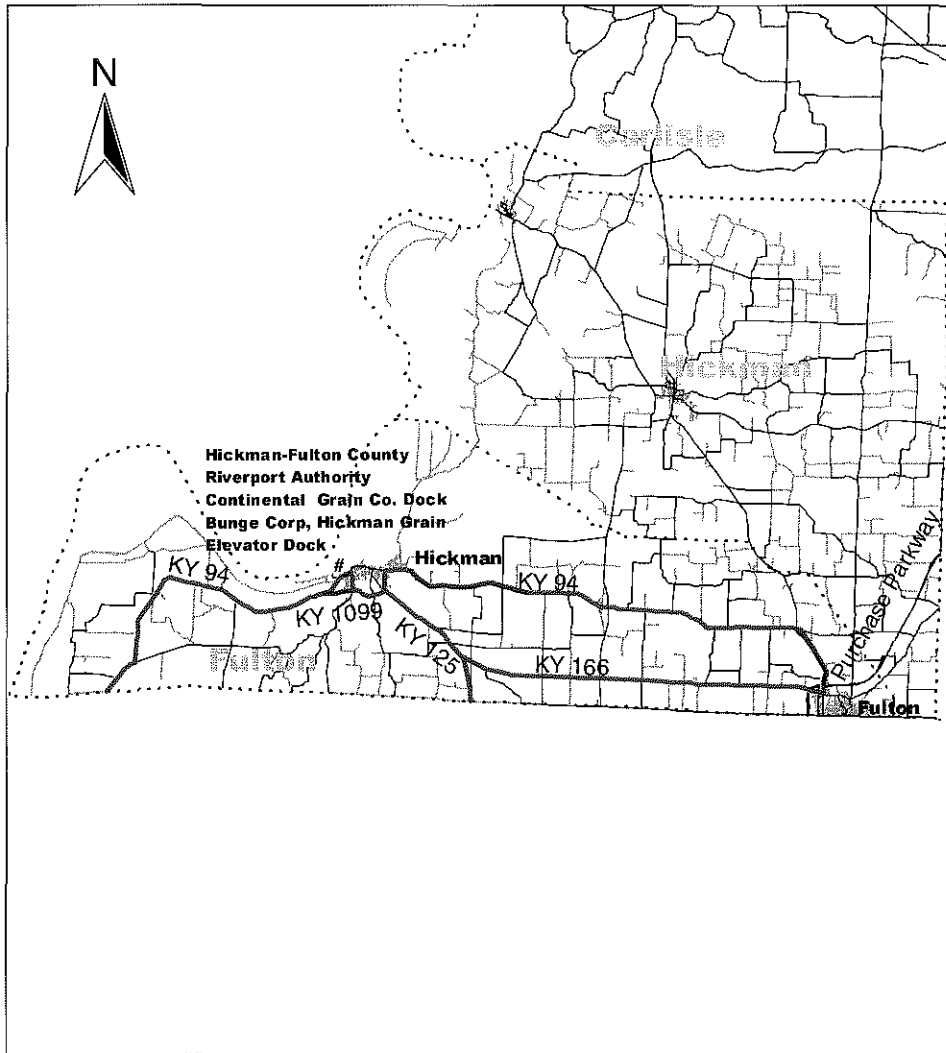
Figure 7: Lane Widths

Figures 7 through 10 illustrate the sections of the routes having different widths of lanes and shoulders. Except for very short sections of KY 94 and KY 125 the majority of these routes have “less than adequate” 10 foot lanes. The shoulders (except at intersections and along one improved section of KY 94) ranged from 2 to 4 feet of either gravel or turf to 1 to 2 feet of paved shoulder with gravel. These types of narrow shoulders, regardless of surface type, are considered “less than adequate” in this study as they do not allow for emergency stopping of large trucks.

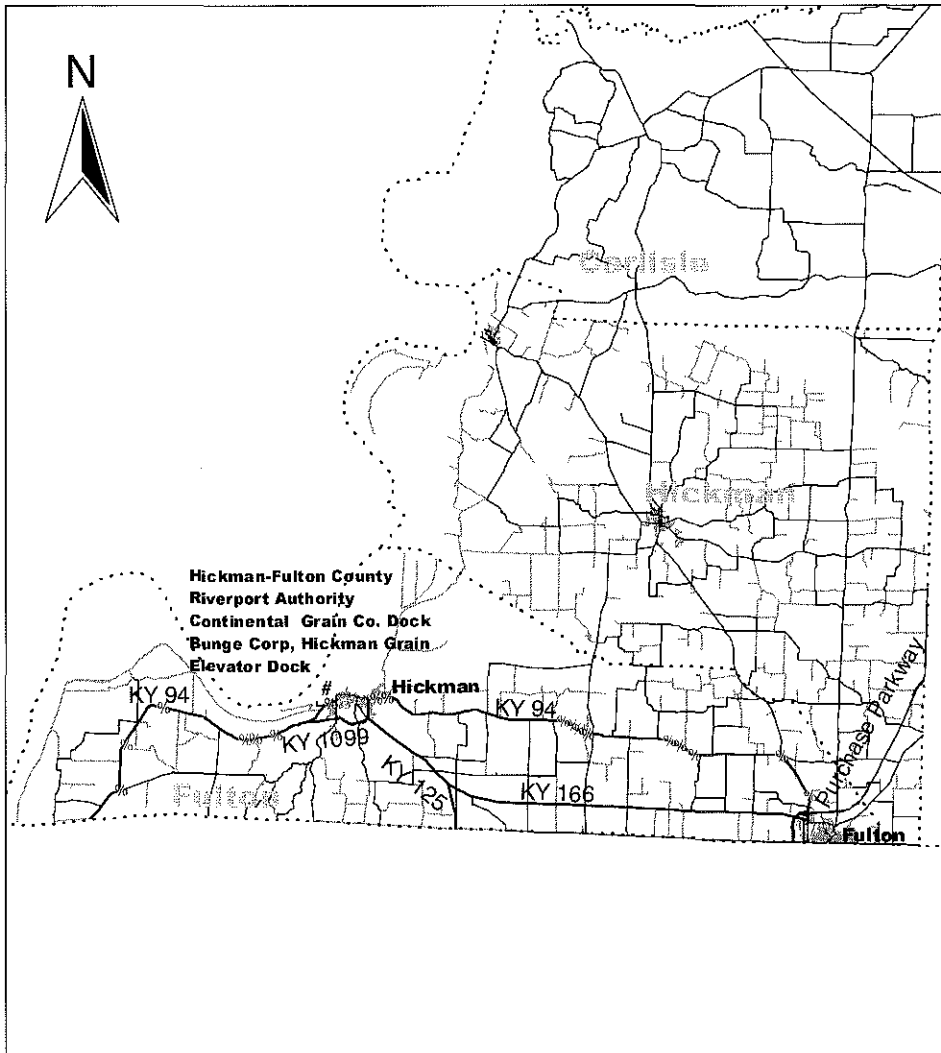
Figure 11: Horizontal Curves with Potential Offtracking Problems

Locations where offtracking may occur were estimated using wheel base lengths, horizontal curvature information from the HIS database and lane widths measured in the field. No curve widening was noted in the field. Locations of potential offtracking problems (19 in total) are shown in Figures 11 and 12, while details are listed in Appendix B. Only 7 of the curves on these routes (all on KY 94) also failed the ball bank reading guidelines when traveled at the speed limit or the posted advisory speed for these curves. These locations are shown in Figure 13.

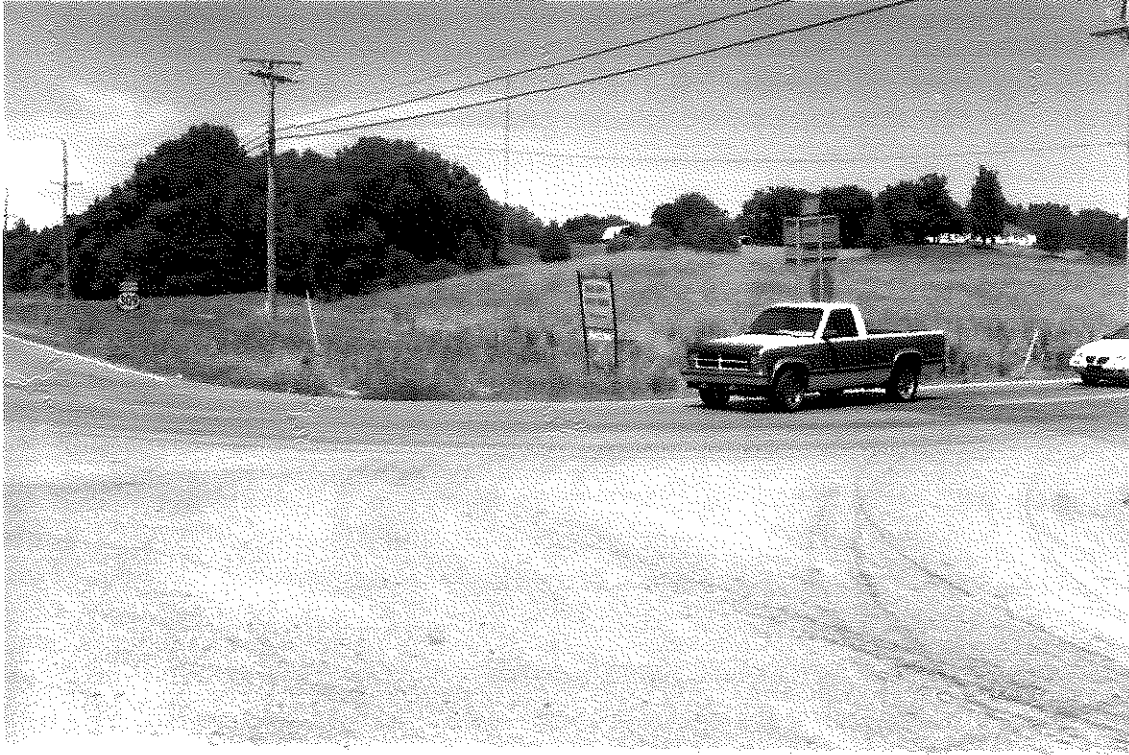
Figure 16: Intersection of KY 309 and KY 1099

The right turning radii at two intersections within the town of Hickman are “less than adequate” for the trucks traveling these routes. A sketch of the intersection of KY 125 and KY 1099 is shown in Figure 14, while the intersection of KY 1099 and KY 309 is shown in Figure 15. Trucks were observed offtracking into opposing traffic lanes while making both left and right turns at these intersections. Figure 16 illustrates the tire marks on the road at the intersection of KY 309 and KY 1099 where trucks make right turns from KY 1099 (on the right in the picture) onto KY 309 as well as make left turns from KY 309 to KY 1099. The tire marks clearly indicate trucks moving out of their travel lanes.

However, despite the very small radii indicated on Figures 11 and 12 very little opportunity to widen the paved area is possible at these intersections. Deep ditches are found on all four corners at KY 309 and KY 1099. The headwalls of a very narrow bridge over a creek start only 20 feet south of the edge of the KY 1099 travel lanes. At the intersection of KY 125 and KY 1099 the same creek crosses under the intersection on an angle as shown in Figure 14. All four corners of this intersection have commercial land uses and parking lots which abut the intersection. There are many utility poles and signs also at the corner. Both of these intersections are rated “less than adequate” according to this study methodology.

Possible minor improvements, and even complete reconstruction, should be considered for the two intersections on the Hickman By-pass (KY 1099). Routing traffic such that KY 309 is avoided might be possible if improvements west of Hickman, particularly the KY 94 and KY 1099 intersection, were implemented.

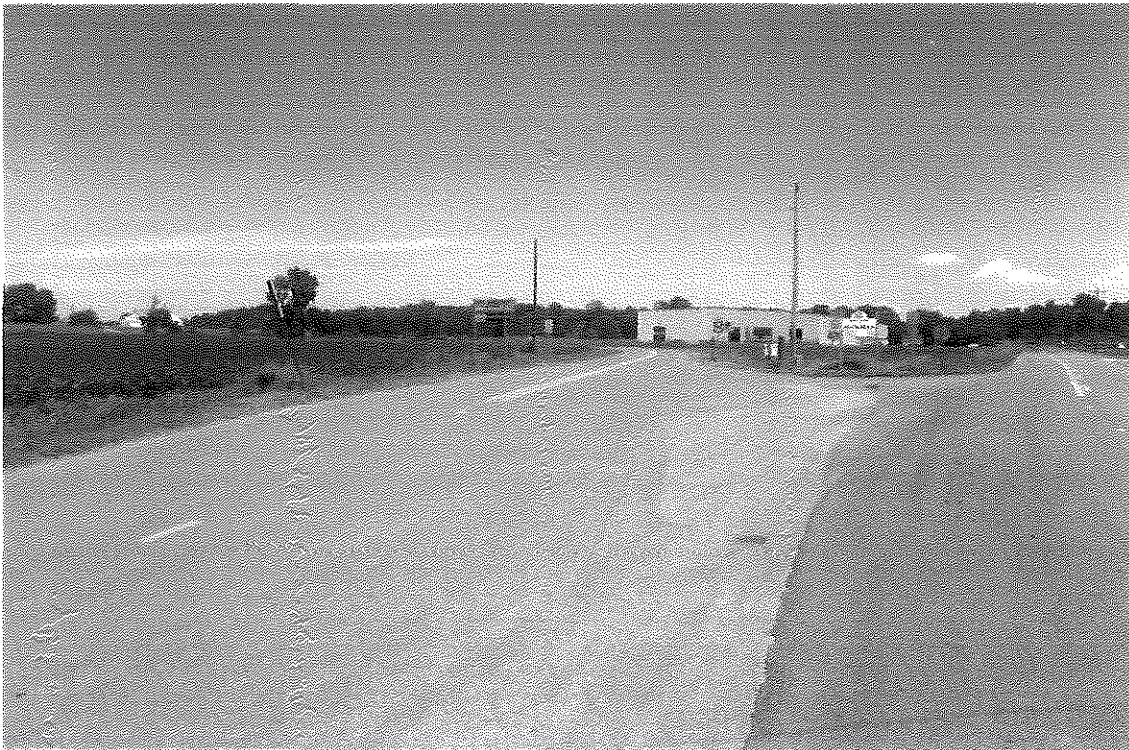
Figure 17: Intersection of KY 94 and KY 1099

Two intersections outside of Hickman were found to have limiting “Y” configurations as shown in Figure 17. Figure 18 illustrates the intersection of KY 94 and KY 1099 just west of the riverports. Figure 19 illustrates the intersection of KY 125 and KY 166 between Hickman and Fulton just north of the Tennessee border. Turning radii for the current dominant truck travel routes are not problematic. For example, westbound trucks on KY 1099 do not turn right onto KY 94. Likewise, northbound trucks on KY 125 do not turn right on KY 166. However, changes in truck travel patterns or addition of new facilities in the area might require improvements to these intersections. Furthermore, if the intersection of KY 1099 and KY 94 were different trucks might be able to use this route as an alternative to traveling through the residential neighborhood along KY 309 (mentioned in phone surveys). Owing to the travel patterns of trucks accessing the facilities under study, neither of these intersections is rated less than “preferred”.

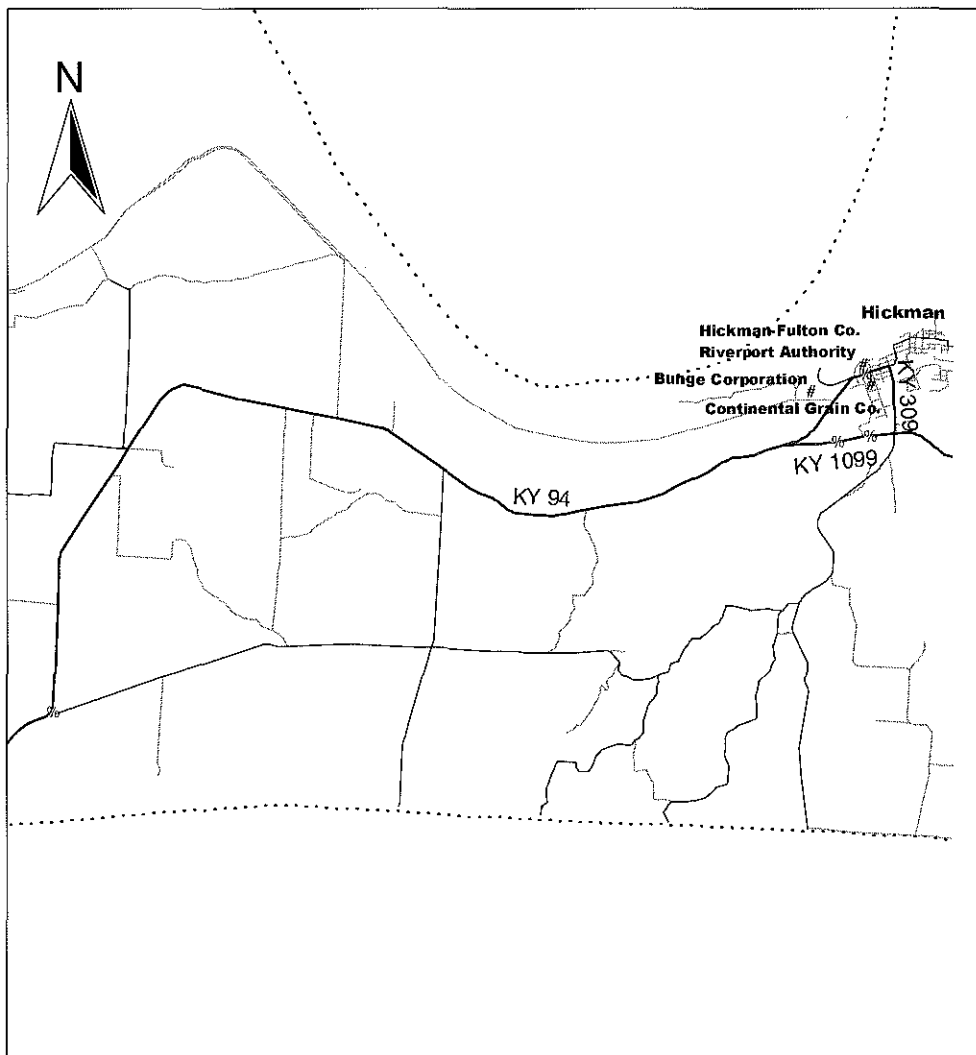
Figure 20: Railway Crossings

There were four at-grade railway crossings along these routes as shown in Figure 20. The rail crossings on KY 1099 have no warning signs, lights or gates. There is poor sight distance in one direction at each crossing. The rail lines appear unused so are not rated “less than adequate” in the tallies provided in section 4. This assessment is further confirmed by the tracks being paved over on KY 94 at the riverports (shown in Figure 20). All three of these crossings have good smooth pavement surfaces. The rail crossing immediately north of the Tennessee border on KY 94 occurs on a sharp corner as shown in Figure 21. Although there is sufficient sight distance, the crossing could be confusing or awkward. The surface is very rough and might pose problems for trucks. Although this rail line may not be used by trains the configuration and surface quality indicates it be assigned a “less than adequate” rating.

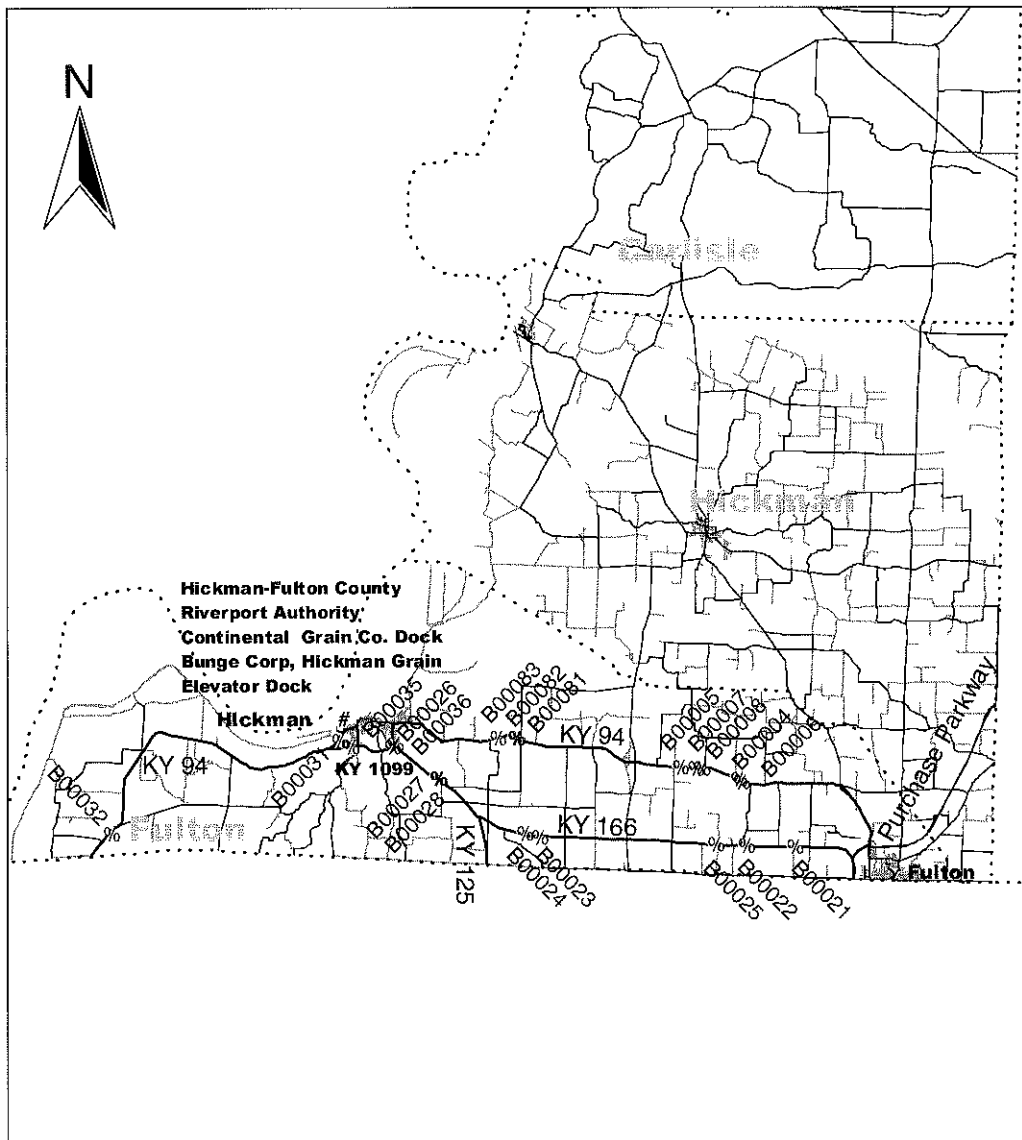
Figure 22: Bridge Locations

The locations of the bridges along this route are shown in Figure 22. Bridge sufficiency ratings were available from the KYTC Division of Planning as shown in Table 6. The far right column of Table 6 indicates how these sufficiency ratings translate into the adequacy indicators used in this project.
