**VISUAL INSPECTION OF KEYSTONE BLOCK WALL
AND EMBANKMENT SLIDE AT MIST LAKE PLAZA
IN LEXINGTON, KENTUCKY**

Research Report KTC-97-11

June 5, 1997

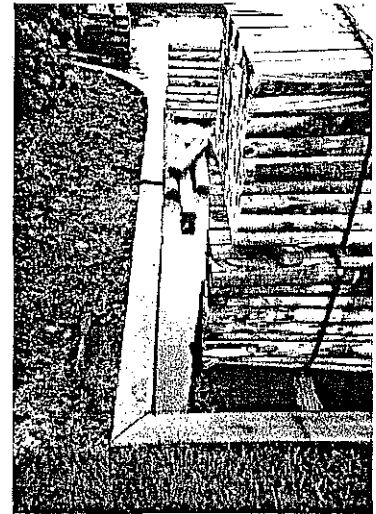
Surface drainage was inspected on May 8, 1997 shortly after a rainfall event. It is evident that the surface drainage conditions are likely causing additional distress in the retaining wall structure and the soil embankment. Figure 1 shows water standing even with the top of the curb on the north end of the parking area (north end of the wall). The photo also shows that water has been running through a break in the curb. It is apparent that this area of the parking lot has settled and that surface water is no longer flowing to the storm drains.

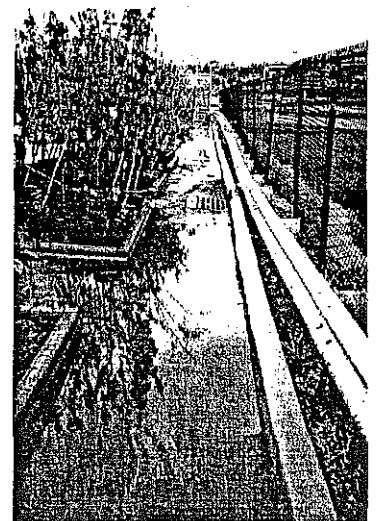
Figure 2 also indicates that water is not reaching the collection system. The drop inlet box is located toward the center of the retaining structure. A significant amount of this water is likely percolating through the pavement and saturating the fill behind the retaining structure. Figure 3 shows staining that is occurring in the face of the retaining structure located directly in front of the drop box inlet shown in Figure 2. It is also likely that a portion of the percolating surface water is flushing backfill fines through the structure.

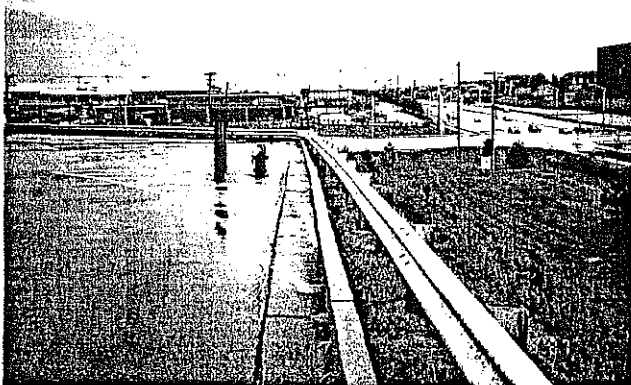
Figure 5

A combination of storm water being discharged from the down spouts on the Walmart building and heavy truck loads traveling behind the store (at the top of the embankment) has failed the pavement structure. Rutting in the pavement is preventing water from reaching the storm water collection system. It is likely that a significant amount of this water is saturating the embankment (Figures 4 and 5). Sliding in the embankment has also caused separations between the curb and the pavement allowing water to seep into the embankment (Figure 6). The embankment slide is shown in Figure 7.

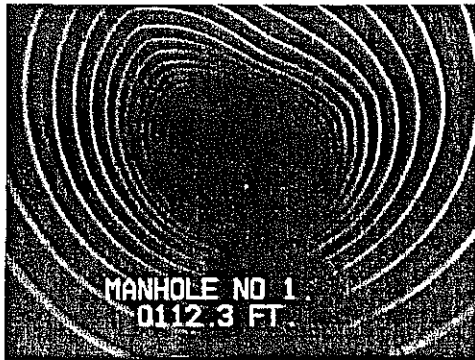
Figure 10

Significant vertical compression, sagging and bending were observed in several locations (Figures 9 and 10). A significant amount of compression and sagging was located around the drop box inlets. Settlement in the fill around the vertical inlet boxes has likely caused a significant portion of the distress.

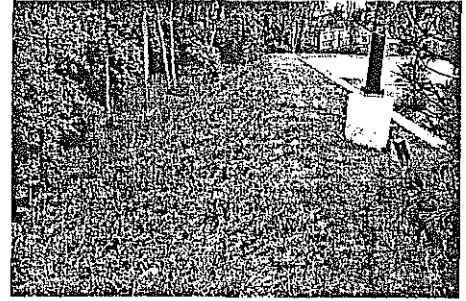
Figure 14

The embankment on the south end of the parking area which extends behind Walmart was inspected on May 8, 1997 and again on May 29, 1997. It is evident the embankment is sliding in several areas (Figures 14-17). The most critical area is at the south end of the Keystone Block Wall. It is evident that pavement settlement has increased around the catch basin and the slide is pulling the concrete curb away from the asphalt pavement. Water appears to be percolating out of the slide at approximately the same elevation that the water is entering the nearby vertical drop box inlet shown in Figures 12 and 13. The slide is apparently causing displacement in the blocks of Keystone Block wall. It is apparent that the slide is separating the blocks and pushing the toe of the wall forward (Figures 18 and 19).

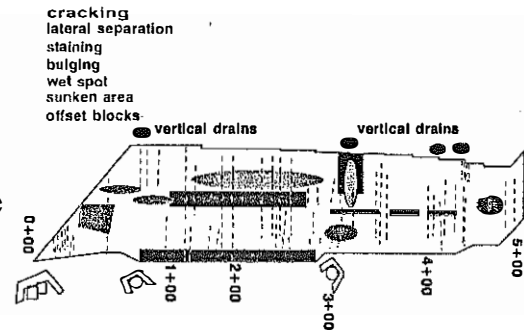
Figure 20

The face of the wall was inspected on May 13, 1997. All observed distresses were cataloged and photographed. This was conducted prior to placing control monitoring points which will supply more information on where movement may be occurring. The wall was divided into five sections for monitoring. A schematic of the wall and the observed distress is shown in Figure 20.

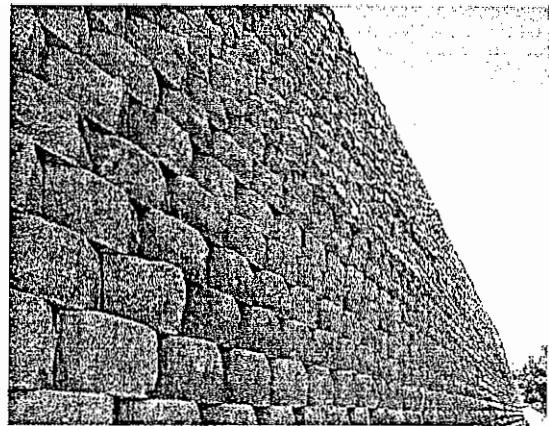
Figure 21

From the distress survey, it is apparent that movement has occurred in all five sections. Significant amounts of crushed stone appear to be migrating from horizontal separations in the Keystone Block. Significant amounts of forward movement had occurred on the north end of the wall. The top half appears to have moved (slid) forward approximately four inches. This is currently being monitored. (Figure 21).

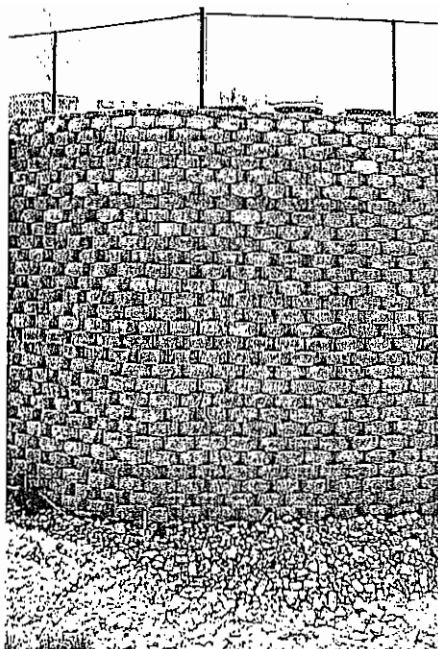
Figure 22

Cracking of the Keystone Blocks was observed in several locations along the wall. The most severe cracking had occurred 442 feet from the south end (Figure 22). The surface of the blocks also appeared to be wet in several areas (Figure 23). This indicates the backfill may be saturated behind the retaining structure.
