THE BUMP AT THE END OF THE BRIDGE

KYHPR-64-17; HPR-1-(4), Part II

Division of Research
DEPARTMENT OF HIGHWAYS
Commonwealth of Kentucky

June 1969

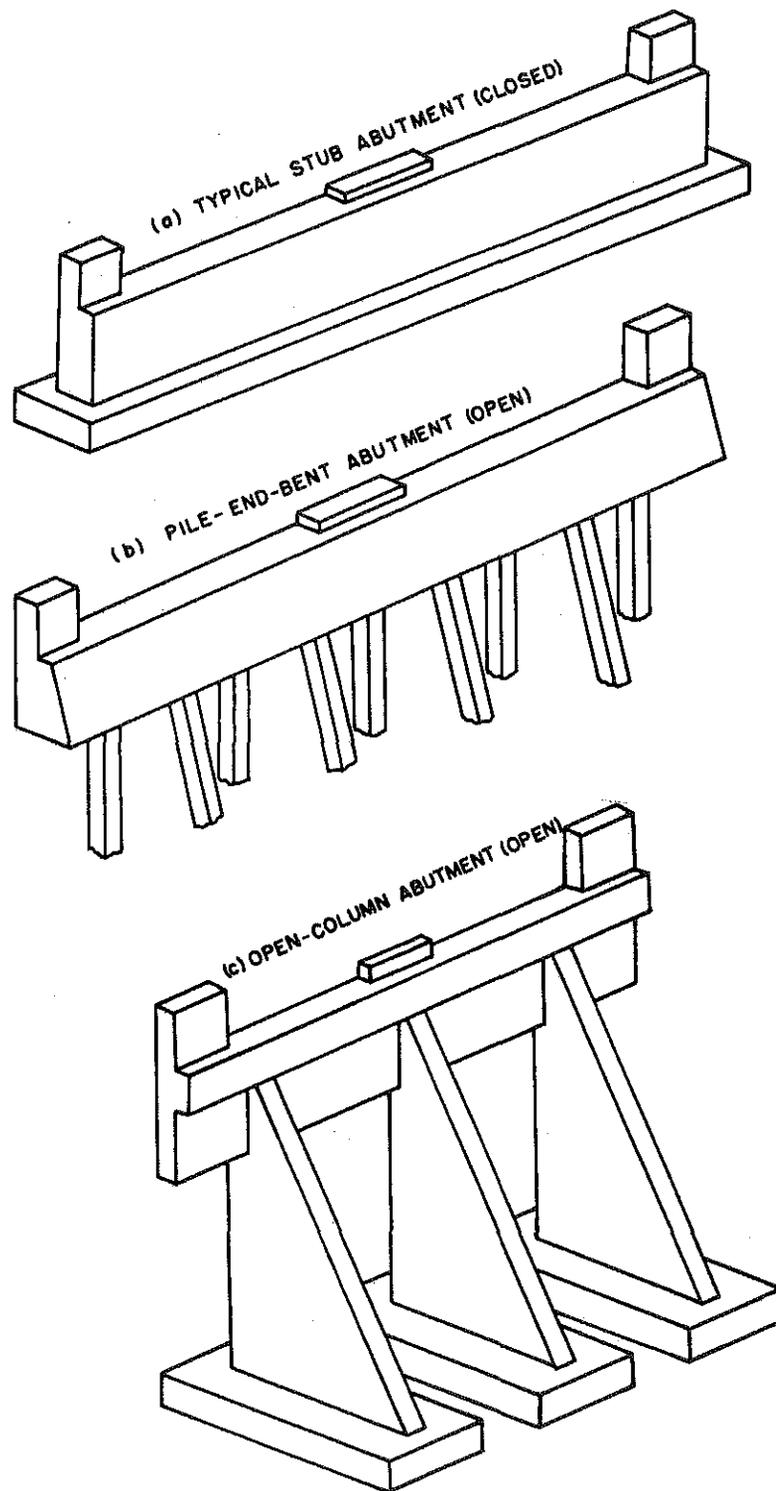
Figure 6 Typical Types of Abutments Used in Kentucky

A comparison of the most commonly used types of abutments (see Figure 6), with respect to the three settlement groups, Figure 7a, revealed that the open-column type (open-end) was more commonly

associated with Settlement Group III than either the pile-end-bent (open-end) type or stub type (closed-end) in 1964. The relationship between average height of embankment, average thickness of foundation soil and type of abutment with respect to settlement groups is shown in Figures 7b and c. Notice that stub abutments are associated with smoother bridge approaches, smaller average heights of embankment and thinner foundation soils. The pile-end-bent abutments had greater average heights of embankment and thicknesses of foundation soils than the open-column abutment, but the pile-end-bent abutments had better bridge approaches. The better performance of approaches located behind stub abutments may be attributed to smaller settlements associated with shallower embankments and foundation soils. The comparatively larger time for consolidation before construction of the pavement and the need for less hand compaction near the abutment may account for better performance of approaches associated with pile-end-bent abutments than those approaches at open-column abutments. However, in 1968 there was an increase in percentage of faulted approaches for all types of abutments with the percentage for pile-end-bents increasing the most. There were small differences in percentages between the pile-end-bent and open-column abutments. Although the percentage of faulted approaches increased, stub abutments still had a comparatively high percentage of smooth approaches in 1968. For both surveys, there was a large number of defective bridge approaches associated with all types of abutments.

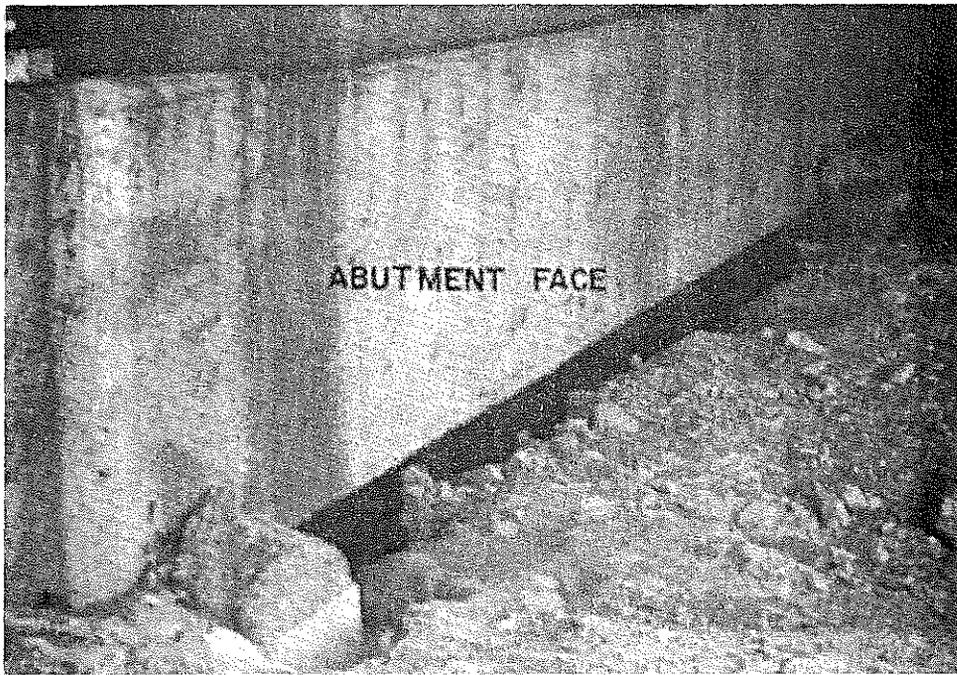
Figure 8 Illustration of Erosion of Soil at the Abutment Face

In a few cases, the 1964 study indicated that erosion of soil adjacent to the abutment (Figure 8) contributed to the development of the approach fault. In one observed case, grouting material from the mudjacking operation had effused from underneath the face of the abutment. As shown in Figure 9, there was an increase in the percentage of repaired approaches when such erosion occurred. This type of erosion appears to be a result of ground water seepage (including runoff from the pavement) as shown diagrammatically in Figure 10.

Loss of material around the abutment could result in a loss of subgrade material and, consequently, cause the approach to settle. By 1968 the percentage of defective approaches had increased noticeably, and there were no significant differences in percentages of smooth approaches as well as faulted approaches for approaches with erosion and without erosion. However, the number of faulted approaches with erosion at the face of the abutment increased considerably.

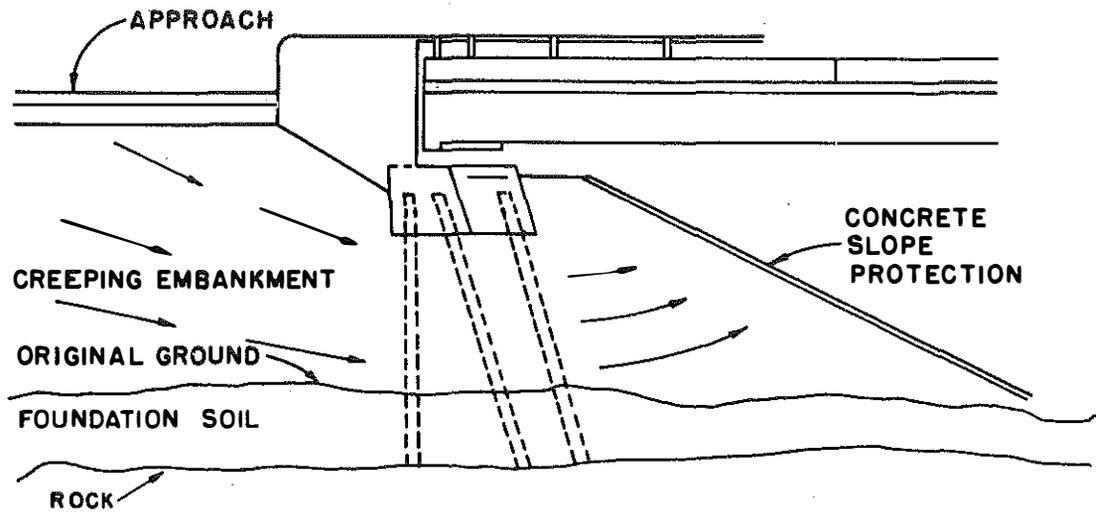
Figure 13 Creep of Embankment Slopes

There was suggestive evidence that progressive failure, or creep, of the approach embankment may, in some cases, contribute to development of the approach fault. Figure 12 is a comparison of approach embankments with cracked concrete slope protections, embankments with uncracked concrete slope protections, and embankments with no slope protection, suggesting a relationship between cracked slope protections and bridge approach settlement. One possible explanation for the cracked slope protections could be progressive failure of the embankment, as shown in Figure 13, resulting in a loss of subgrade support. In some cases, slope protections did appear to be bulging outward.

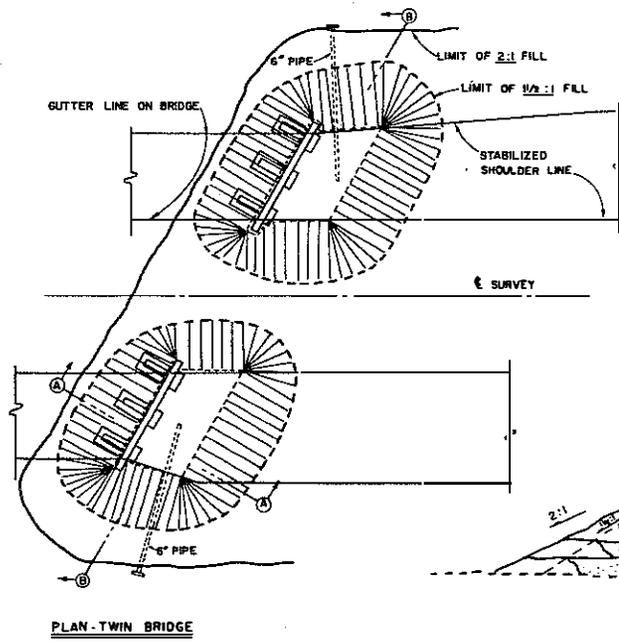
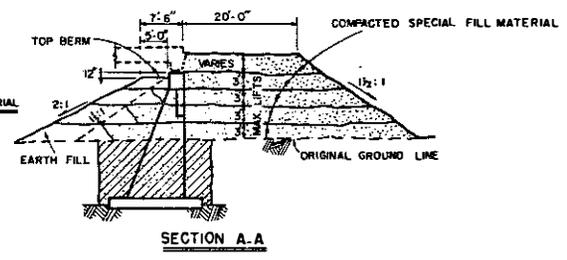
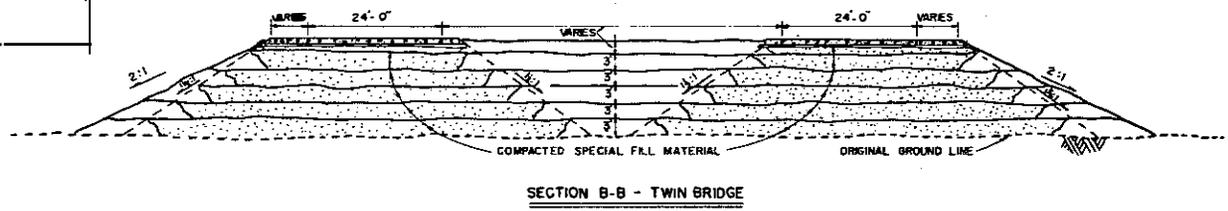
Figure 19 Kentucky Standard Drawing SF-1 showing the Requirements for Backfilling around Abutments with a Granular Material

At 54 bridge approaches located on I 64 between Frankfort and Louisville, the approach embankments were constructed of a special granular fill material extending approximately 20 to 60 feet behind the abutments. The special fill was formed and placed around the abutments, primarily open-column, in accordance with Kentucky Standard Drawing SF-1 (see Figure 19), which is no longer in use. Below original groundline, the special fill consisted of either sand, crushed or uncrushed gravel, crushed limestone, crushed sandstone, crushed slag, broken stone from solid rock excavation, or a combination thereof and was required to meet the gradation shown in Figure 19. Above groundline, the special backfill was of a type listed above; however, gradation requirements were waived. Whenever crushed stone or slag was used, the backfill was formed and compacted by spreading with a dozer or grader blade in such a manner that voids, pockets and bridging were minimized; the maximum layer thickness did not exceed three feet. Whenever sand was used, the backfill was compacted by saturation with water. In this case, the layer thickness did not exceed one foot. No stone or fragment of the special fill material was placed within one foot of the finished subgrade elevation.

The performance of bridge approaches associated with the special granular backfill is shown in Figure 20 and compared with bridge approaches not associated with the special backfill on the same route. The data show that backfilling behind abutments in a manner specified by Kentucky Standard SF-1 did not check the development of faulted approaches. Moreover, for cases involving the special backfill when compared to cases without the special fill, there was an increase in frequency of faulted approaches.

the use of a special granular backfill material in a manner specified by Kentucky Standard Drawing SF-1 was unsuccessful in preventing the development of faulted approaches. Results of methods currently used in maintaining a smooth transition between a bridge deck and roadway were not always satisfactory; in many cases, approach pavements had to be mudjacked and(or) patched as many as two or more times. Patching was considered to be more effective than mudjacking, mainly because patching did not crack the approach pavement. Apparently, at least for a short period of time, rigidity of portland cement concrete pavements reduced the occurrence of approach faults by bridging the presumed depression behind abutments. Generally, approach settlements seldom appeared to exceed six inches and were confined within 100 feet of the end of the bridge.
