Owner/ Operator Hauling Asphalt Flux Dies After Driving into a Ravine and Striking Trees

Incident Number: 11KY072

Kentucky Fatality Assessment and Control Evaluation (FACE) Program

Release Date: August 13, 2012

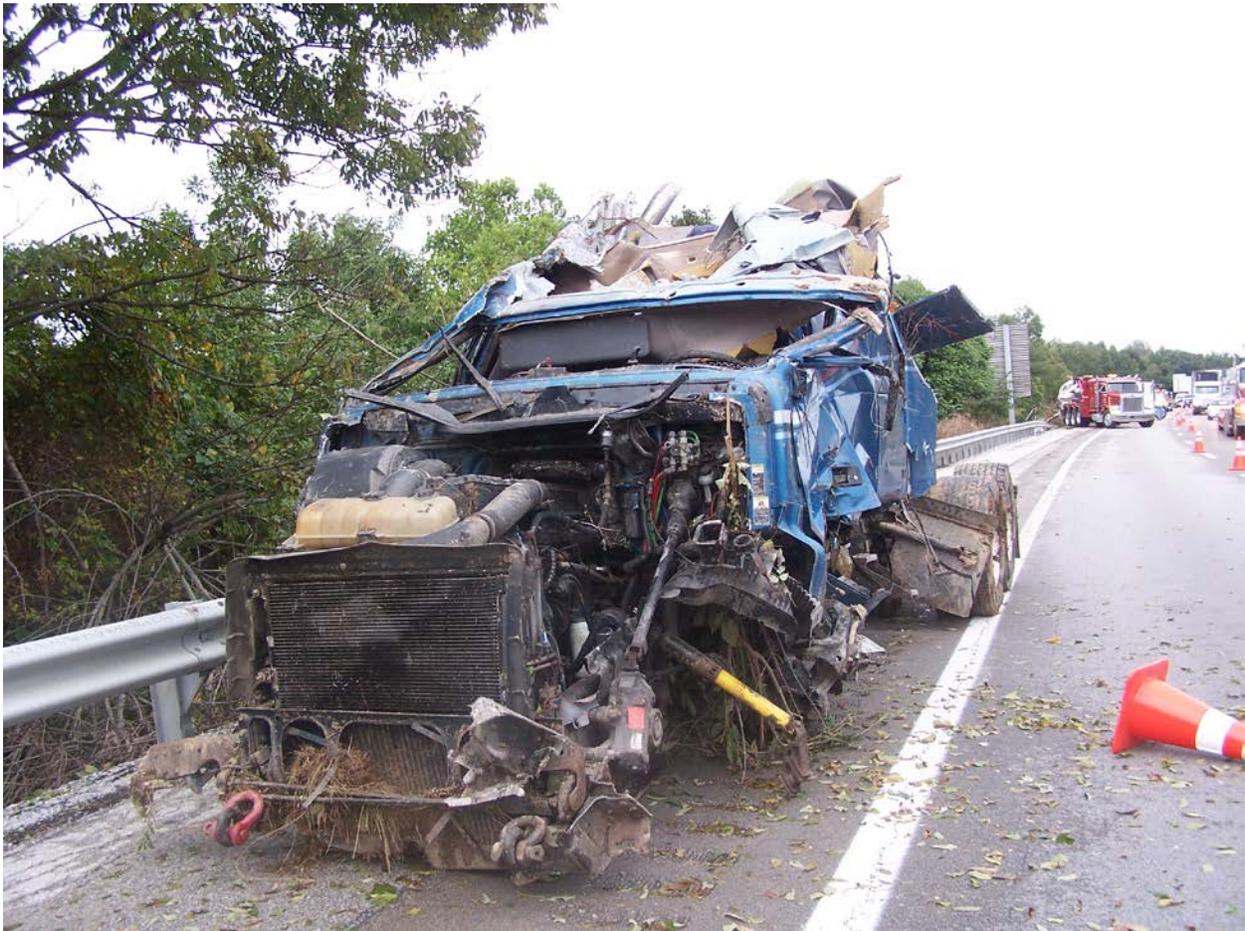
Photograph of semi involved in this incident. Property of KY FACE.

As the driver approached the exit, he crossed the fog line and sideswiped the driver's side of an SUV parked in the emergency lane with the semi's right steer tire. After striking the SUV with the steer tire, the semi became uncontrollable and went through the guardrail on the north side of the west bound lane emergency lane. Upon going through the guardrail, the unit proceeded downward into a ravine where tanker dislocated from the semi. Both the semi and tanker struck numerous trees and received considerable damage. According to the police report, the driver had utilized the restraint system, but was still ejected from the semi.

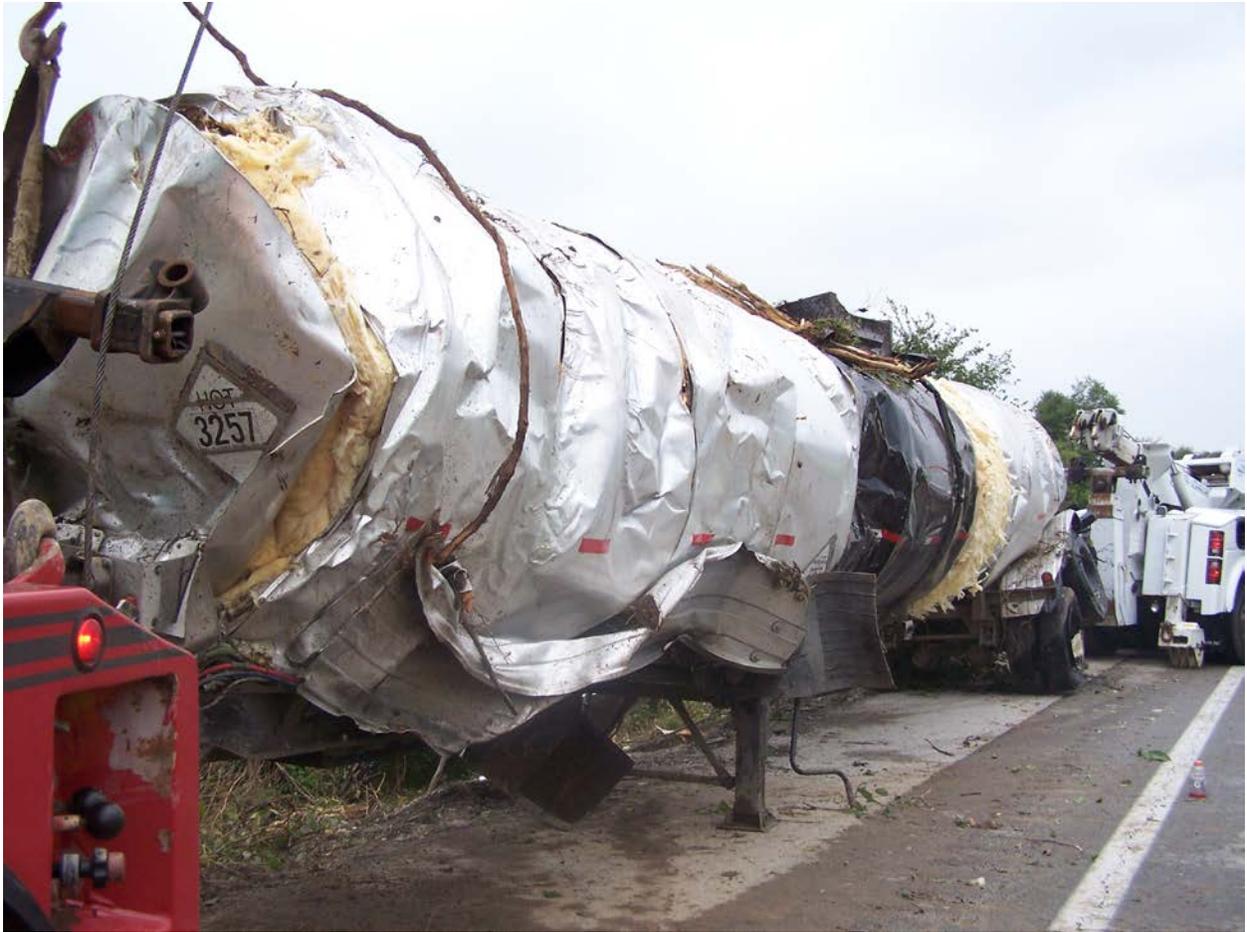
Photograph of tanker hauling asphalt flux involved in this incident. Property of KY FACE.
