KY FACE # 01KY062

May 22, 2002

SUBJECT: Youth Riding as Passenger on Tractor Killed by Overturn

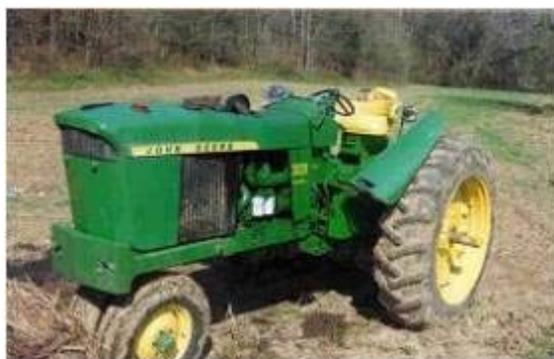
On the day of the incident the driver of the tractor and the victim had been baling hay since morning. At approximately 19:30 the victim was accompanying the driver and was seated on the fender over the left wheel of the tractor (see Figure 1). The tractor was a 65 horsepower diesel-powered John Deere 1969 tricycle, Model 3020, which the driver had bought used 2 years prior. The rear tires were spread 67" apart (center to center). This 6200-pound tractor (Official Guide – Tractors and Farm Equipment¹) was designed as a general-purpose farm tractor. The tractor and its tires were in good condition prior to the incident and the brakes were functioning. The tractor was not equipped with a ROPS or seatbelt. The rear tires were fluid filled to approximately the same level, one-third to one-half full. The tractor had no front-end counter weights for greater stability.

Figure 1. Tractor that overturned showing fender on which victim had been sitting.

The tractor suffered minor damage such as: left side fender was bent, steering wheel broken, seat bent, exhaust stack bent over, right hand mounting fender bracket broken, air intake valve sheared off.

Recommendation #1: Individuals should not ride as passengers on an operating tractor, and drivers should not allow extra riders/passengers.

Recommendation #2: Tractor should be equipped with rollover protective structures and seatbelts.

Recommendation #4: Tractors should be equipped with front-end counterweights.

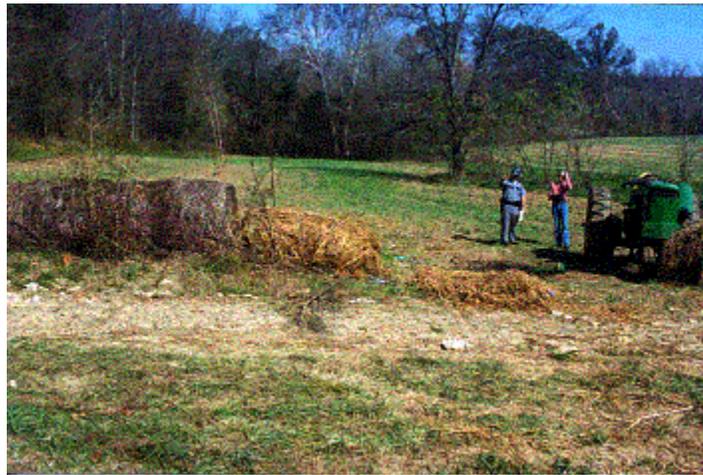
The weather was cloudy and about 70 degrees. Rainfall a couple of days prior to the day of the incident had left the ground somewhat muddy. The driver was attempting to load a bale of hay onto a 3.5 foot spike that was 2 inches in diameter. It was dusk and the tractor had its headlights on. The tractor had been moving backwards towards the bale of hay in a westerly direction down a slope that declined approximately 1 inch per foot, increasing to a slope of approximately

Figure 2. Site of Tractor Incident.

2 inches per foot at the spot where the tractor overturned (see Figure 2). As it reversed, the right rear wheel of the tractor proceeded over the hay bale causing the tractor to overturn sideways to the left (see Figure 3). According to the driver's father, the driver reported that both the victim and the driver each attempted to push the other free of the falling tractor. The victim was trapped underneath the driver's seat. The driver was thrown clear by a rotating tire, but sustained damage to his lungs and ribs. Nevertheless he attempted to free the victim. When he was unable to free her, he started up the nearby road on a steep hill that led to his home, a quarter mile away.

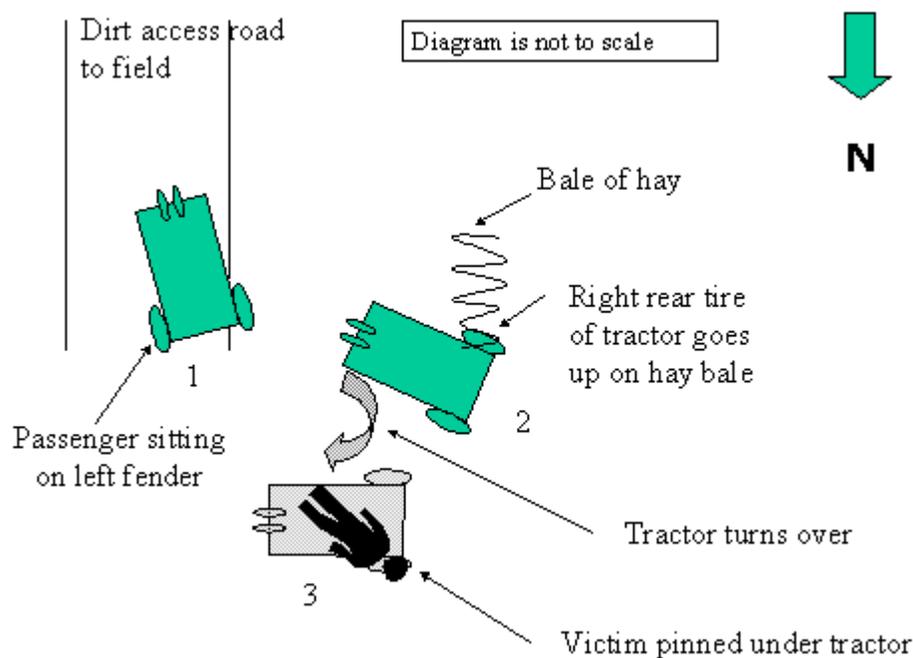
Figure 3. Schematic diagram showing sequence of tractor overturn and final position of victim. The father of the driver was working in an adjacent field without visual access to the field in which the incident occurred. When he no longer heard his son's tractor running he went over to investigate. The father called EMS, who arrived at the scene 16 minutes after being called. A Kentucky State Police Trooper arrived at the scene minutes later. EMS used airbags to lift the tractor and free the victim. The victim arrived at the hospital almost two hours after the incident occurred and was pronounced dead from compression
