## Proposal for Monitoring Concrete Painting as a Preventive Maintenance Tool (Abutments and Pier Caps)

KTC-TA-17-03/IPN16-57-8

**Technical Assistance Report**  
KTC-TA-17-03/IPN16-57-8

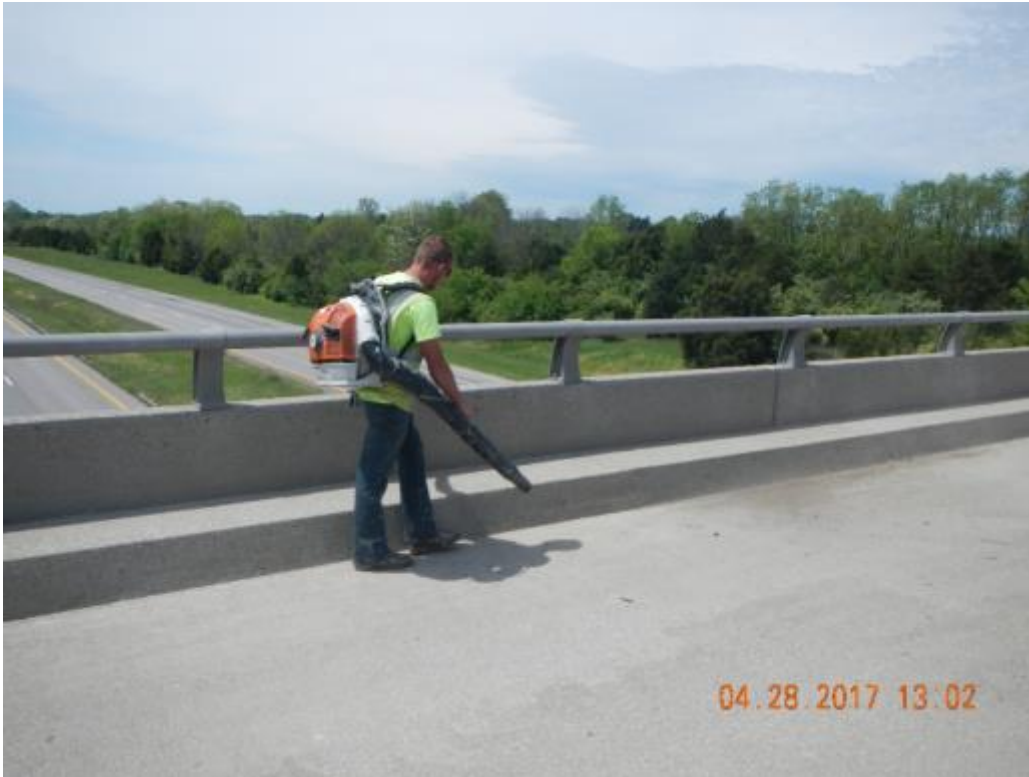
The wash crew was far ahead of the painting crew after a few days. As a result, the painting crew could not comply with the application requirement of coating within 72 hours of washing. A leaf blower was used prior to painting to remove any loose debris that had accumulated due to wind and traffic (Figure 3).

Figure 3 Removing debris with leaf blower

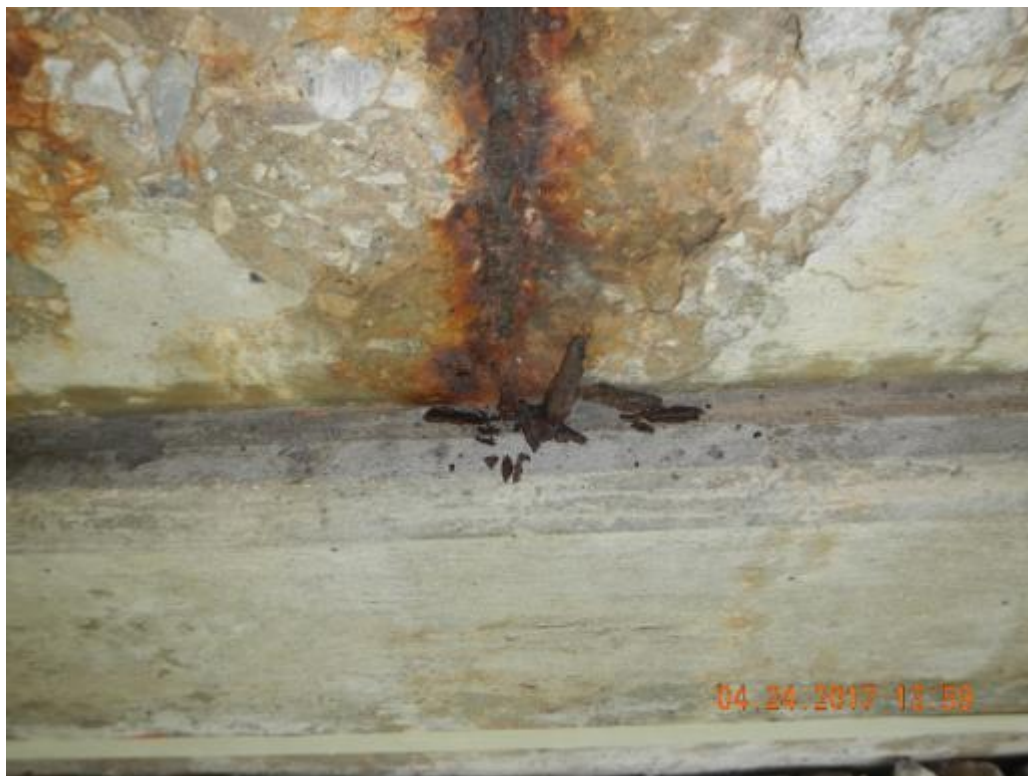
Pressure washing was complete approximately 96 hours prior to coating. The contractor continued to wash and coat in a similar fashion as the previous bridge. Although repair work was not within the scope of this project there were spalled areas with exposed reinforcement on the abutments that needed repair prior to coating (Figure 5). Washing these areas was not sufficient to remove stratified rust (Figure 6).

*Figure 6 Loose rust after washing*

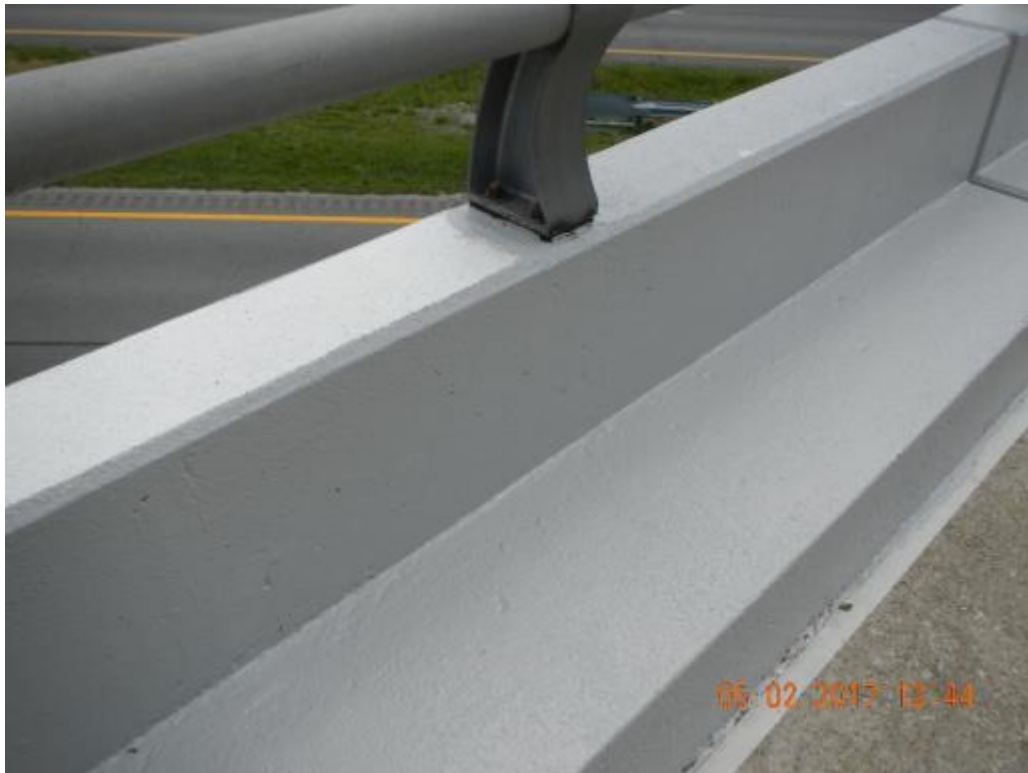
During the top coat application, KTC personnel measured WFTs of 5 to 6 mils. There were multiple places with severe runs as well as large areas that were completely missed (Figure 7). These areas were coated during the second coat application. The minimum recoat interval for applying acrylic to acrylic is 4 hours at 77°F. Application of the second coat of acrylic began prior to the minimum recoat interval as both coats of acrylic were applied to this bridge in approximately 5.5 hours.

Figure 7 Top of barrier wall with no top coat

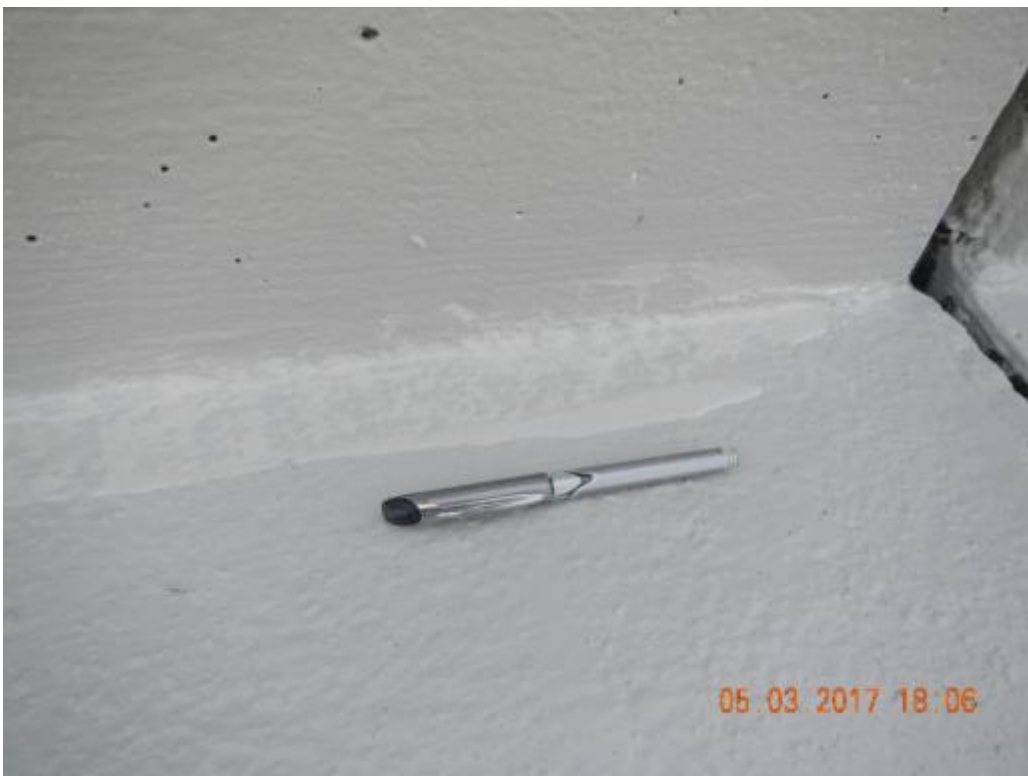
Figure 8 Excessive runs

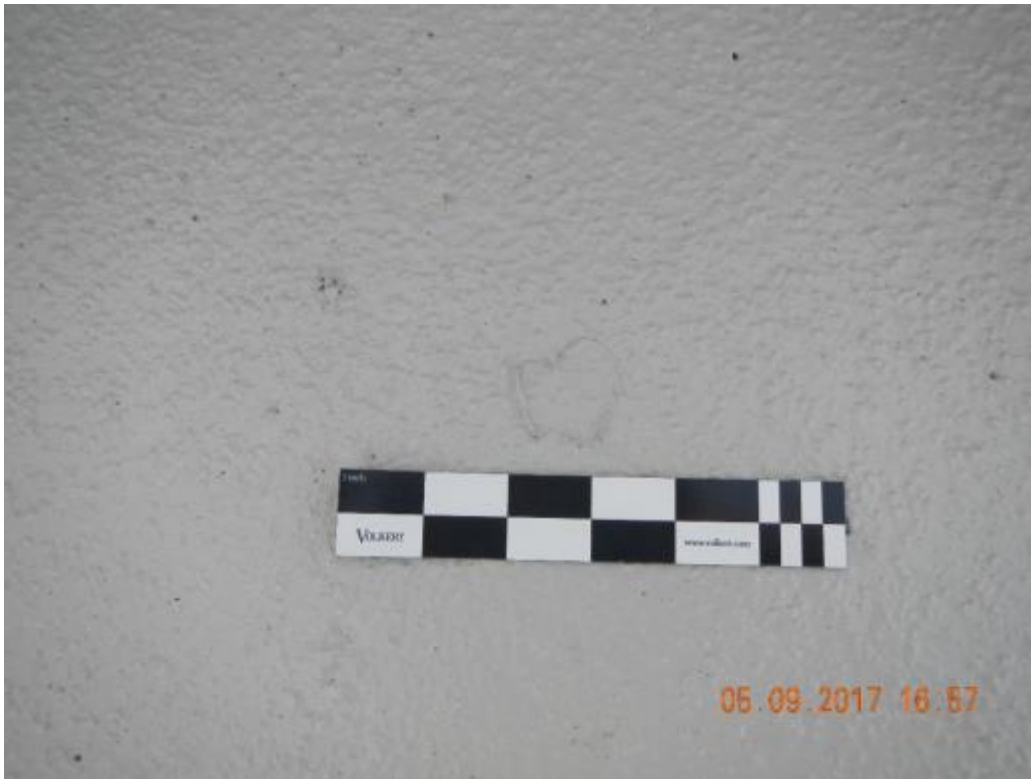
Figure 9 Coated debris

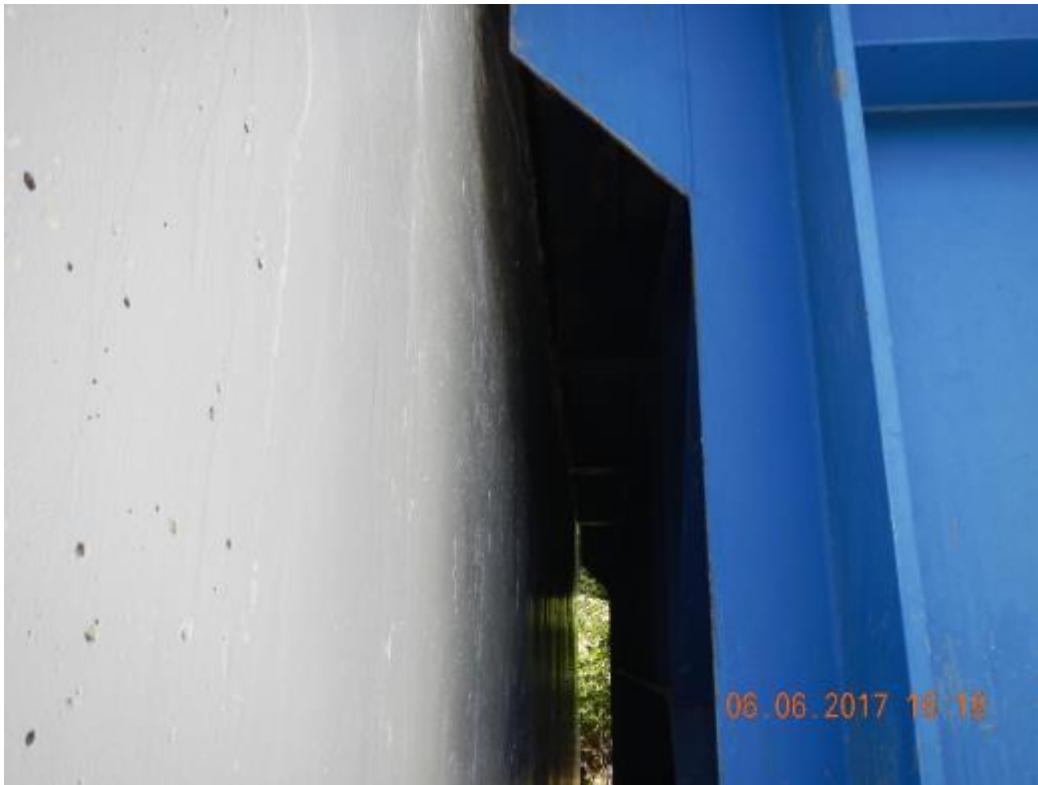
*Figure 11 Back wall of abutment with floor beam in close proximity*

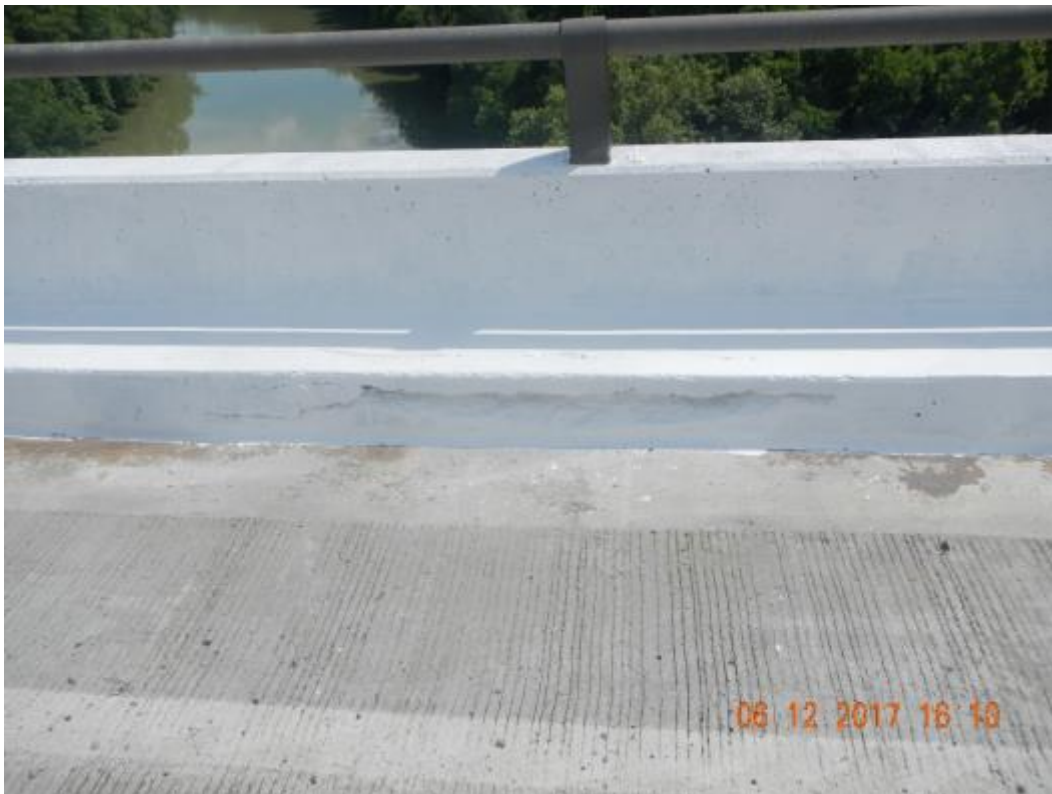
*Figure 12 Spalled concrete*

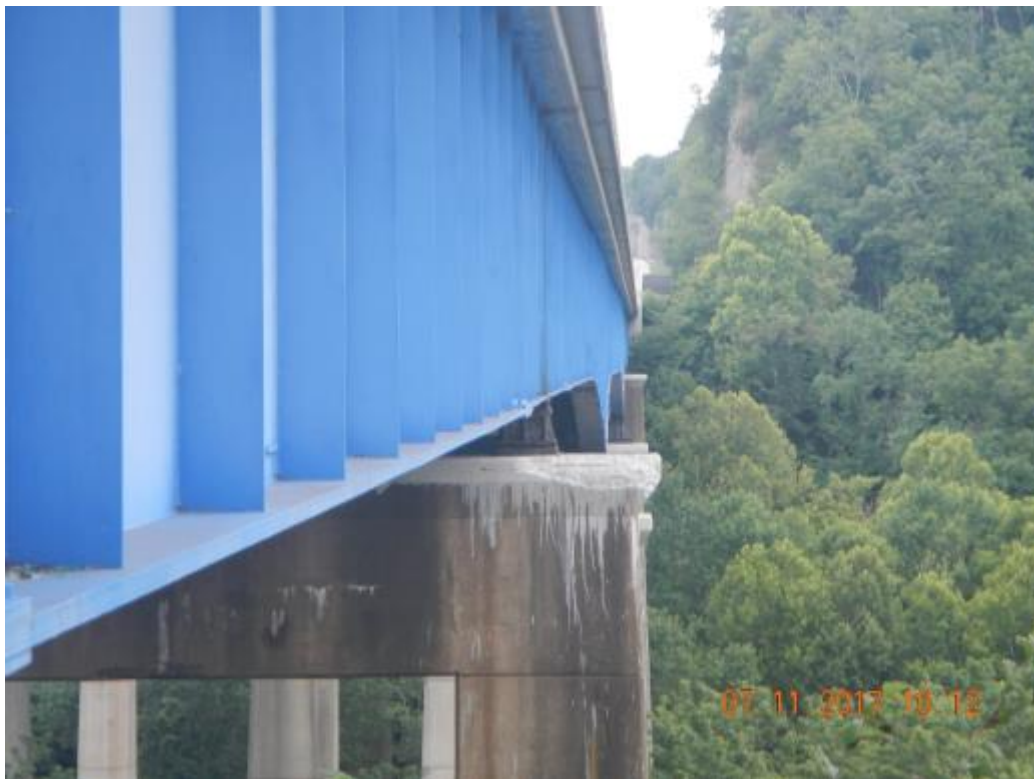
Of the issues observed during this project none could be considered as immediate problems, other than possibly aesthetics (Figure 14). After the project was complete, KTC personnel made a final visit on July 10 and 11, 2017, to the bridges that were monitored. The following issues were observed.

*Figure 14 Severe runs — poor workmanship*
