38 Year-Old Construction Laborer Dies When Trench Walls Collapse

Incident Number: 03KY107

Release Date: November 5, 2004

Subject: 38 Year-Old Construction Laborer Dies When Trench Collapses

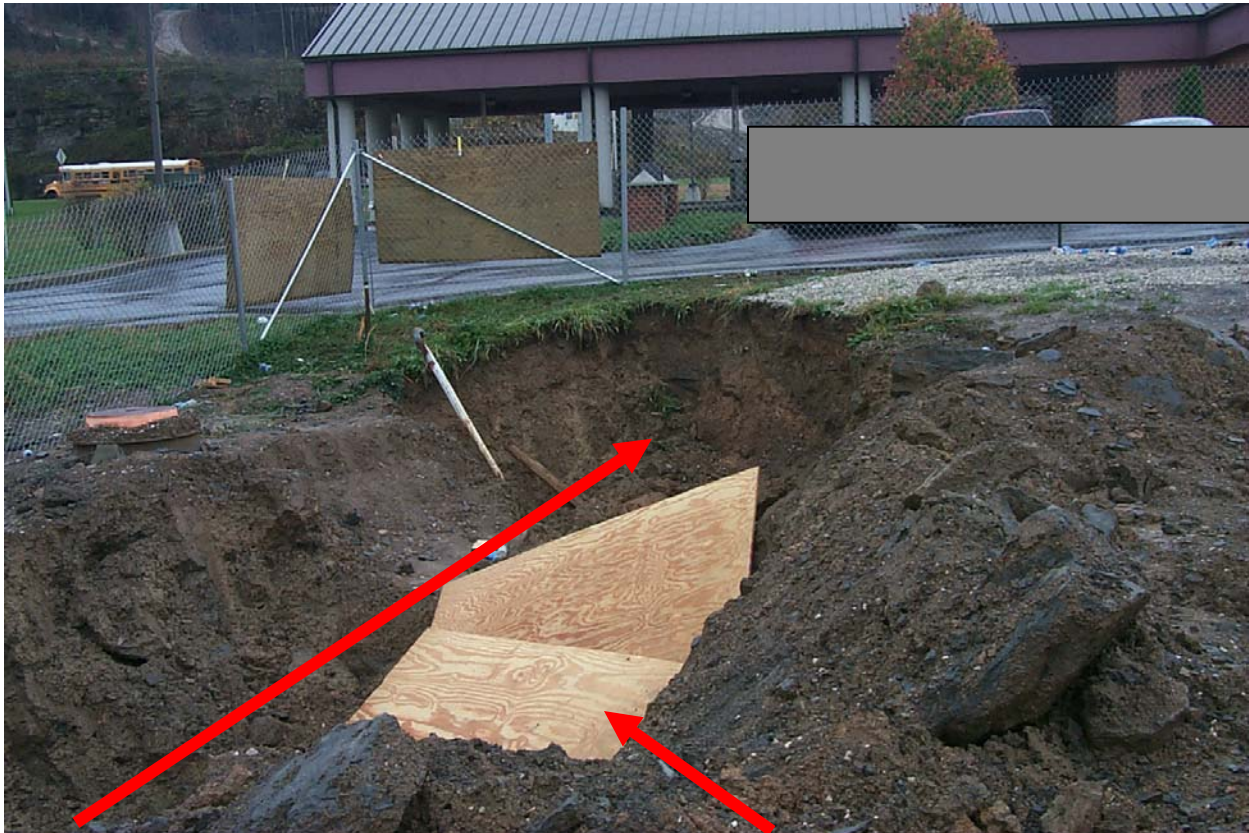
Location of victim in trench when sides collapsed. Plywood used by emergency response personnel.

At 11:15 am, the superintendent and the subcontractor's foreman were at the boundary line next to the trench where the work crew had worked in since Thursday. The two men determined the location where the old abandoned gas pipe was to be cut off at the boundary line. After this decision was made, the superintendent returned to the trailer and the foreman proceeded to operate a track hoe and excavate to dig a 6 foot wide x 8 foot deep x 16 foot long trench from the end of Thursday's trench to within 4 feet of the boundary line and fence. This trench was within 10 feet of the heavily trafficked driveway which served the two neighboring businesses. No sloping or benching methods or shoring equipment were used in the trench. Instead, the sides of the trench, sheared by the teeth of the track hoe, were straight down. After the trench was dug by the foreman, he moved the track hoe to the far end of Thursday's ditch (see Diagram). The victim jumped in the hole with a saw and proceeded to cut through the gas line and casing (making this cut should have only taken a minute). While the laborer was cutting through the gas line and casing the sides of the trench caved in, burying him.

Recommendation No. 1: Employers and employees should not take shortcuts.

According to one person interviewed, the decedent's job of cutting the exposed gas line pipe and casing with a saw should have only taken a few minutes to accomplish. Taking the time to shore the sides of the trench would have taken longer than sawing the pipe and casing. Instead, it was decided to take a shortcut and not protect the laborer from the possibility of the trench sides collapsing.

Employers are required by OSHA Standard 29 CFR 1926.652(a)(1) to protect employees from cave-ins while performing excavation work. This regulation also stipulates configurations for sloping sides of trenches and appropriate materials to be used in shoring walls of excavation sites. Any trench 5 feet or more in depth must have an adequate protection system before being used by employees.
