# **Cleaner Falls 35 Feet to His Death Through Temporary Roof Opening**

**Incident Number: 04KY011**

## **Kentucky Fatality Assessment and Control Evaluation (FACE) Program**

**Subject: Cleaner Falls 35 Feet to His Death Through  
Temporary Roof Opening**

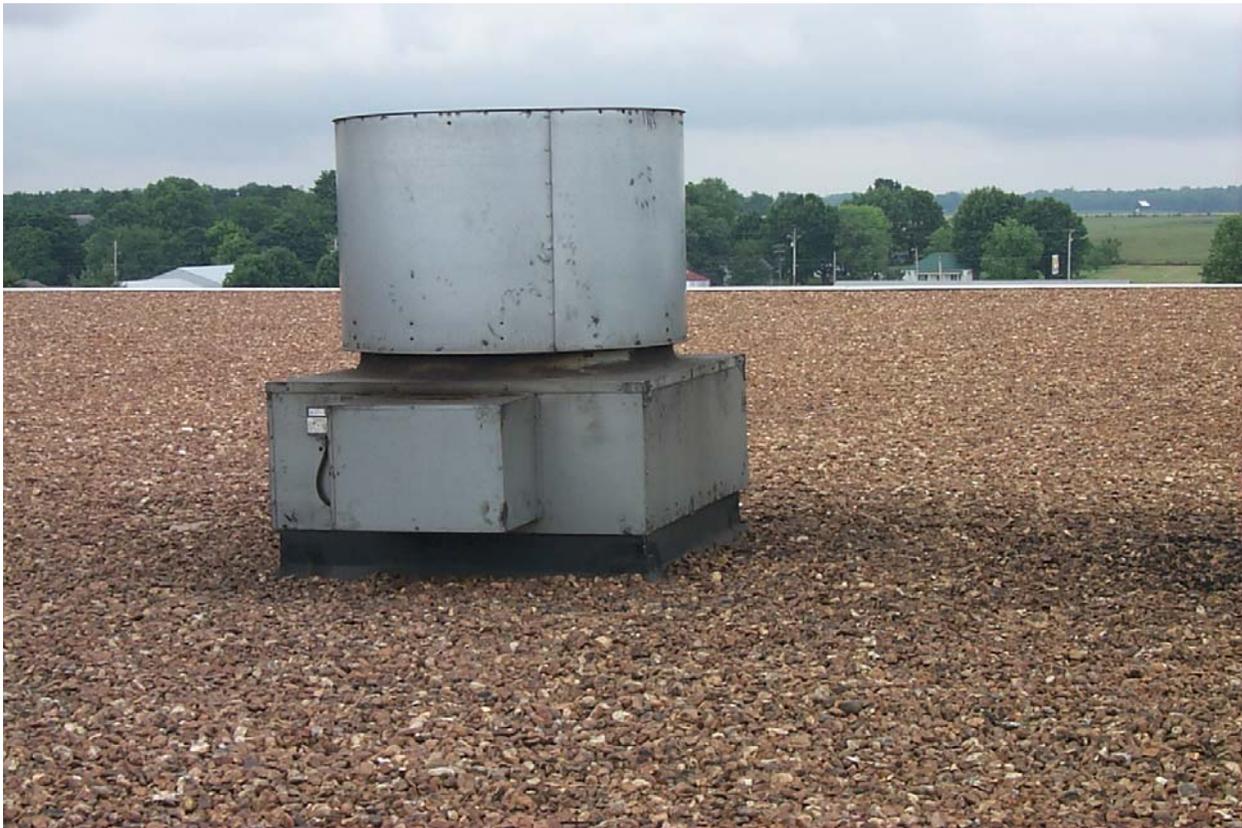
**Exhaust fan had been removed for cleaning, creating a temporary opening where cleaner fell approximately 35 feet onto a piece of machinery in the factory.**

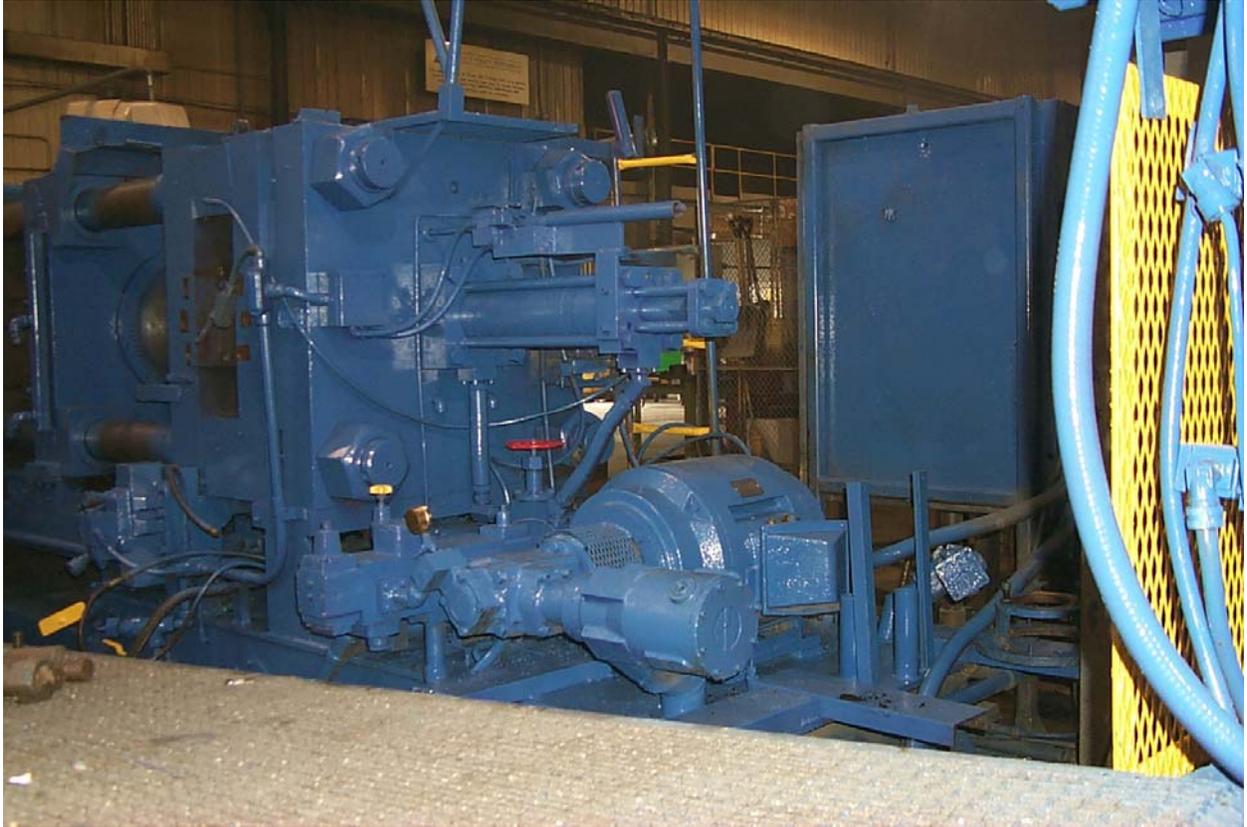
At approximately 8:30 am, the decedent was preparing to clean a fan removed from its casing by the three laborers (one of which had been the decedent). The fan was placed beside the temporary opening on the roof. The distance between the fan and the temporary opening is unknown. It appears that the decedent was facing the fan with his back to the roof opening. Apparently the decedent took a step back away from the fan then fell backwards through the temporary opening, into the factory onto a piece of machinery. No one saw him fall. At the time of the decedent's fall, the other two laborers were each cleaning fans in different areas of the roof and it was break-time. One of the laborers walked toward the man lift while the other went to tell the decedent it was break time (it was approximately 8:40 am – 8:45 am). In the meantime, according to the employer, the laborers heard an ambulance approach the factory. The laborer looking for the decedent, approached the area where the decedent had been cleaning a fan, did not see the decedent, and only saw the water hose guided down into the factory. The laborer looked through the opening in the roof and observed the decedent had fallen onto a piece of machinery.

Machinery onto which the cleaner fell.

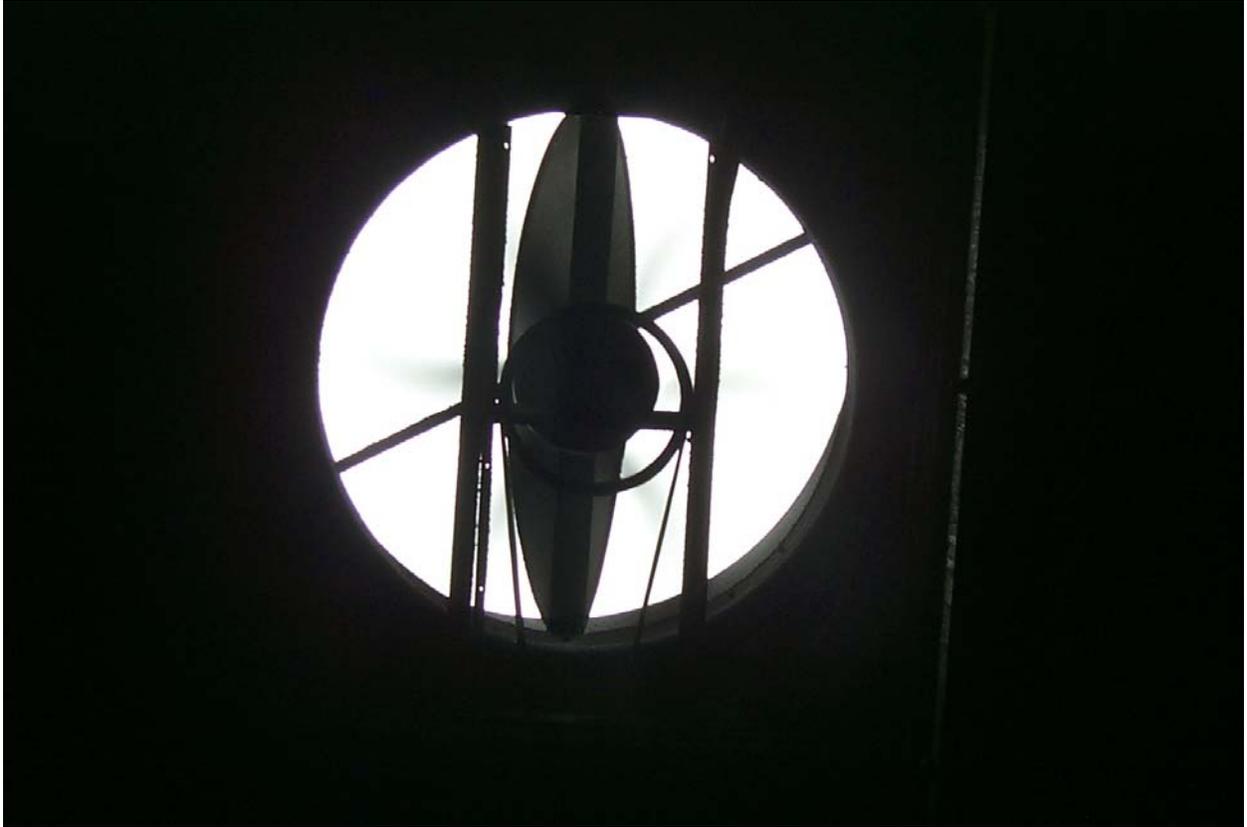
Exhaust fan above machinery on factory floor where fatal incident occurred. Picture was taken from factory floor.
