**Bulldozer Owner / Operator Drowns While
Trying to Repair a Pond
Incident Number: 03KY073**

Kentucky Fatality Assessment and Control Evaluation (FACE) Program

Incident Number: 03KY073

**Subject: Bulldozer Owner / Operator Drowns While
Trying to Repair a Pond**

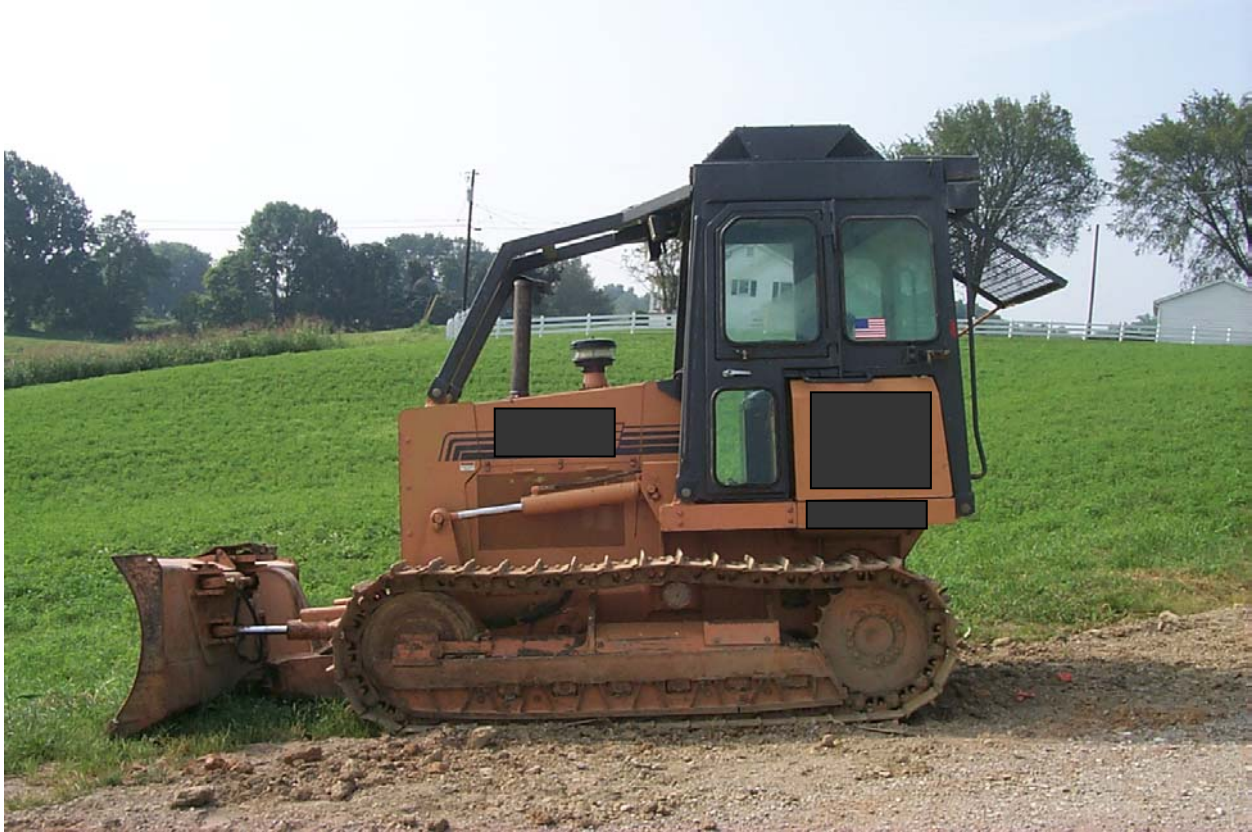
A picture of the bulldozer after it had been partially cleaned up and repaired. Notice the diagonal line on the window. This line shows the amount of pond water that remained in the cab after the decedent had been removed from the cab.
