Chinese Immigrant Restaurant Owner Electrocuted

Incident Number: 02KY131
Date of Incident: August 12, 2002
Report Release Date: August 14, 2003

Kentucky Fatality Assessment and Control Evaluation (FACE) Program

Incident Number: 02KY131

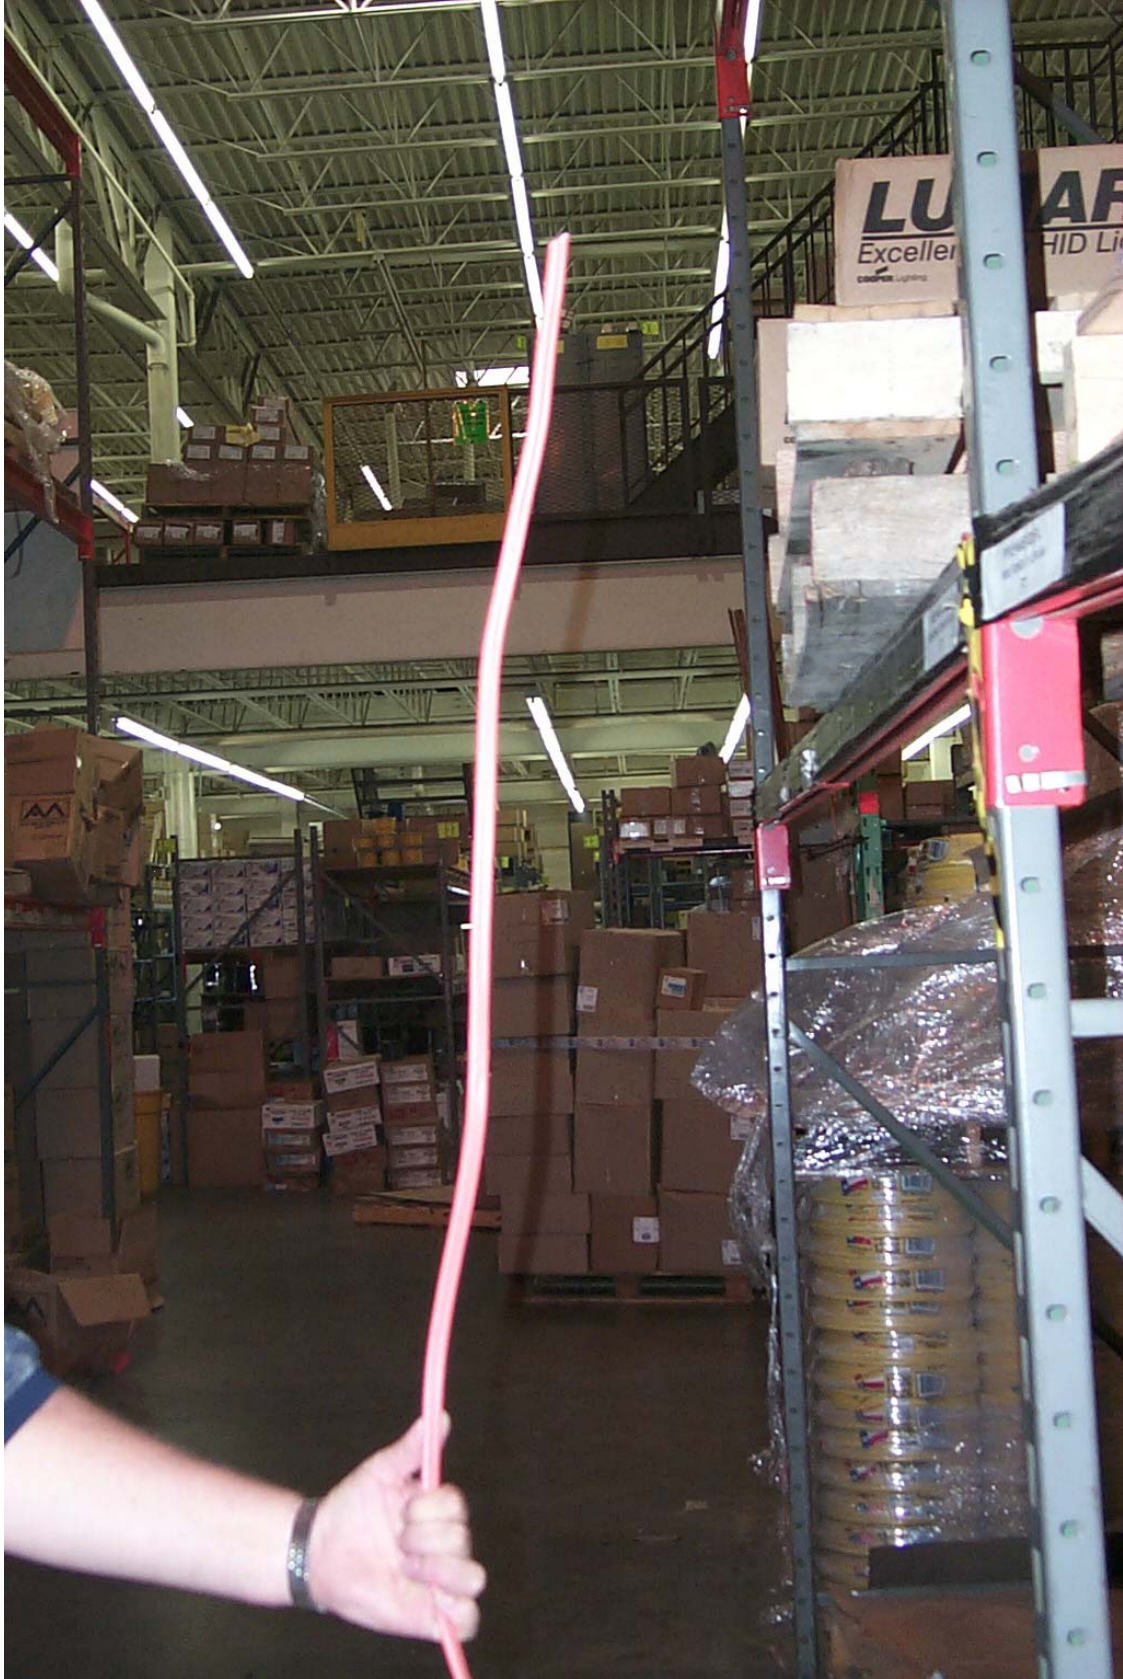
The local electrical codes inspector went to the scene and investigated this incident. During the interview, he said the wiring connections to the unit and the splices were made correctly but the restaurant owner had used inappropriate material to fabricate the extension cord. The 10/2 wire was too rigid for the application the decedent used it for.

The wire the decedent chose to use to fabricate the extension cord is very rigid and does not allow flexibility in movement. The stiffness of the wire caused the connection to fail and the

wire to become loose and touch the metal frame of the cooler. It is unknown why he chose 10/2 wire instead of a more flexible wire to fabricate the extension cord. Also unknown is why the decedent chose not to plug the existing cord into an approved extension cord to lengthen the existing cord.

An example of 10/2 wire. Notice how rigid it is.

Only persons properly trained in electrical procedures should perform electrical services.

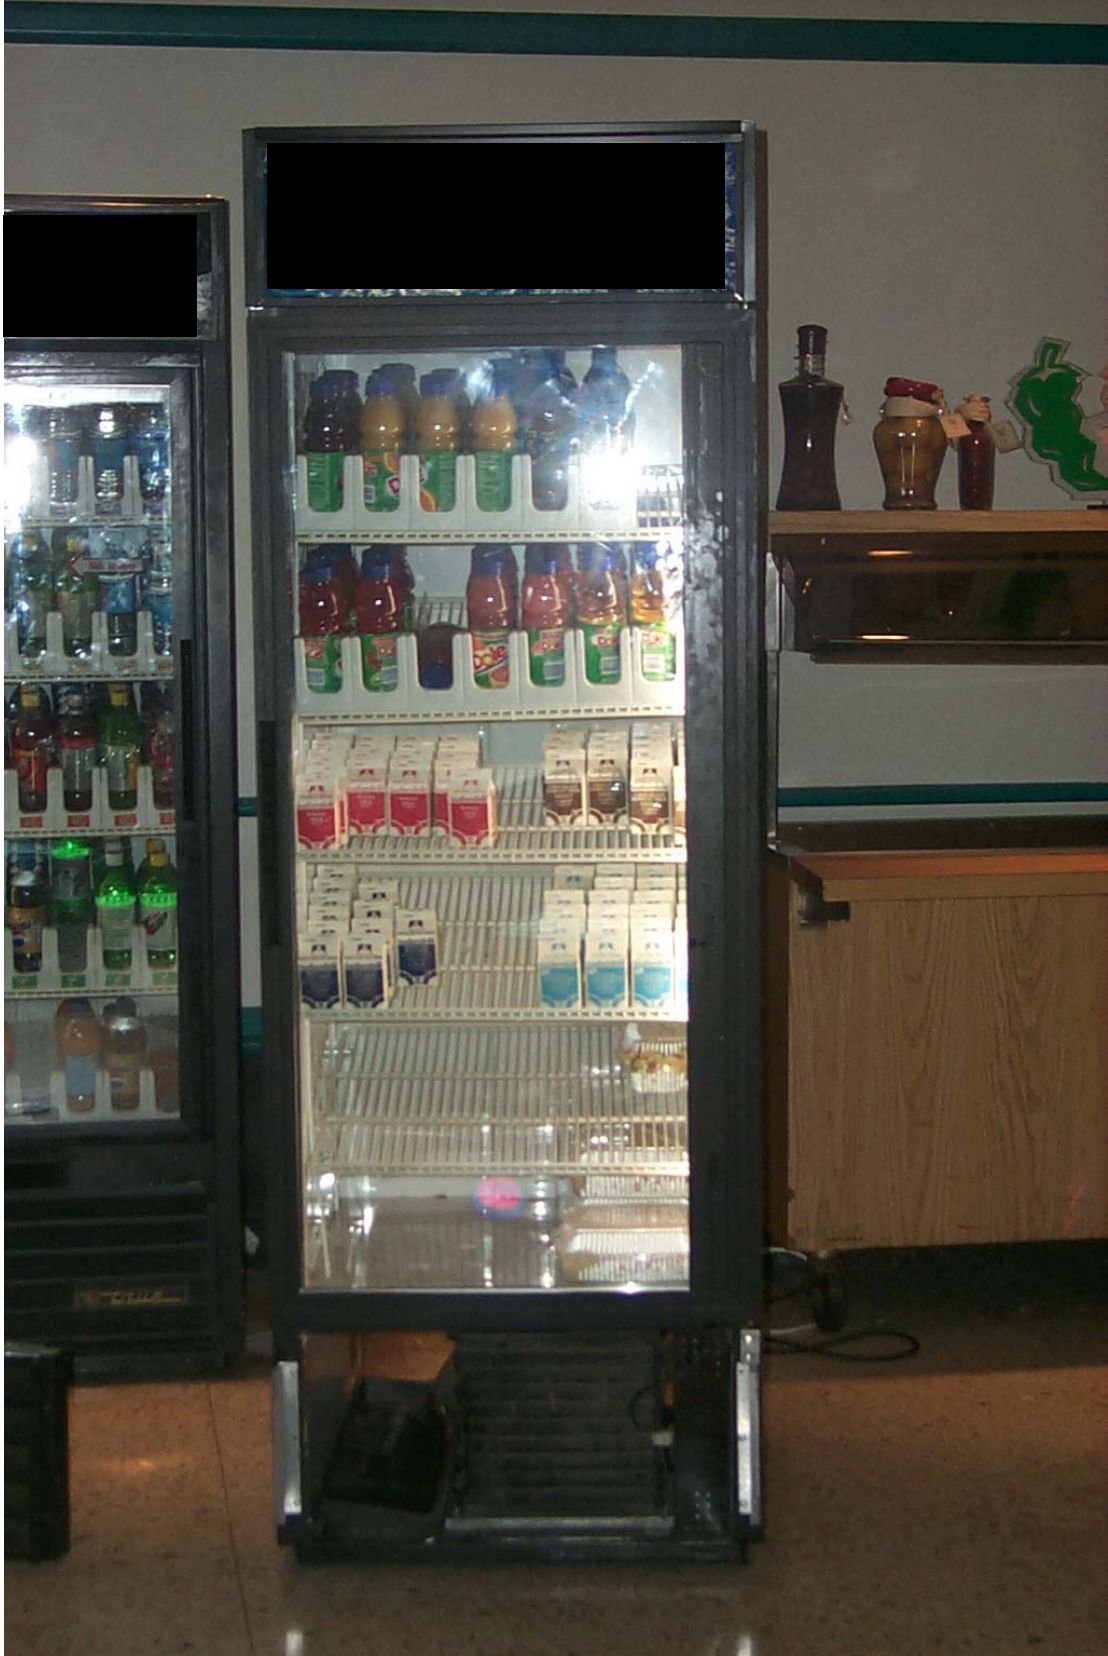
around the kitchen to keep it out of the way as they cleaned. The electrical cord to the cooler was not long enough to allow much mobility of the cooler and have it remain plugged into the wall. In order to increase the distance the cooler could be moved and still remain plugged into the wall, the restaurant owner replaced the electrical cord of the unit with a self-fabricated extension cord composed of a 10 foot length of 10/2 wire and a one foot length of extension cord. The decedent wired the 10/2 wire to the electrical panel in the back of the cooler and spliced the other end into one foot of extension cord. He wrapped the spliced area with electrical tape then plugged the unit into the wall receptacle. During the course of the day, the man and his wife moved the cooler to different locations around the kitchen. The first time the cooler was moved, it felt normal to the touch. However, subsequent to the initial move, each person moving the cooler felt a slight tingling to their hands when they touched the metal frame. The ground wire had detached from its connection to the electrical panel inside the cooler. The exposed ground came into contact with the metal side of the cooler. This energized the outside of the cooler.

By evening, the unit had been moved approximately eight to twelve inches catty-corner to a gas cook stove. The restaurant owner who was hot, sweaty and shirtless bent down between the cook stove and the cooler. As he did so, his chest touched the outside aluminum casing of the cooler and his back touched the metal stove. He was electrocuted as the electric current traveled from the cooler through him to ground through the stove.

Cooler similar to the one in the restaurant.
