41 Year-Old Male Dies after Being Struck in the Head with an Auger

Incident Number: 02KY127
Date of Incident: October 23, 2002
Report Release Date: June 17, 2003

Kentucky Fatality Assessment & Control Evaluation (FACE) Program

Incident: 02KY127

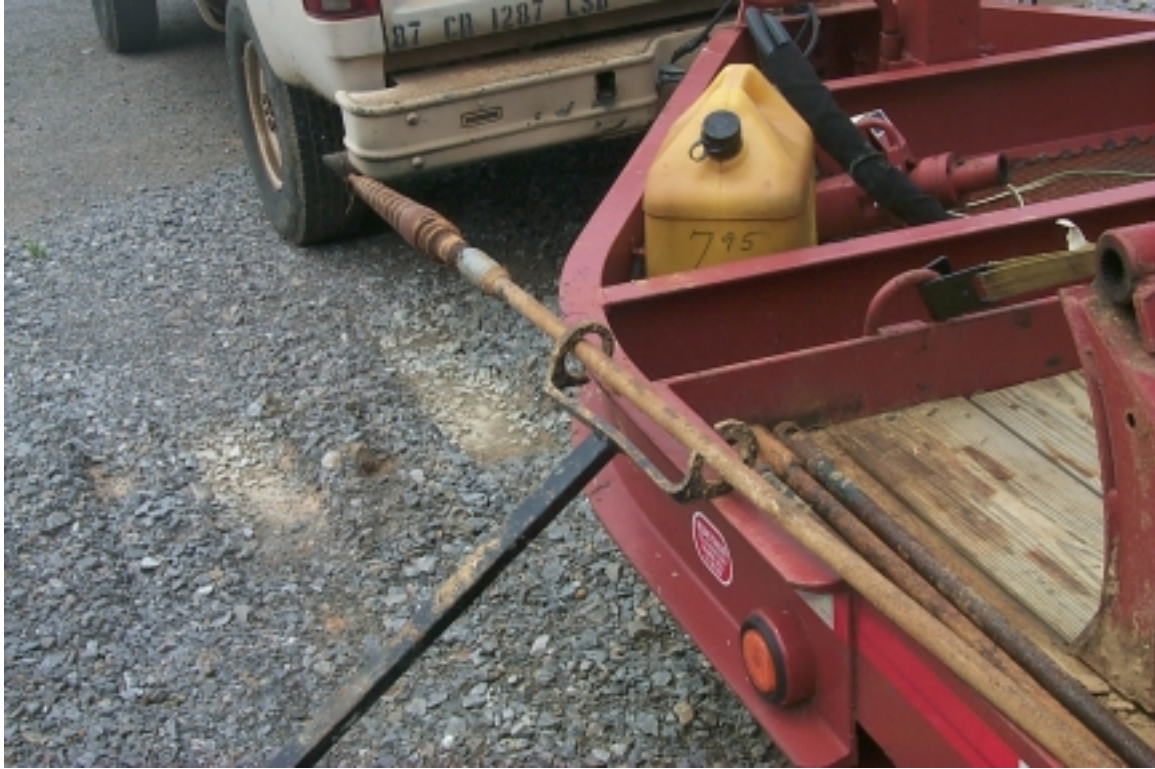
Auger bit with handle in proper location on rod to guide bit forward.

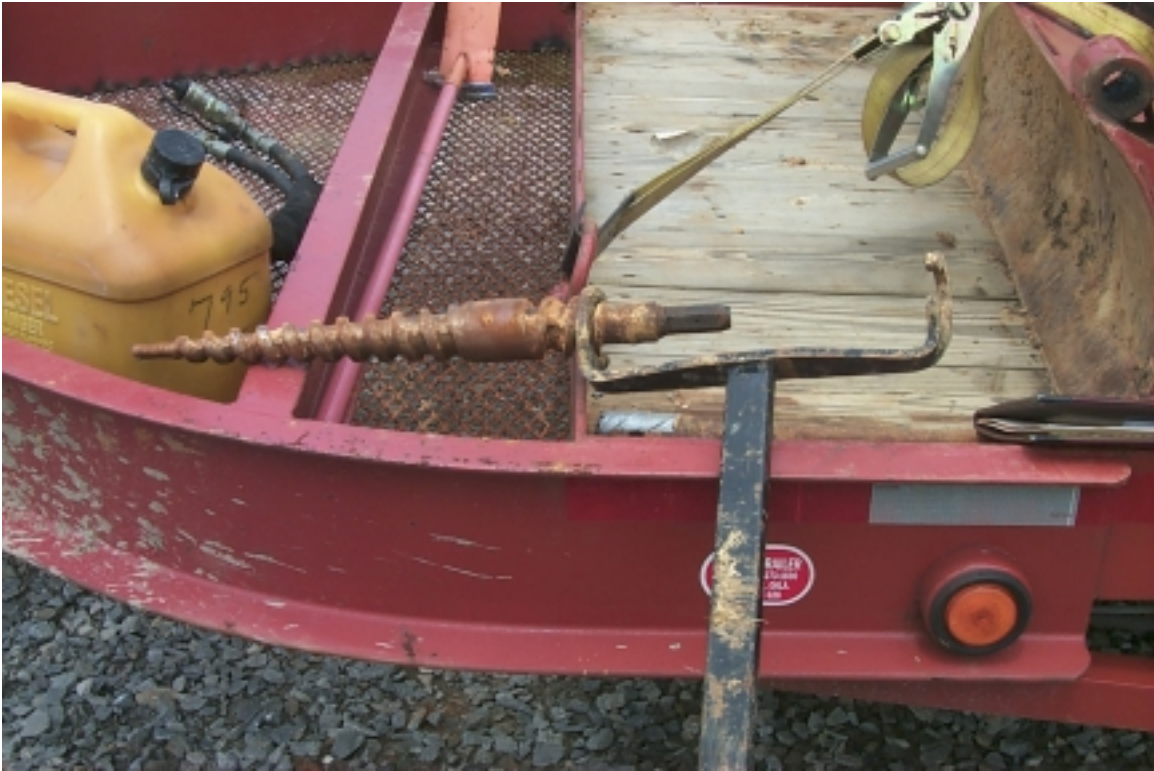
There are four components to the auger: the power train, the rod, the handle and the bit. The bit is attached to the end of the rod, which is guided on the side by the handle. The handle has two open loops that are open on opposite sides of the loop. These loops fit over the rod. The power train makes the rod and bit rotate to move forward or backward. The handle on the rod allows the operator to guide the bit where it needs to bore. The handle should not touch the bit, only the rod. According to safe operating procedures, when the bit direction is reversed, the handle needs to be removed. This prevents the bit from becoming entangled in the handle. Training should be reinforced on a regular basis on correct use of augers. Had the handle been removed prior to reversing direction, this incident may have been prevented.

Auger bit threaded into handle as it would have done at time of incident.

When an auger is being operated forward, it can be guided by a handle. When the bit direction is reversed, the handle should be removed. This keeps the bit from becoming entangled in the handle. The decedent had safely operated the auger hundreds of times before the incident occurred. It is unknown why he did not remove the handle in this particular instance. Perhaps manufacturers could research different handle designs and attachment mechanisms to allow the handle to stay attached safely while the bit is moving in the reverse direction. Another option would be to have the bit un-operational in the reverse direction when the handle is still attached.

Note: As of the writing of this report, the handle design has been redesigned by the manufacturer to break away if the bit and rod become uncontrollable. The handles are being replaced free of charge to customers.
