21 Year-old Male Dies when Struck in the Head with a Track Hoe Bucket

Incident Number: 02KY106
Date of Incident: November 22, 2002
Report Release Date: June 17, 2003

Kentucky Fatality Assessment and Control Evaluation (FACE) Program

Subject: 21 Year-old Male Dies when Struck in the Head with a Track Hoe Bucket

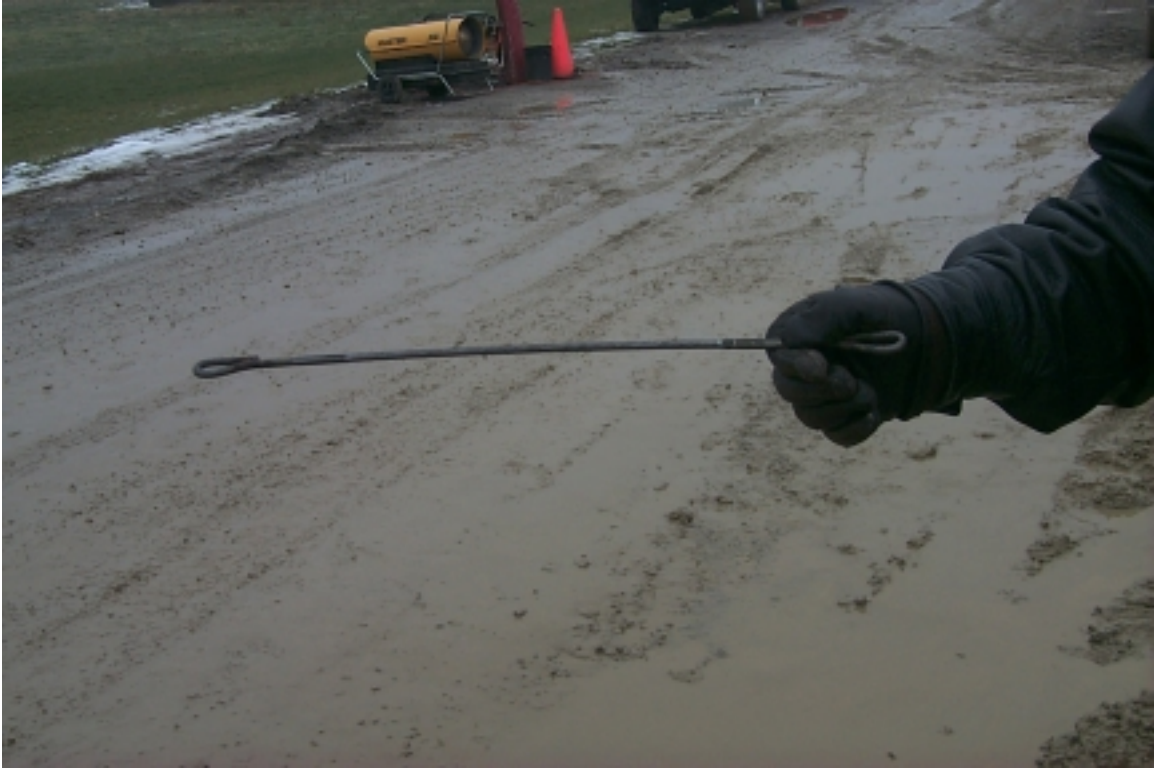
Picture of wire used for horizontal stability of concrete form.

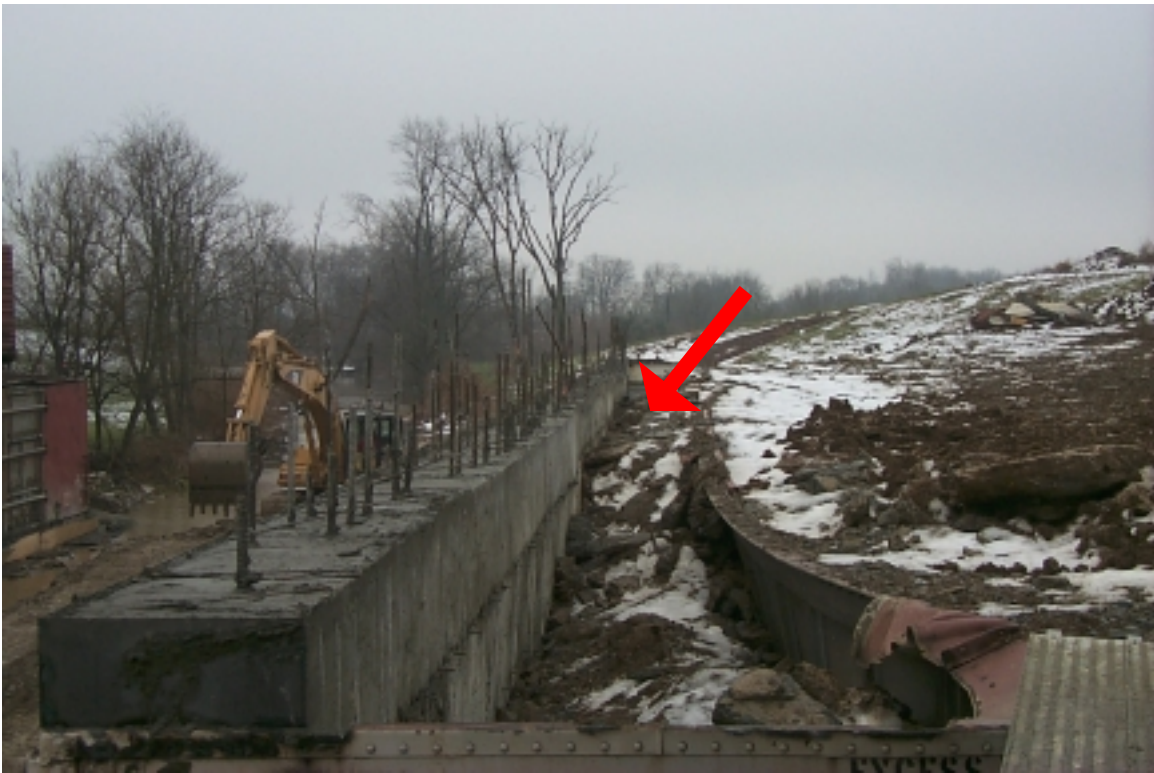
Location where incident occurred. Actual location is at the bottom of this form.

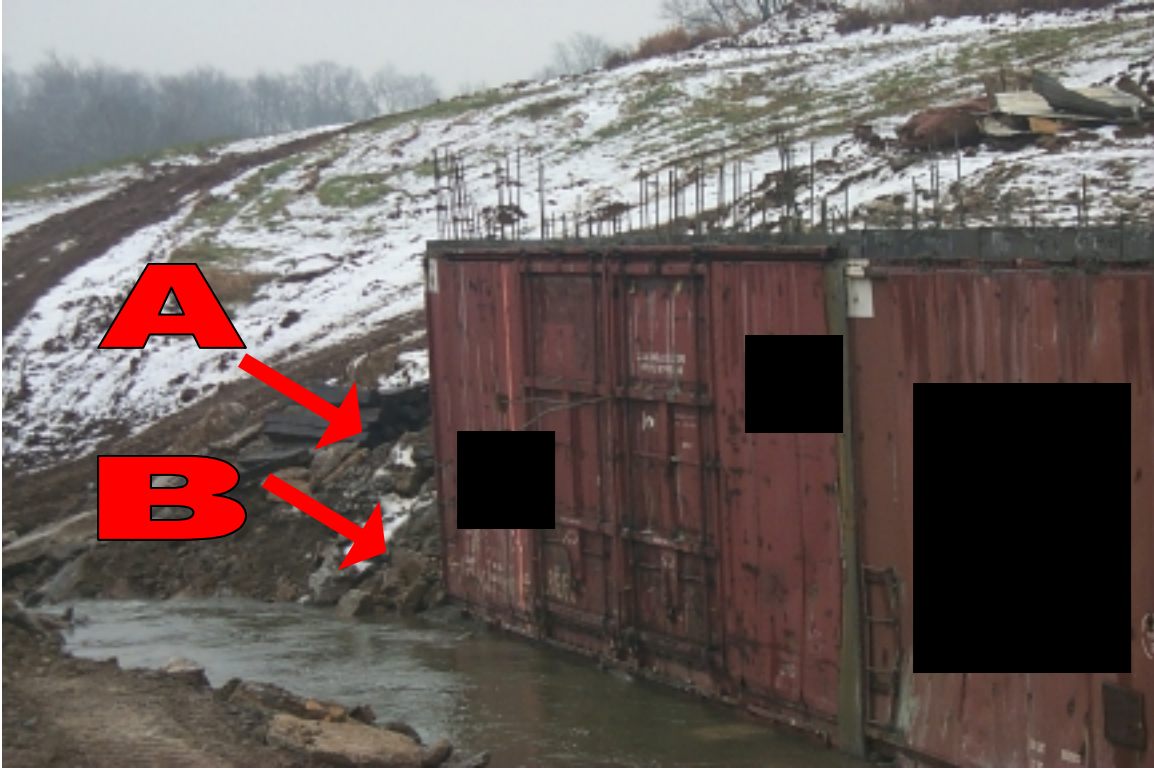
In efforts to free the trapped worker from the cement, the remainder of the crew decided to use a track hoe that was on site and shovels. The track hoe was driven to the area of the trapped coworker to help remove some of the cement and the operator was waiting for instructions. While the operator waited, he locked out the control mechanisms (two joy sticks) so the bucket could not be moved. The decedent obtained a shovel to aid in freeing his coworker from the cement. As he retrieved the shovel, he had positioned himself between the wall of the retaining form and the bucket of the track hoe. In this location the decedent was out of sight of the track hoe operator.

After the situation was assessed, the operator unlocked the controls so he could begin to remove some of the escaped cement. At that moment, a laborer on the ground asked the operator if there was a chain in the cab of the track hoe. When the operator looked down at the floor to see if there was a chain or not, his hand brushed one of the unlocked joy sticks and the bucket moved, which hit the laborer in the head.

A: Track hoe location at time of incident
B: Location of Decedent at time of incident

Recommendation No. 1: A hazard assessment of the work area should be performed every time work conditions change. Workers should not be in a blind spot of heavy equipment operators without the operator's knowledge. When blind spots are identified, a spotter should be used.

A thorough hazard assessment of the job site should be performed whenever conditions change. This would have included taping off the area the track hoe was working in. When working around heavy equipment, an evaluation of potential blind spots should be included in this hazard assessment. Potential blind spots would have been identified and employees not allowed in that area. When workers find themselves in blind spots of equipment operators, there should be a spotter who is in communication with the equipment operator to communicate with the operator while a worker is performing job functions in the operator's blind spot.

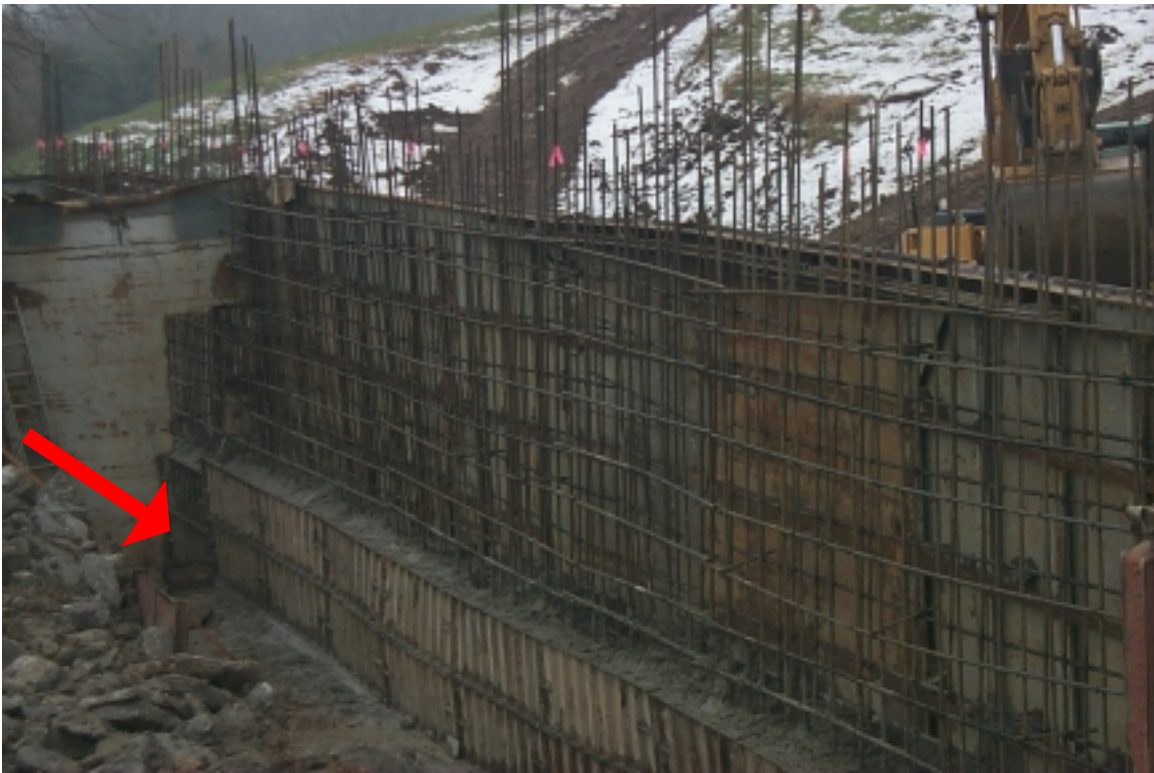
The decedent laborer had been assigned to help build the private airfield. On the afternoon of the incident, the work crew of 6 to 7 employees was pouring a concrete footer when one of the sides of the form collapsed. Three employees were in the path of the flowing concrete. One employee was trapped up to his waist and the other two managed to escape.

Picture of the opposite form being poured. This is how the other side looked when forms broke, trapping a worker waist high in cement.

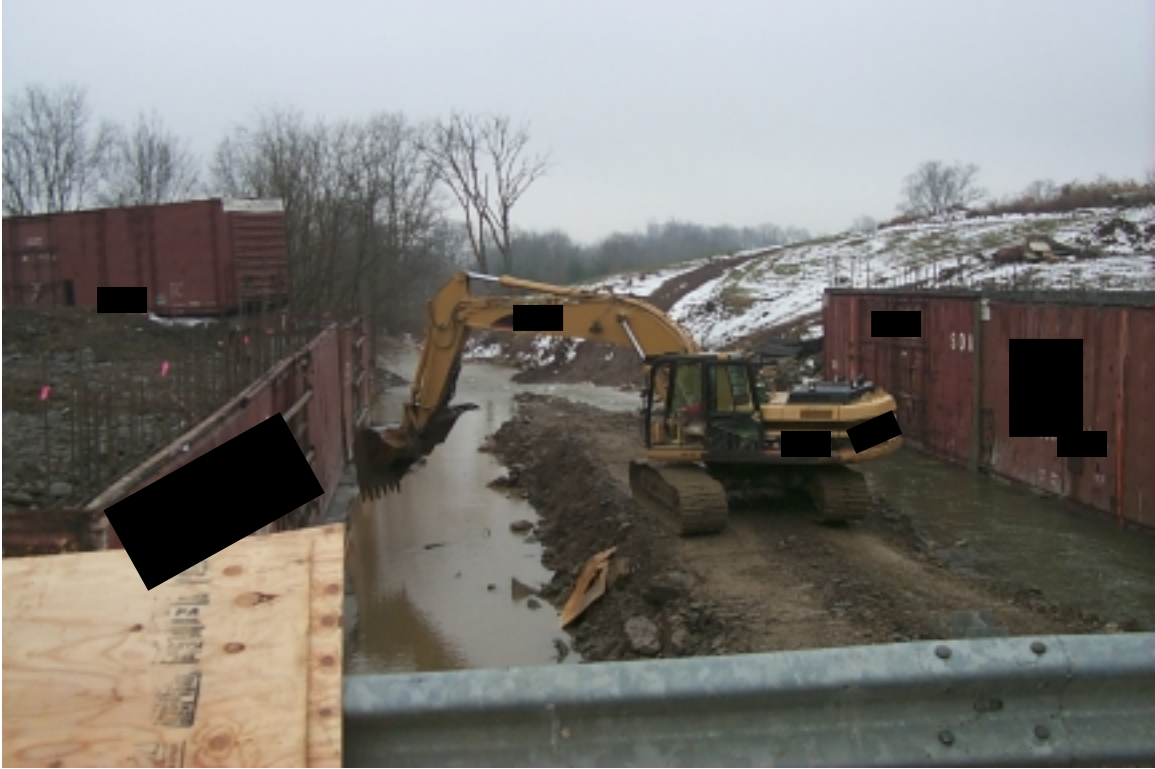
Picture of track hoe used to pull concrete away from worker.
