# **Municipal Solid Waste Collector Dies after Falling from Solid Waste Vehicle Hopper Area**

**Incident Number: 10KY006**

**Kentucky Fatality Assessment and Control Evaluation (FACE) Program**  
**Incident Number: 10KY006**  
**Release Date: January 11, 2011**  
**Subject: Municipal Solid Waste Collector Dies after Falling  
from Solid Waste Vehicle Hopper Area**

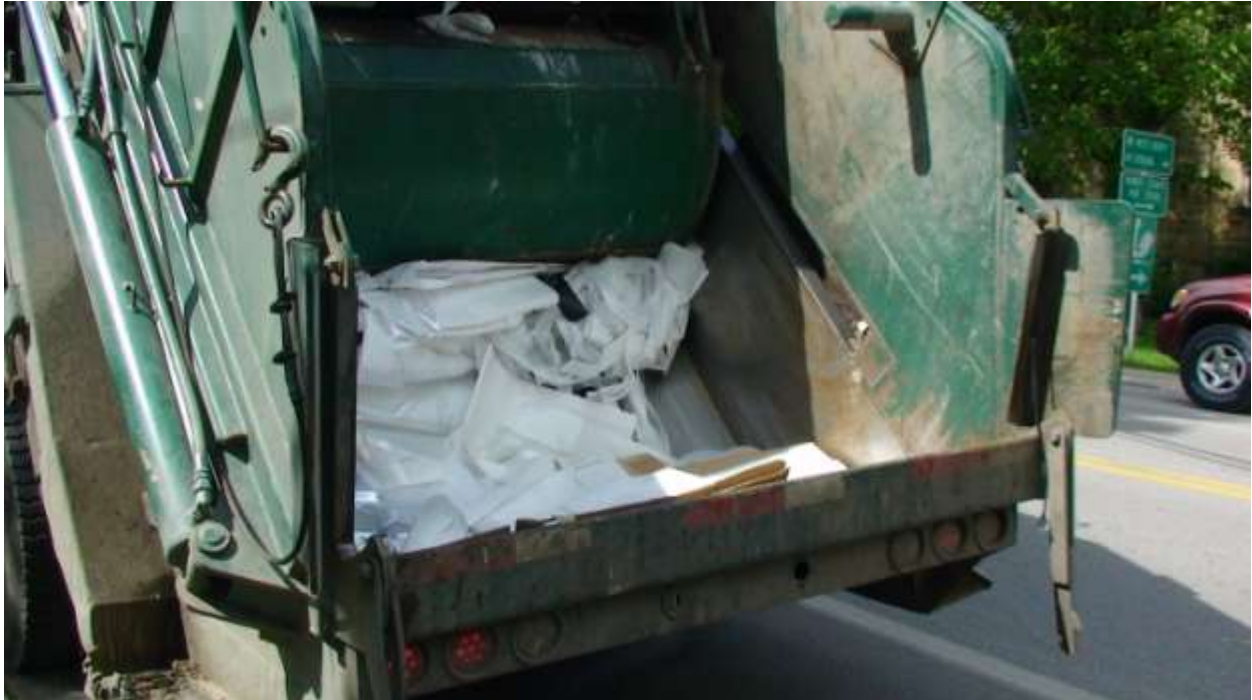
**Photograph of hopper from which Collector fell. Photograph courtesy of KY Labor Cabinet.**

Between stops, Collector 1 rode on the rear step on the passenger side of the solid waste truck. The rear step on the driver side of the truck was broken and it would not support Collector 2's weight. Without a step to ride on, Collector 2 rode on the driver side in the hopper area located in the back of the truck where the solid waste was collected from the trash receptacles. As he sat in the hopper area between stops, Collector 2 separated cans from the trash.

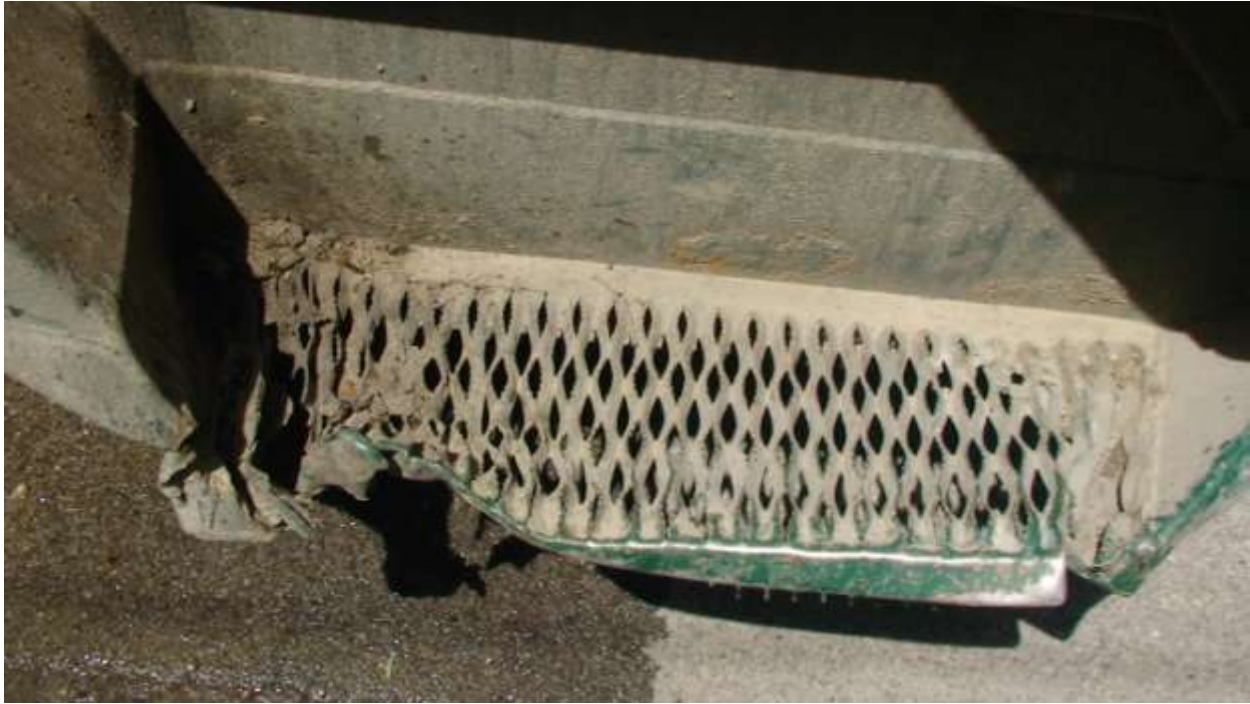
Each time the DVIR is completed, a supervisor should be notified so that needed repairs can be promptly completed. CFR 396.11 also requires that repairs affecting safety be completed prior to the vehicle being operated. According to a municipal official, the broken step had been reported as needing repair for six months prior to the incident. At the time this incident occurred, supervisors were notified verbally that repairs were needed on the solid waste trucks. After this incident, repair requests are now documented in writing.

Photograph of broken step.. Photograph courtesy of KY Labor Cabinet.

**Recommendation No. 1: Municipal solid waste divisions should require drivers to perform daily post-trip safety checks on solid waste collection vehicles and timely repairs should be performed.**

Municipal solid waste divisions should follow the United States Department of Transportation, Federal Motor Carrier Safety Administration, CFR 396.11 Driver vehicle inspection report(s), regulation that requires the driver of a commercial vehicle to perform a post-trip vehicle inspection at the end of the workday. A written report on the condition of the vehicle is also required. A Department of Transportation Driver's Vehicle Inspection Report, DVIR, (Attachment) should be used to note any defects that need to be corrected before the vehicle is operated. The report lists important aspects of the vehicle such as the air compressor, air lines, battery, body, brakes, clutches, wheels and rims, windshield wipers, etc., which the driver should be required to inspect each time the solid waste truck is operated. There is a section on the form for the driver to make notes of items not listed on the DVIR that may need to be addressed immediately or in the future. The DVIR does not contain an item on operation of the hopper. Municipal solid waste divisions should customize the DVIR to include specific items such as proper hopper functioning, and steps' and grab bars' condition.

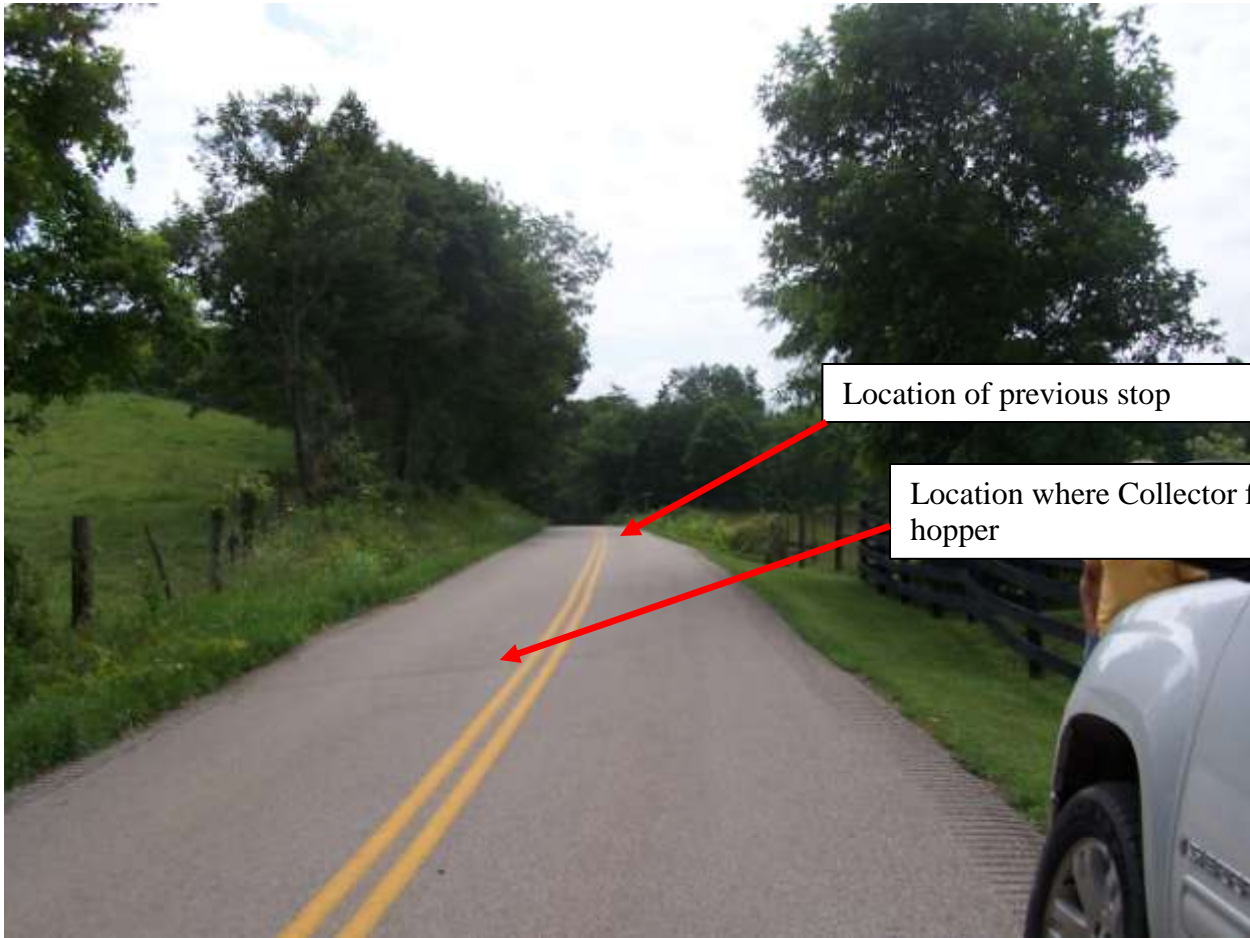
The crew took a lunch break then restarted the route. At approximately 11:40 AM, the crew collected trash from the end of a driveway then proceeded up the road 280 feet toward the next stop. The pavement surface was asphalt, and was smooth, flat and dry; the weather was clear. The posted speed limit was 55 miles per hour. According to the police report, the truck was going between 5 – 10 mph when Collector 2 attempted to jump out of the hopper area, falling onto the pavement striking his head. The vehicle was 50 feet from the next stop. The driver looked out the rearview mirror, saw Collector 2 on the pavement and stopped the truck. The driver and Collector 1 ran to Collector 2; Collector 1 administered first aid. There was no cell phone service at the scene, so the driver drove the solid waste truck several miles to a nearby store, and at 11:50 AM called emergency medical services and his supervisor. Emergency

Location of previous stop

Location where Collector fell from hopper

Roadway where Collector fell out of hopper of solid waste truck. Photograph by KY FACE
