**Coal Truck Driver Fatally Injured in Collision
With another Coal Tractor-Trailer
Incident Number: 08KY010**

Kentucky Fatality Assessment and Control Evaluation (FACE) Program

Incident Number: 08KY010

Release Date: February 13, 2008

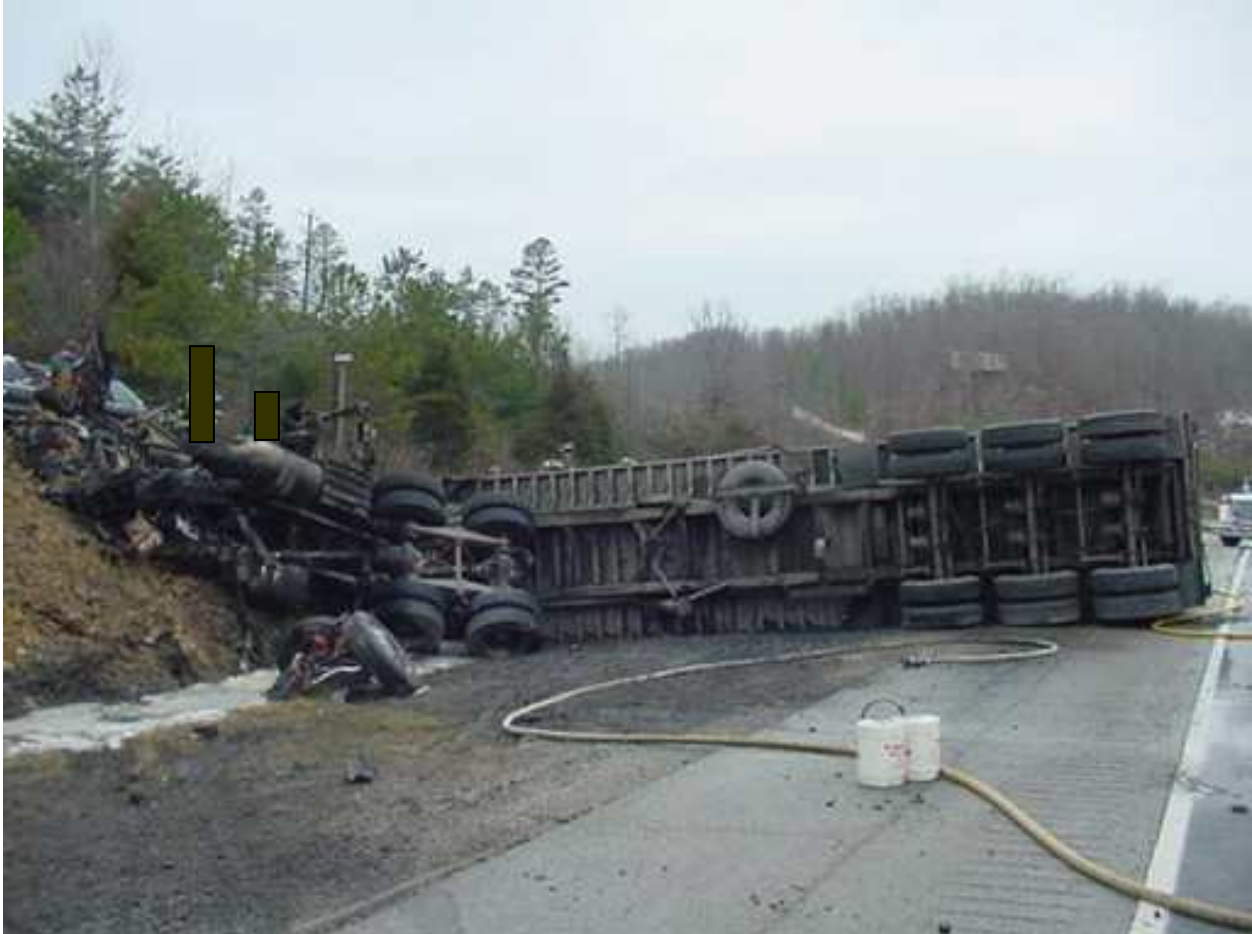
Photograph of coal truck involved in a crash. Photograph courtesy of LEX 18 Archives.

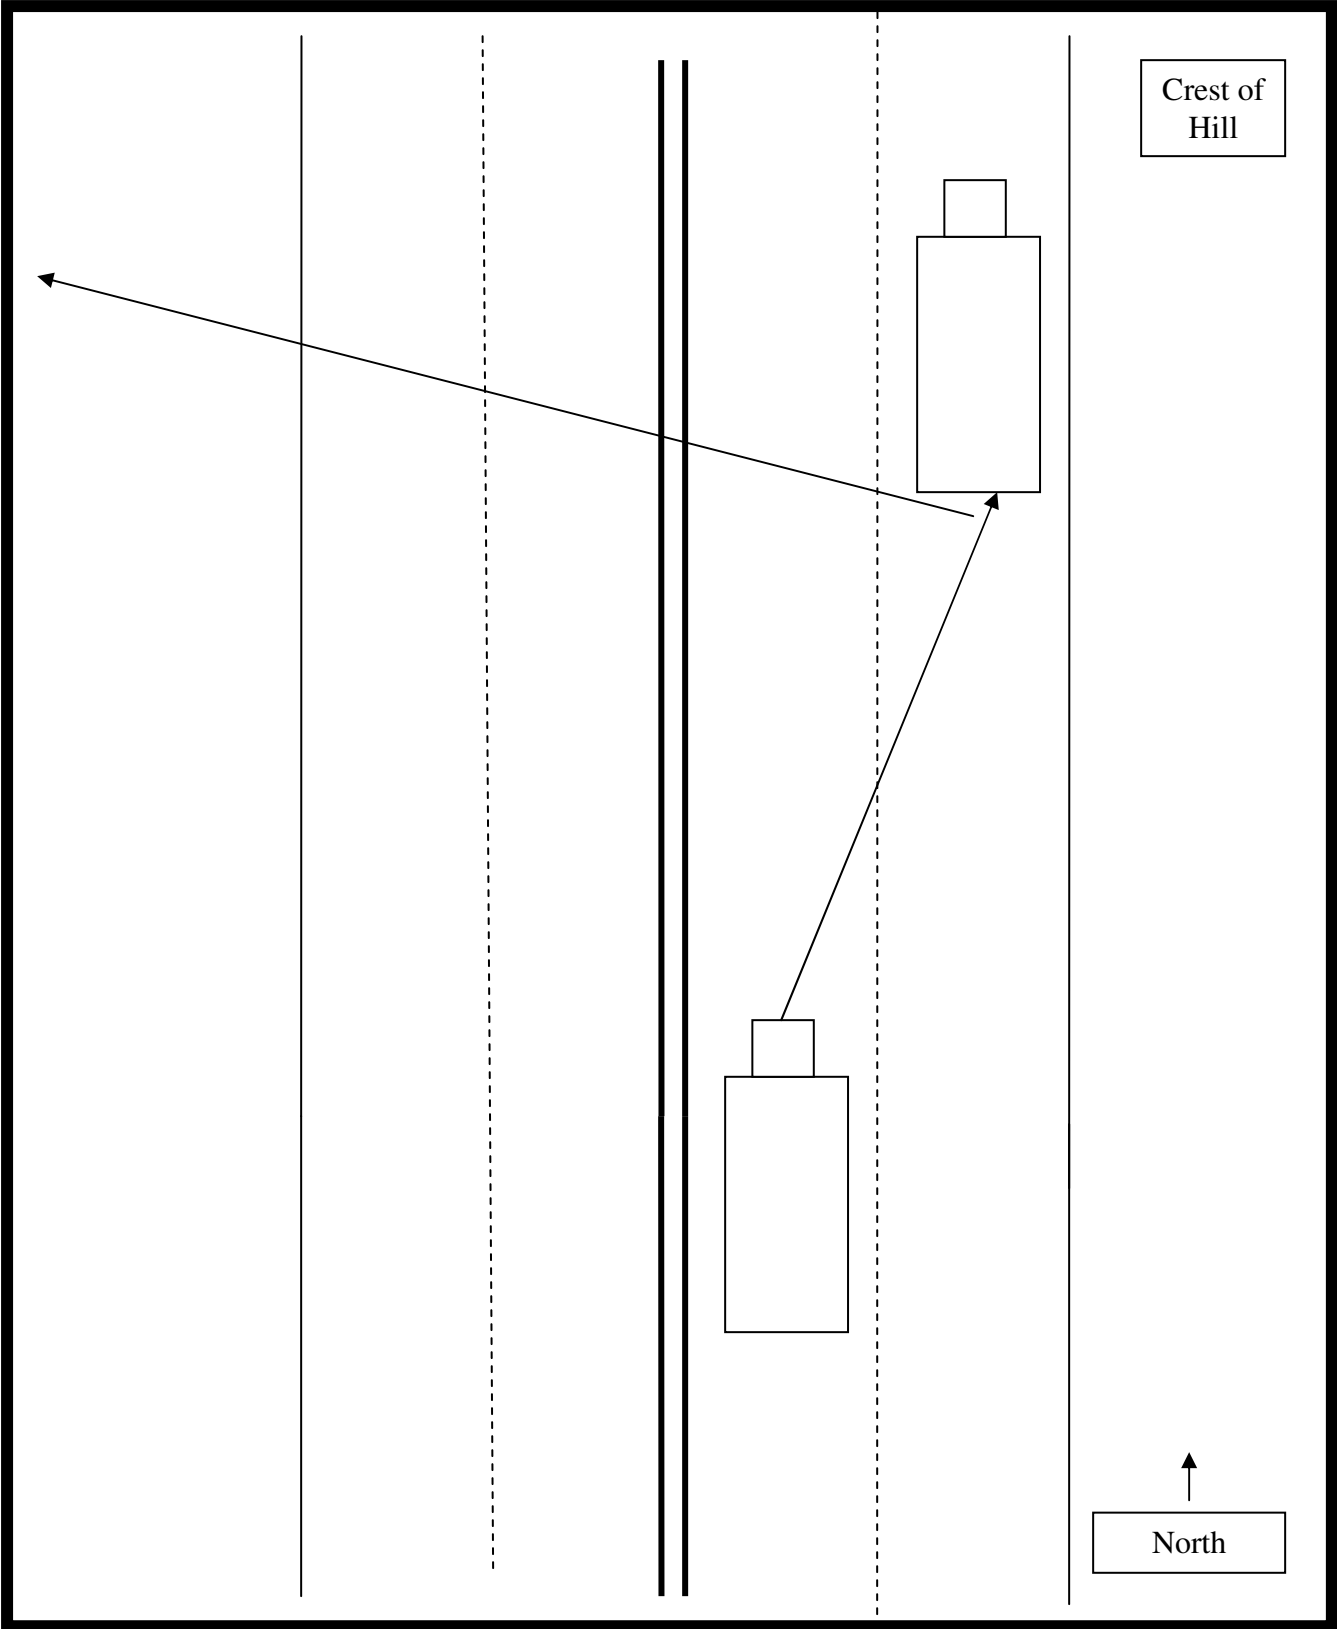
Schematic of incident; not to scale

Truck 1 was in the right lane traveling north. Truck 2 was traveling behind Truck 1 in the left lane. The lane Truck 3 was traveling in is unknown. The three tractor-trailers were traveling down a hill approximately 1/10 of mile long with a 2.5% - 4.4% grade. They approached an intersection where a two lane state highway connects with a stop light at the bottom of the hill. Upon approach to the intersection, there was a flashing yellow caution light alerting oncoming vehicles of traffic signal changes from green to yellow to red. The caution light was part of a signage unit which read "When Flashing Prepare To Stop." Drivers of Trucks 2 and 3 had been conversing via citizen band radio but had ceased communications before reaching the intersection.

Truck 1 was required to stop at the red light. When the light changed to green, Truck 1 proceeded up the next hill; Truck 1's vision up the hill was clear and unobstructed. Truck 2, driving in the left lane, approached the intersection while the light was green. Truck 2 drove through the intersection followed by Truck 3 approximately three tractor-trailer lengths behind. The next hill after the traffic light was approximately 1/10 of a mile long with a 0.5% - 2.4% grade.

Truck1, traveling approximately 40-45 miles an hour, was in the right lane approaching the top of the hill. The speed of truck 2 is unknown. Trucks 2 and 3 were also approaching the top of the hill. The driver of Truck 3 stated that Truck 2 appeared to engage in a normal lane change into the right lane when the driver's side tire of Truck 2 hit the right rear of Truck 1's trailer. Upon impact, the driver of Truck 1 looked in the driver's side mirror and saw Truck 2 veer across the southbound lanes of the highway. Truck 2 crossed over a gravel ditch beside the road, immediately hit an earth embankment, overturned and caught fire. Upon impact with the embankment, the cab separated from the frame of the truck, the fuel tanks were torn open, and the driver was thrown into the passenger side of the sleeper compartment.
