Research Report  
KTC-99-5

EVALUATION OF CORRUGATED STEEL PIPE CULVERTS  
KY 55, SHELBY COUNTY

March 1999

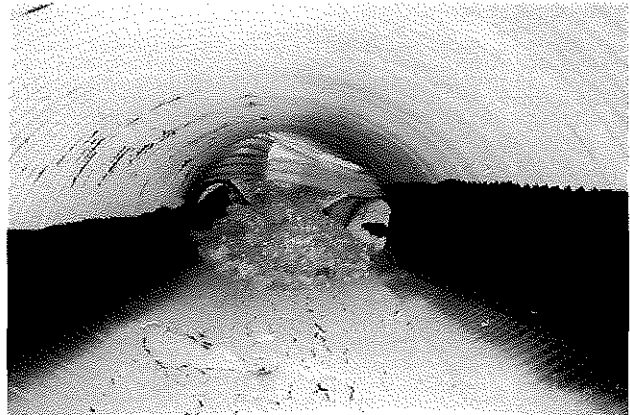
Several random visual inspections were performed throughout the course of the project. During one of the inspections on August 9, 1998, a failure was observed in a pipe arch at Station 531+15 (Figure 1). From conversations with the inspector it is apparent that a pan driver ran over the pipe with less than one foot of fill over the pipe (Figure 2). The failed section of the arch was removed and replaced.

**Figure 1. Failure observed in cross drain at Station 531+15.**

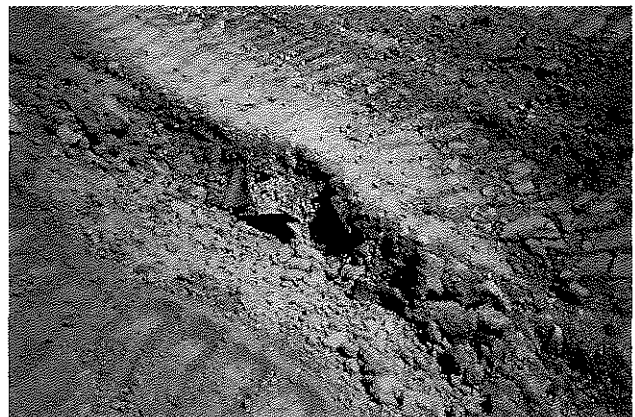
**Figure 2. Top of cross drain damaged by pan at Station 531+15.**

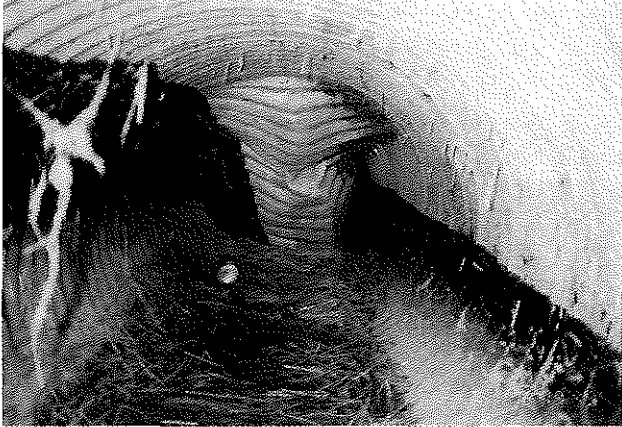
On February 19, 1999, a visual inspection was conducted on every cross drain on the project. During this inspection, significant pipe distress was observed in two cross drains. A 30-inch pipe at Station 602+00 had completely collapsed on both the inlet and the outlet end (Figure 3). The failures had occurred approximately 30 feet from the inlet end and approximately five feet from the outlet end. It is uncertain at this time if the pipe has completely collapsed between these two locations.

**Figure 3. Failure observed in 30" cross drain at Station 602+50.**

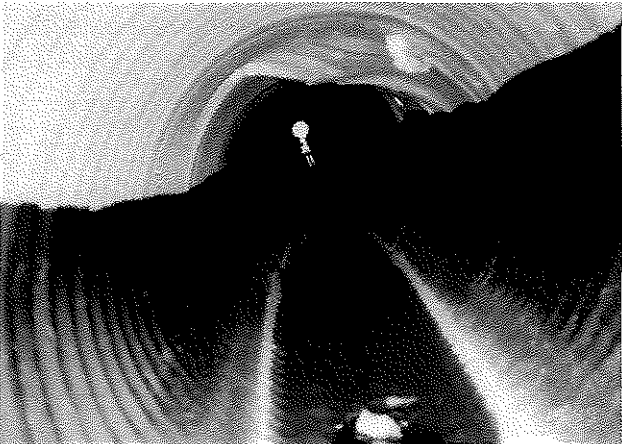
At Station 619+00 a severe buckle was observed in a 30-inch cross drain (Figure 4). The top of the pipe had buckled from the eleven o'clock to approximately the two o'clock position. A tear in the wall of the pipe was also noted. It appears that a rock or a piece of equipment may have been pushed against the pipe.

**Figure 4. Damaged 30" cross drain at Station 619+00.**

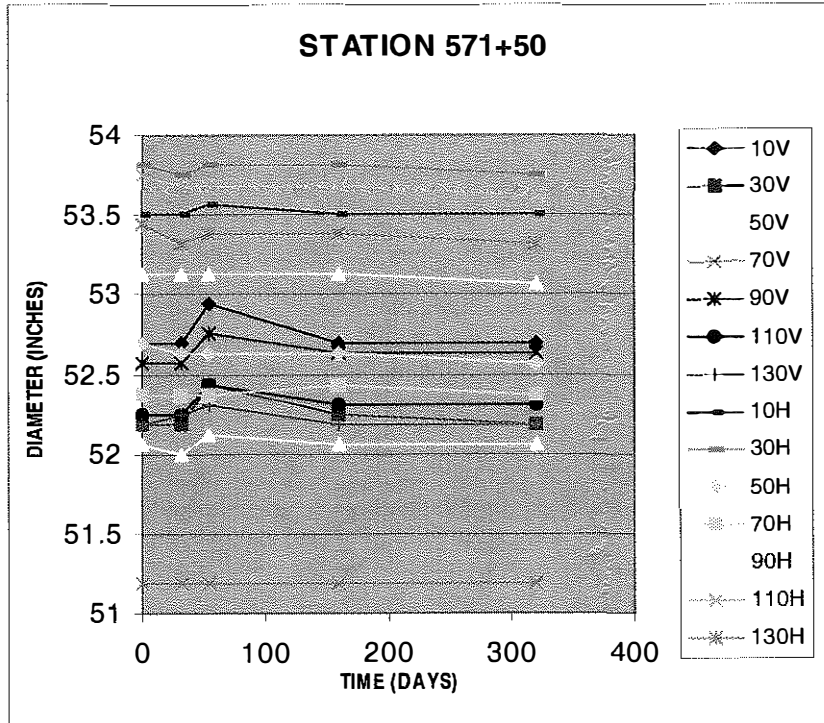
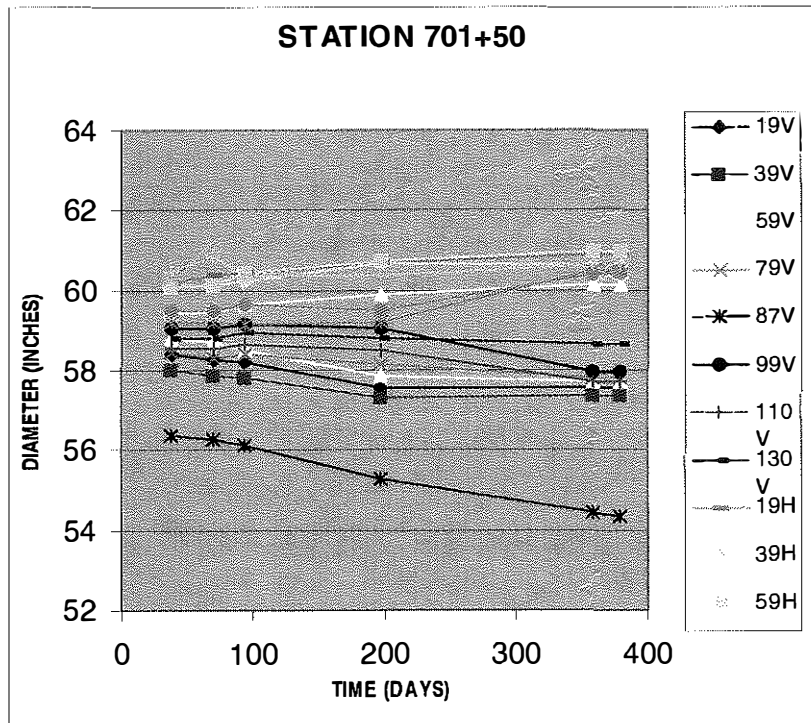
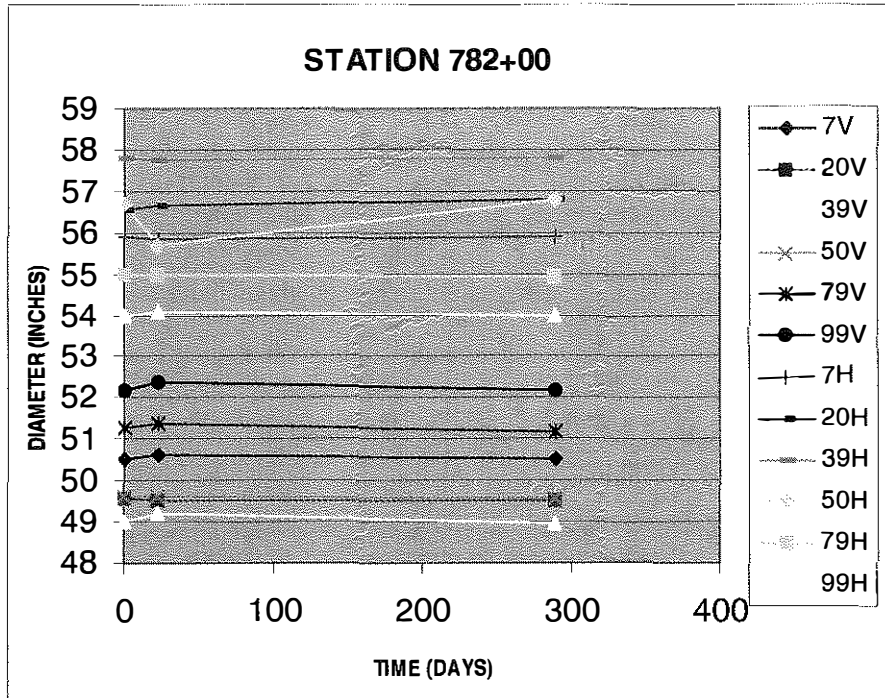
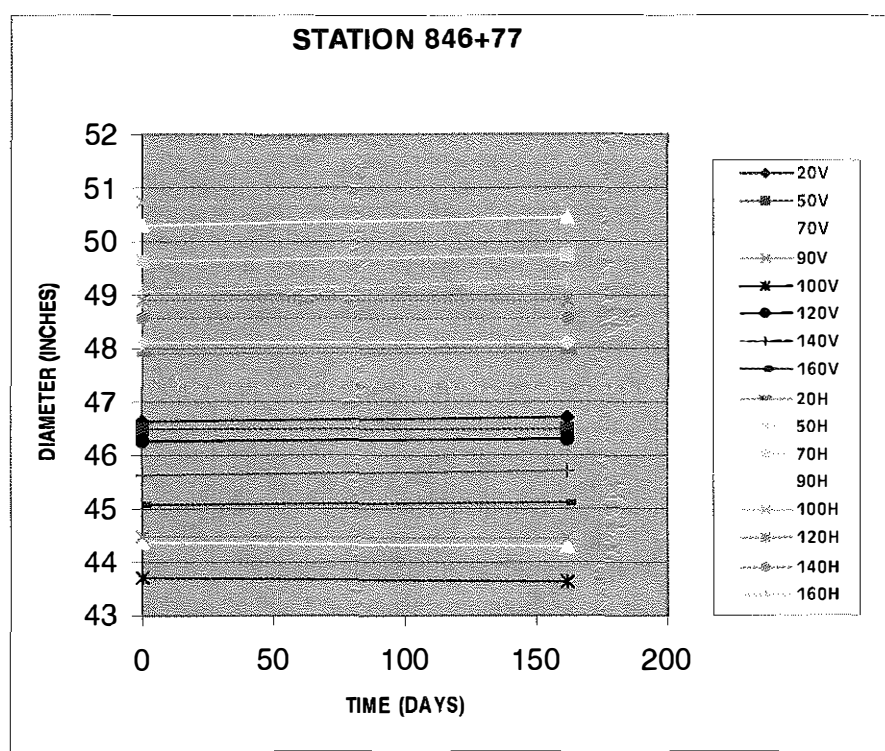
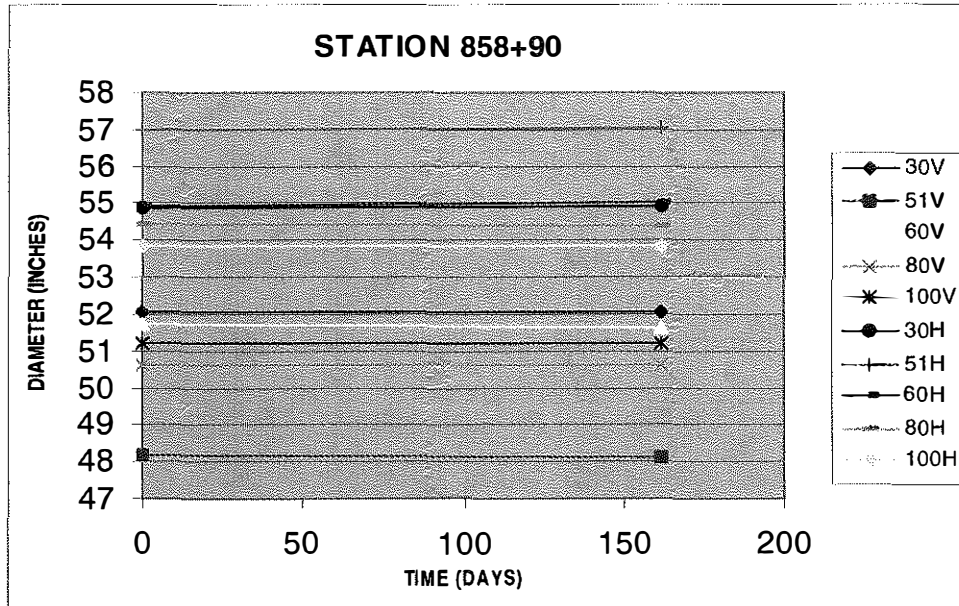
Deflection measurements were taken on five cross drain structures. Deflection measurements are shown in Figures 5 through 9. The 0.5 to 1.0-inch of paved invert was not taken into account during the vertical deflection measurements. In four out of five pipes, the maximum deflection has exceeded the design value of five percent. The deflections appear to have stabilized in most of the pipes except for one location in the 60-inch cross drain at Station 701+50. At monitoring point number 87 approximately midway through the structure the pipe had continued to deflect while the remainder of the structure had stabilized. The pipe was monitored in March and April of 1999. In March, the horizontal deflection remained unchanged and the vertical appeared to have continued to move. Approximately one month later (in April) neither the horizontal nor vertical deflections had changed. Currently the pipe has deflected approximately eight percent.

taken into account during the vertical deflection measurements. In four out of five pipes, the maximum deflection has exceeded the design value of five percent. The deflections appear to have stabilized in most of the pipes except for one location in the 60-inch cross drain at Station 701+50. At monitoring point number 87 approximately midway through the structure the pipe had continued to deflect while the remainder of the structure had stabilized. The pipe was monitored in March and April of 1999. In March, the horizontal deflection remained unchanged and the vertical appeared to have continued to move. Approximately one month later (in April) neither the horizontal nor vertical deflections had changed. Currently the pipe has deflected approximately eight percent.

Although the deflection in several of the pipes does exceed the design value of five percent and are approaching 10 percent no buckling or wall distortion has been documented.

The horizontal deflections observed in the 54-inch pipe culvert at Station 571+50 ranged from 53.25 to approximately 53.75 inches. The horizontal shortening indicates that the soil fill around the haunches and sides of the pipe was well compacted. This compactive effort is likely what is keeping the vertical deflections to 5 percent or less.
