RESEARCH REPORT
KTC-98-22

EVALUATION OF 93-INCH CORRUGATED METAL CULVERT
ON KY 693 AND US 23, GREEN-UP COUNTY

December 1998

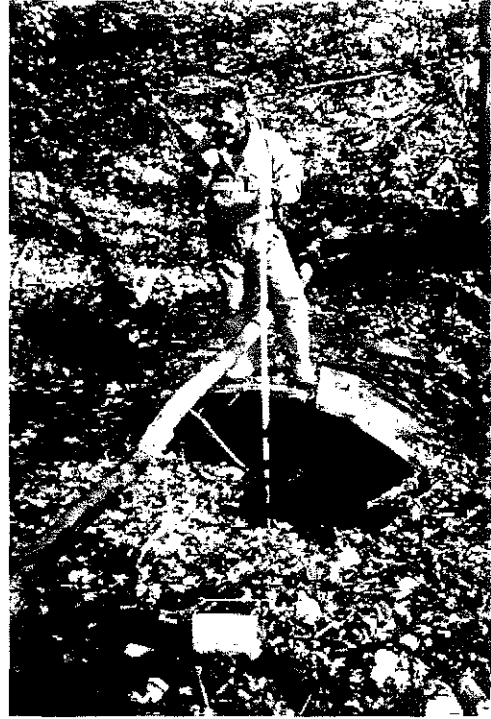
Figure 3. Culvert B

Culvert B was probed. From the debris line in the invert to the crown of the pipe measured approximately 86 inches (Figure 3). The culvert was open to the outlet end (Figure 4).

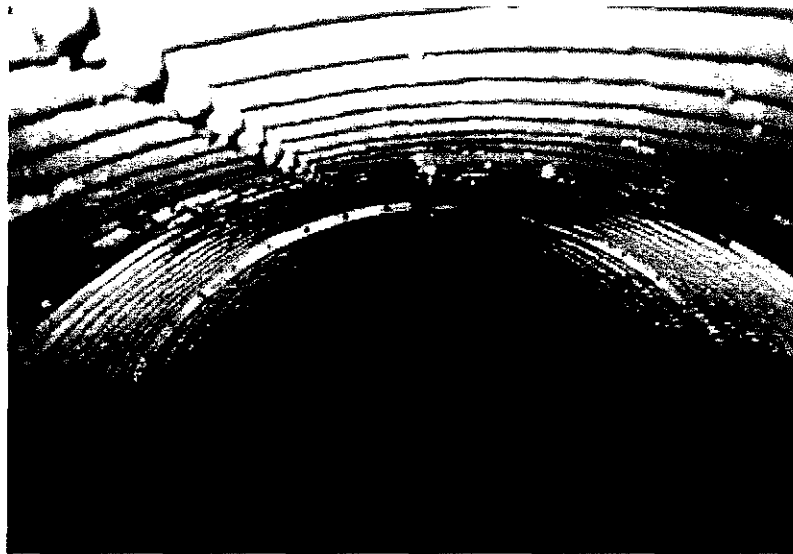
The inlet of Culvert C was probed and measured 78 inches from the debris in the invert of the culvert to the crown of the pipe. The outlet end of the structure was not visible from the inlet (Figure 6).

Figure 6. Inside of Culvert C taken from the inlet end.

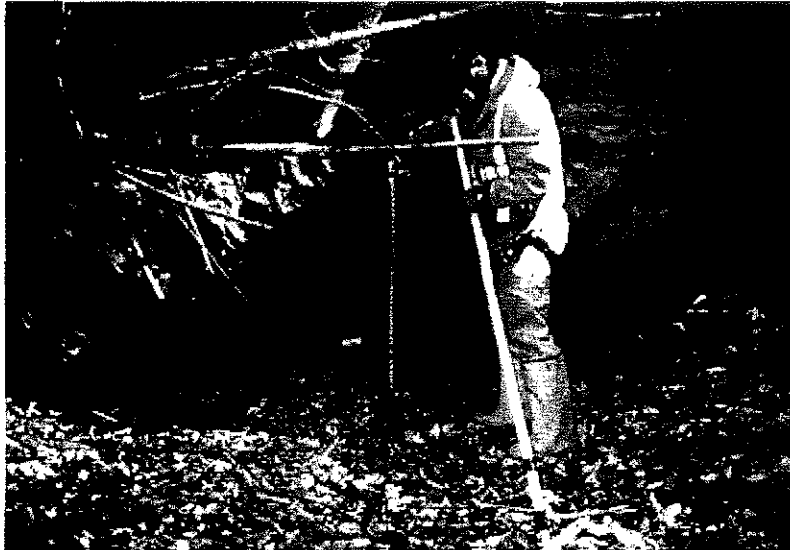
Culvert D appeared to have been constructed several feet higher than Culverts B and C. The culvert had about 34 inches of open area between the debris in the invert and the crown of the pipe (Figure 7). The inside of the culvert appeared to be half full of silt and the outlet end was not visible (Figure 8).

Figure 7. Inlet End of Culvert D.

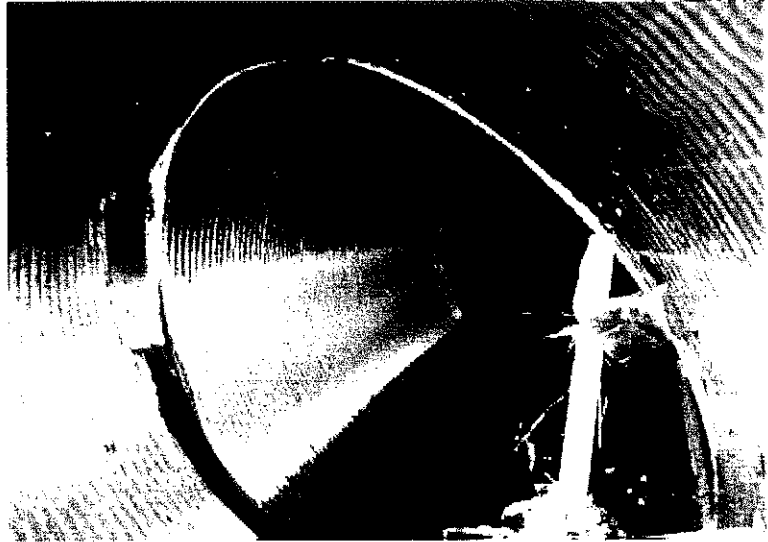
The first two sections of pipe in Culvert E are severely racked and compressed. At this time, the structure appears not to be inlet controlled. The severely racked pipe is likely causing some turbulent flow in the inlet of the structure but at this time addressing the backup at the outlet end of the pipe is more critical.

Photo 1. Joint 1, Severely Racked

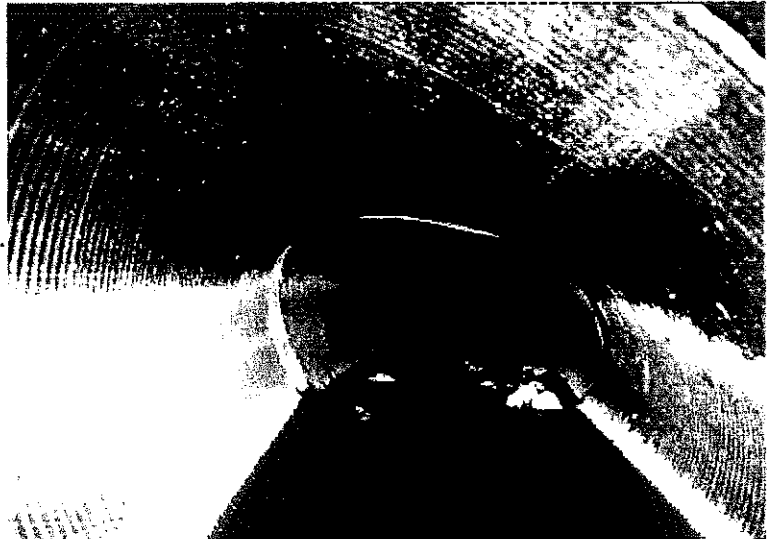
Photo 2. Joint 2, Racked, Vertical Compression

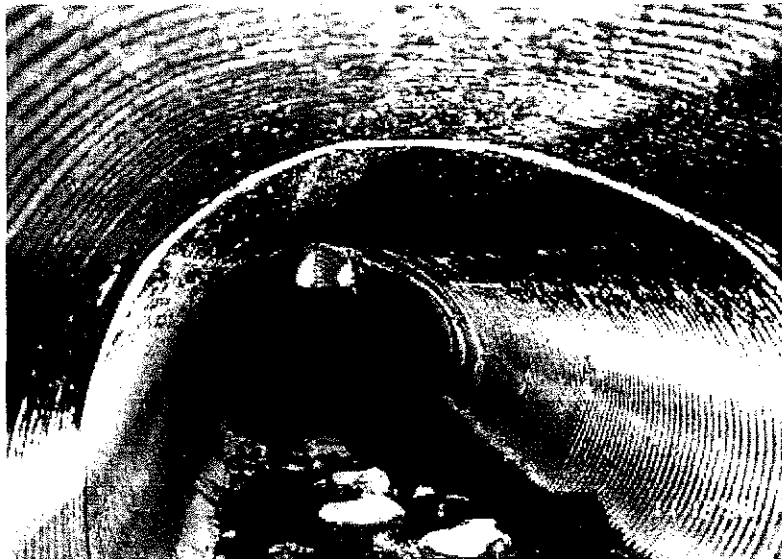
Photo 3. Joint 3-Joint 4, Pipe protruding into crown.

Several storm drains were observed protruding into the crown of Culvert E. These drains should be cut flush with the crown of the pipe.

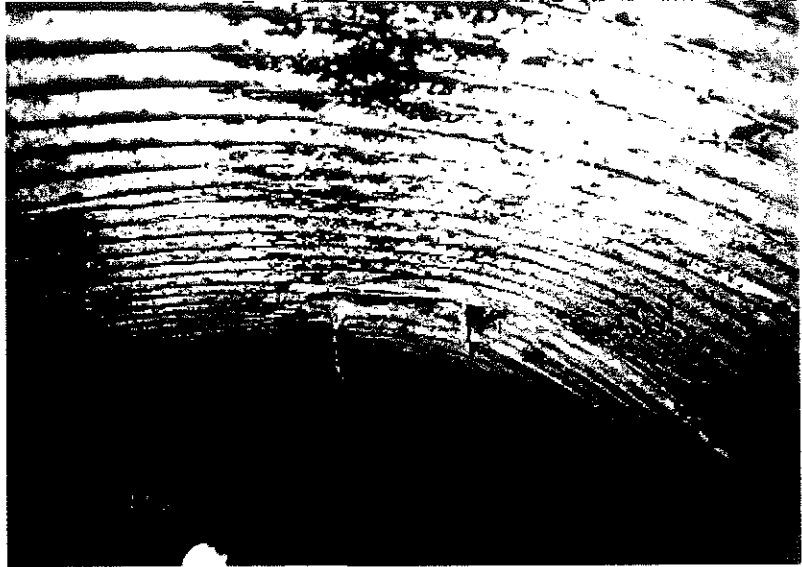
Photo 7. Joint 11, 12-inch pipe tied into crown
