Research Report
KTC-90-2

FIELD INSPECTIONS OF
HIGH-PERFORMANCE BRIDGE PAINTS

March 1990

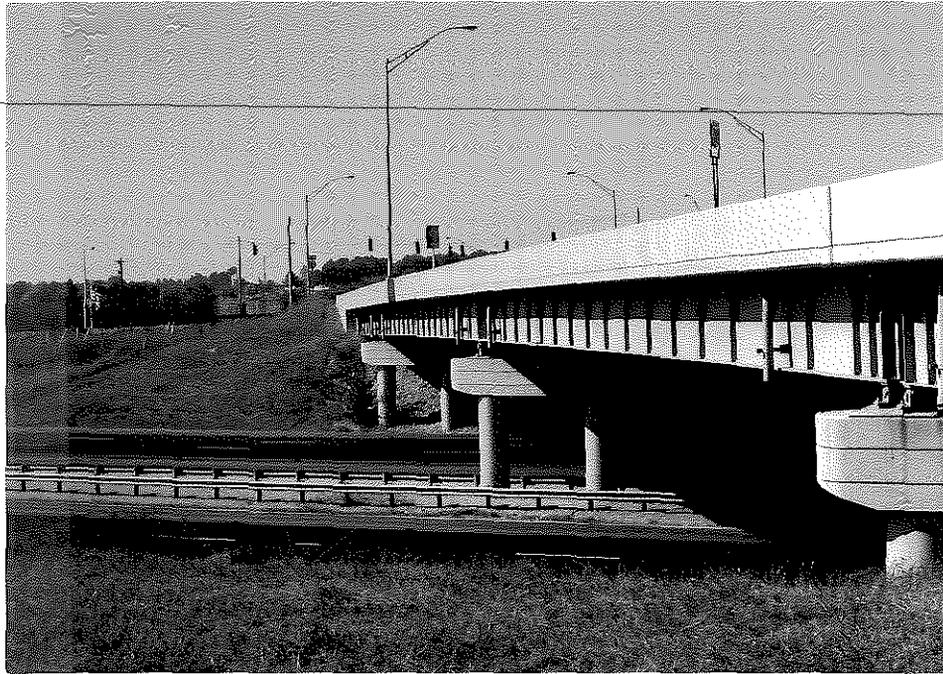
Four construction painted bridges were inspected. The paint coatings ranged from two to five years in age when inspected. The paint condition on all of those bridges was excellent (Figure 1). The paint on each bridge appeared to have been very well applied. The only problem noted was variance in surface sheen which appeared to be the result of overspray settling on wet paint. That imparted a slightly mottled surface appearance.

Figure 1. New Painted Girder Bridge, US 62 over I 65 in Hardin County (August 1987).

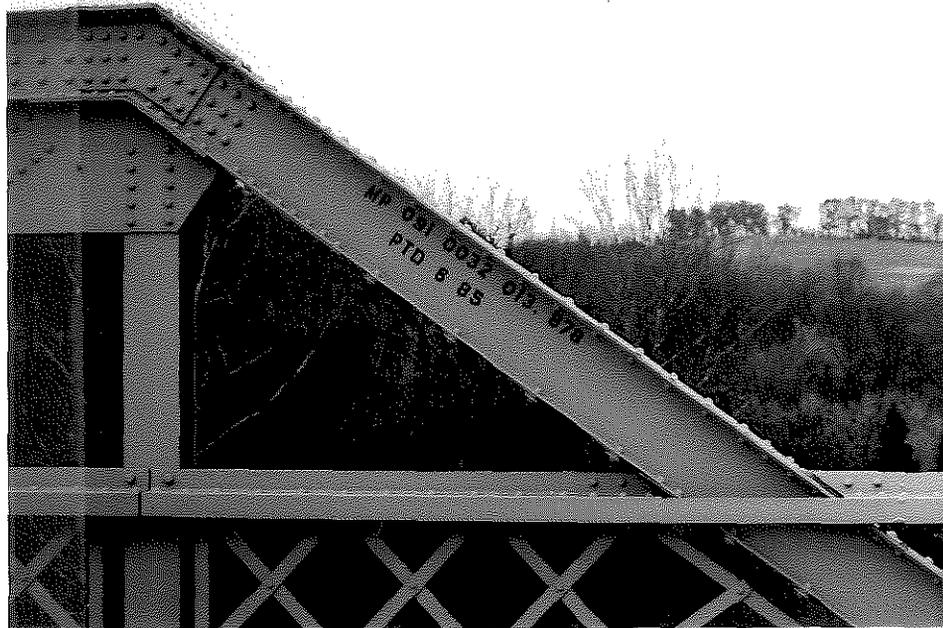
Most of the paint systems on the 13 repainted bridges inspected by Kentucky Transportation Center personnel were performing well (Figure 2). There were no instances of massive coating failure. However, some of the bridges had localized corrosion. Also, paint was peeling on several bridges.

Figure 2. Guardrail and End Post of Truss Bridge, KY 32 over L & N RR (October 1987).

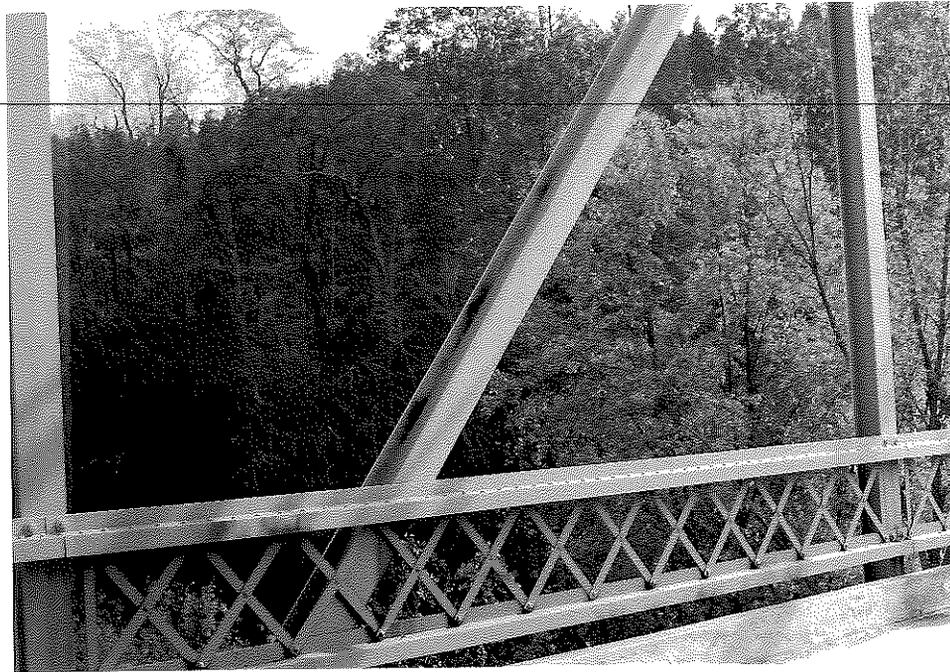
Most corrosion was detected at locations near deck level where chlorides are normally present (Figure 3). The most commonly corroded locations were between the end posts and lower chords and along the lower chords. Another corrosion-prone location was along walkway and guardrails. The floor systems of several bridges had some rust at the ends of spans. Those were the only locations where rust was observed on girder and stringer spans.

Figure 3. Diagonal and Guardrail on KY 89 over Red River (August 1987).

Consideration should be given to investigating wet blast cleaning of surfaces near deck level, especially on bridges that have serious rust damage. Wet abrasive blasting may prove useful for removing surface contaminants such as chloride ions (6). However, wet abrasive blasting may present other problems.

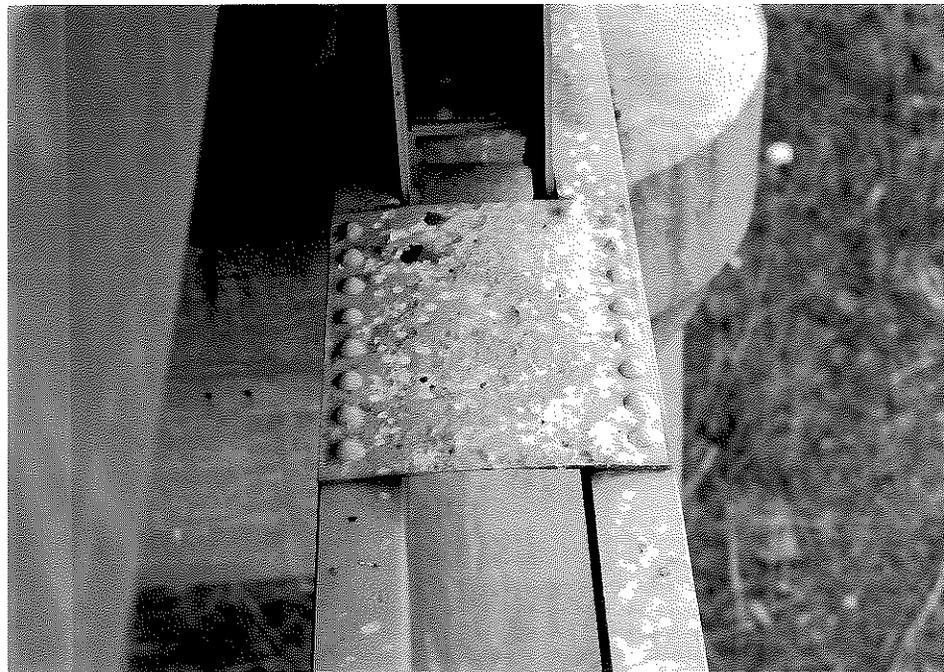
Several bridges had good paint at locations that were previously corrosion pitted and decayed. Those locations were in a severely corroded condition before cleaning and repainting (Figure 4). Other bridges had similar damage, but the paint was depleted and the members were covered with rust. In those cases, the initial corrosion damage apparently hindered adequate cleaning and adversely affected paint performance.

Figure 4. Batten Plate on Lower Chord Showing Previous Corrosion Damage, KY 32 over L&N RR (October 1987).

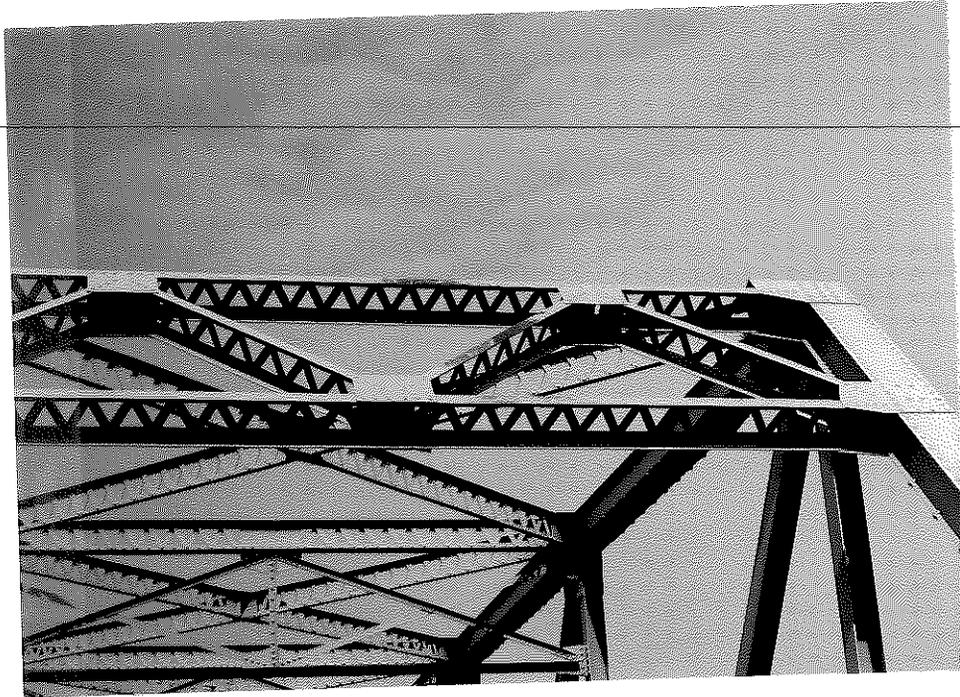
On several truss bridges, rust was present at elevated locations (Figure 5). Typical locations were the vertical posts (on the interior faces of the flanges and on the webs), upper chords, and lateral bracing. Several bridges had only minor cleaning on the interior of the upper chord box members. In some cases, an aluminized epoxy mastic was applied on those surfaces. Sometimes, rust was present at those locations.

Figure 5. Rust Visible on Portal of Truss Bridge, KY 7 over Little Sandy River (November 1987).

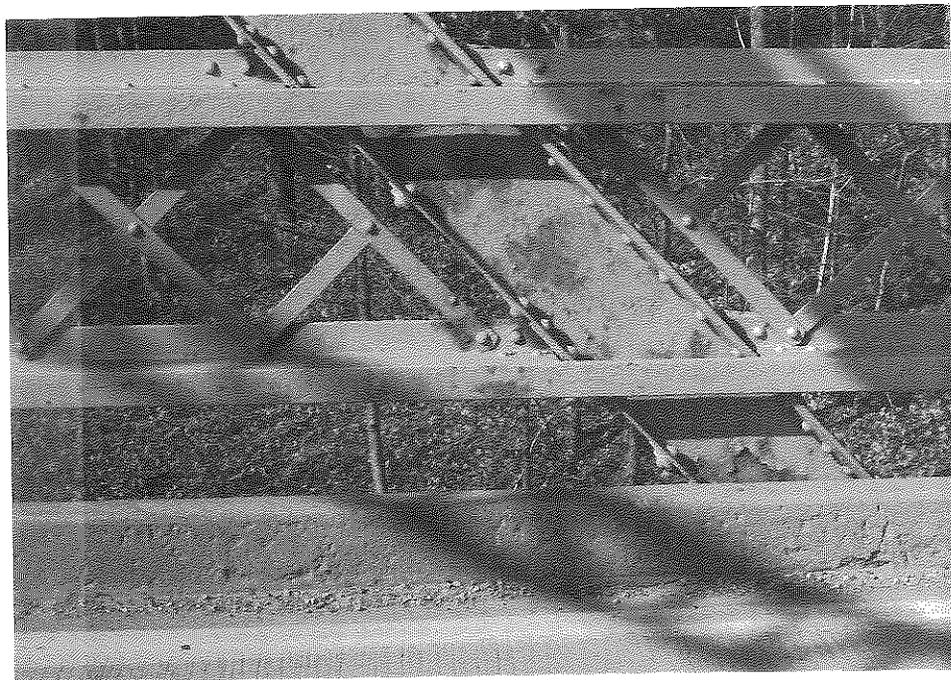
Figure 6. Peeling Paint and Rust on End Post of a Truss Bridge, KY 7 over Little Sandy River (November 1987).
