Research Report
KTC-90-23

GROUND MODIFICATION SYSTEMS
(STONE COLUMNS AND WICK
DRAINS IN JEFFERSON COUNTY)

Bobby W. Meade
Research Investigator

David L. Allen
Chief Research Engineer

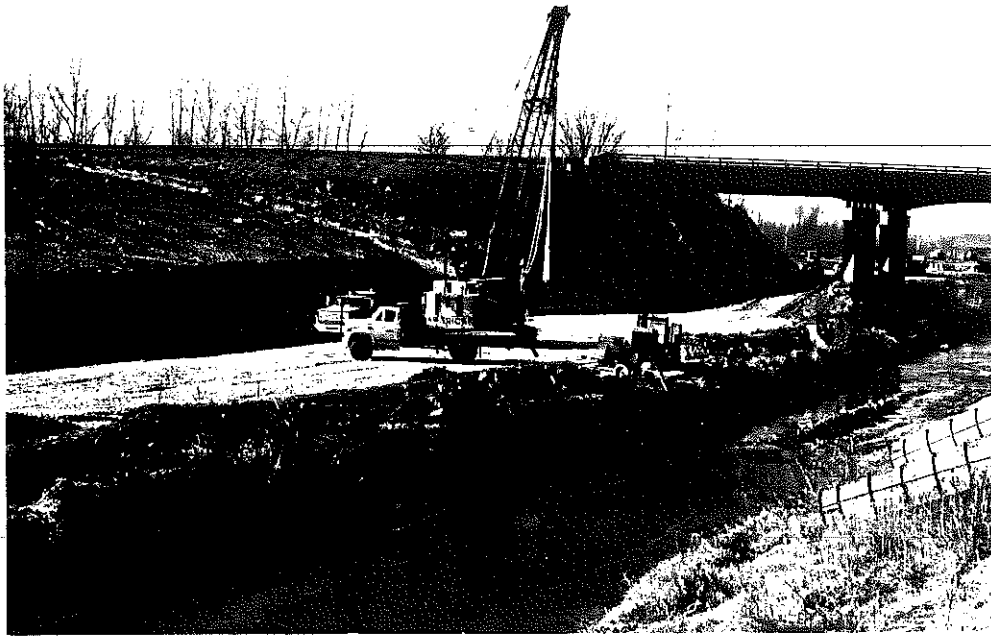
Figure 7. Abutment 1 Foundation.

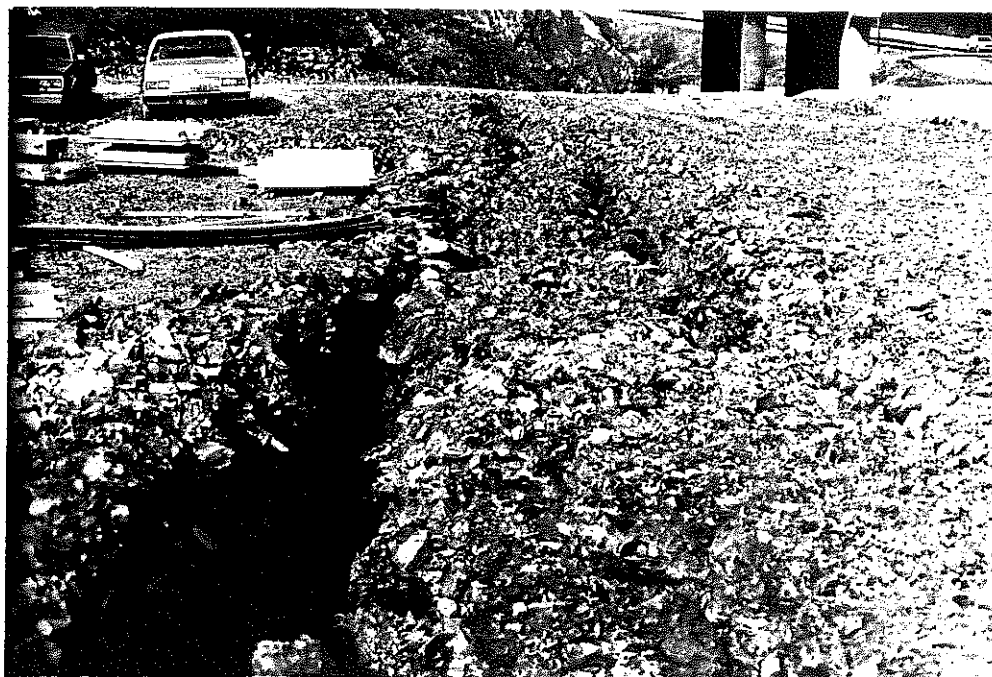
Figure 10. Failed Wall with Tension Cracks.

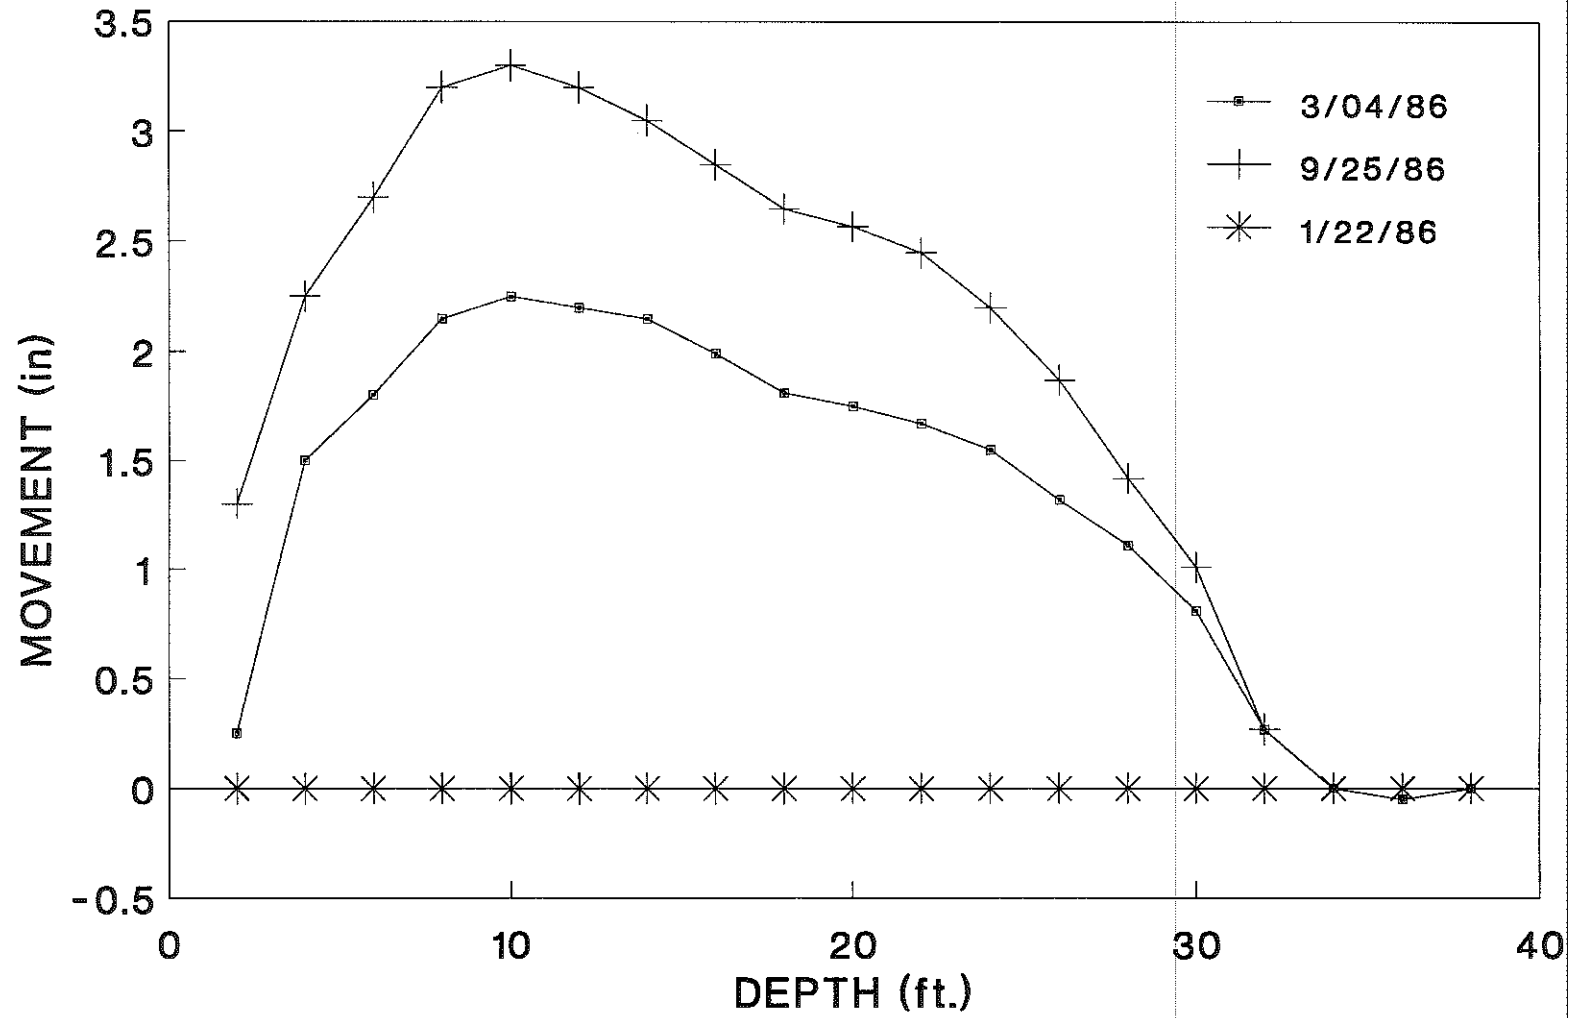
Horizontal displacements of the walls were monitored with slope inclinometers placed adjacent to the walls. Inclinometer 1 (north wall) indicated 3.3 in. of movement at a depth of 10 ft at 240 days after installation. This inclinometer was installed January 22, 1986 and approximately 2.3 in. of movement occurred in 40 days. Lateral movement at Slope Inclinometer 1 is shown in Figure 19.

Figure 19. Lateral Movement (S.I.1) of Foundation at Abutment 2.

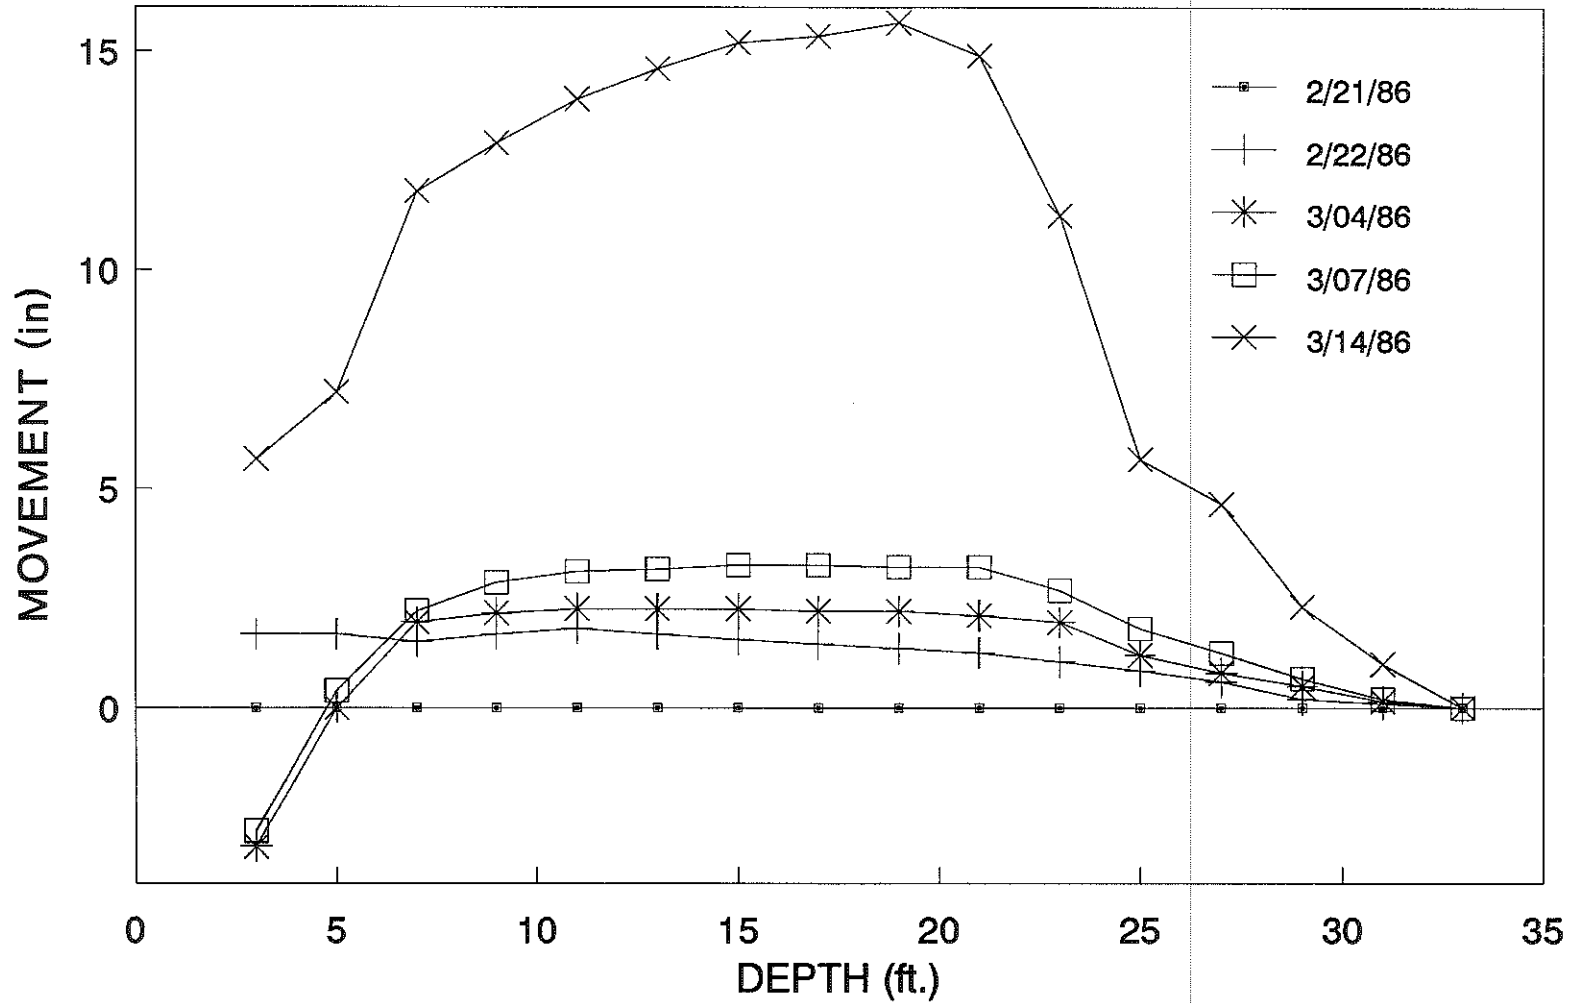
Slope Inclinometer 2 (south wall) was installed on February 21, 1986. The last data collected (March 14, 1986) before failure indicated lateral movement of nearly 16 in. Lateral movement at Slope Inclinometer 2 is shown in Figure 20.

Figure 20. Lateral Movement (S.I.2) of Foundation at Abutment 1.

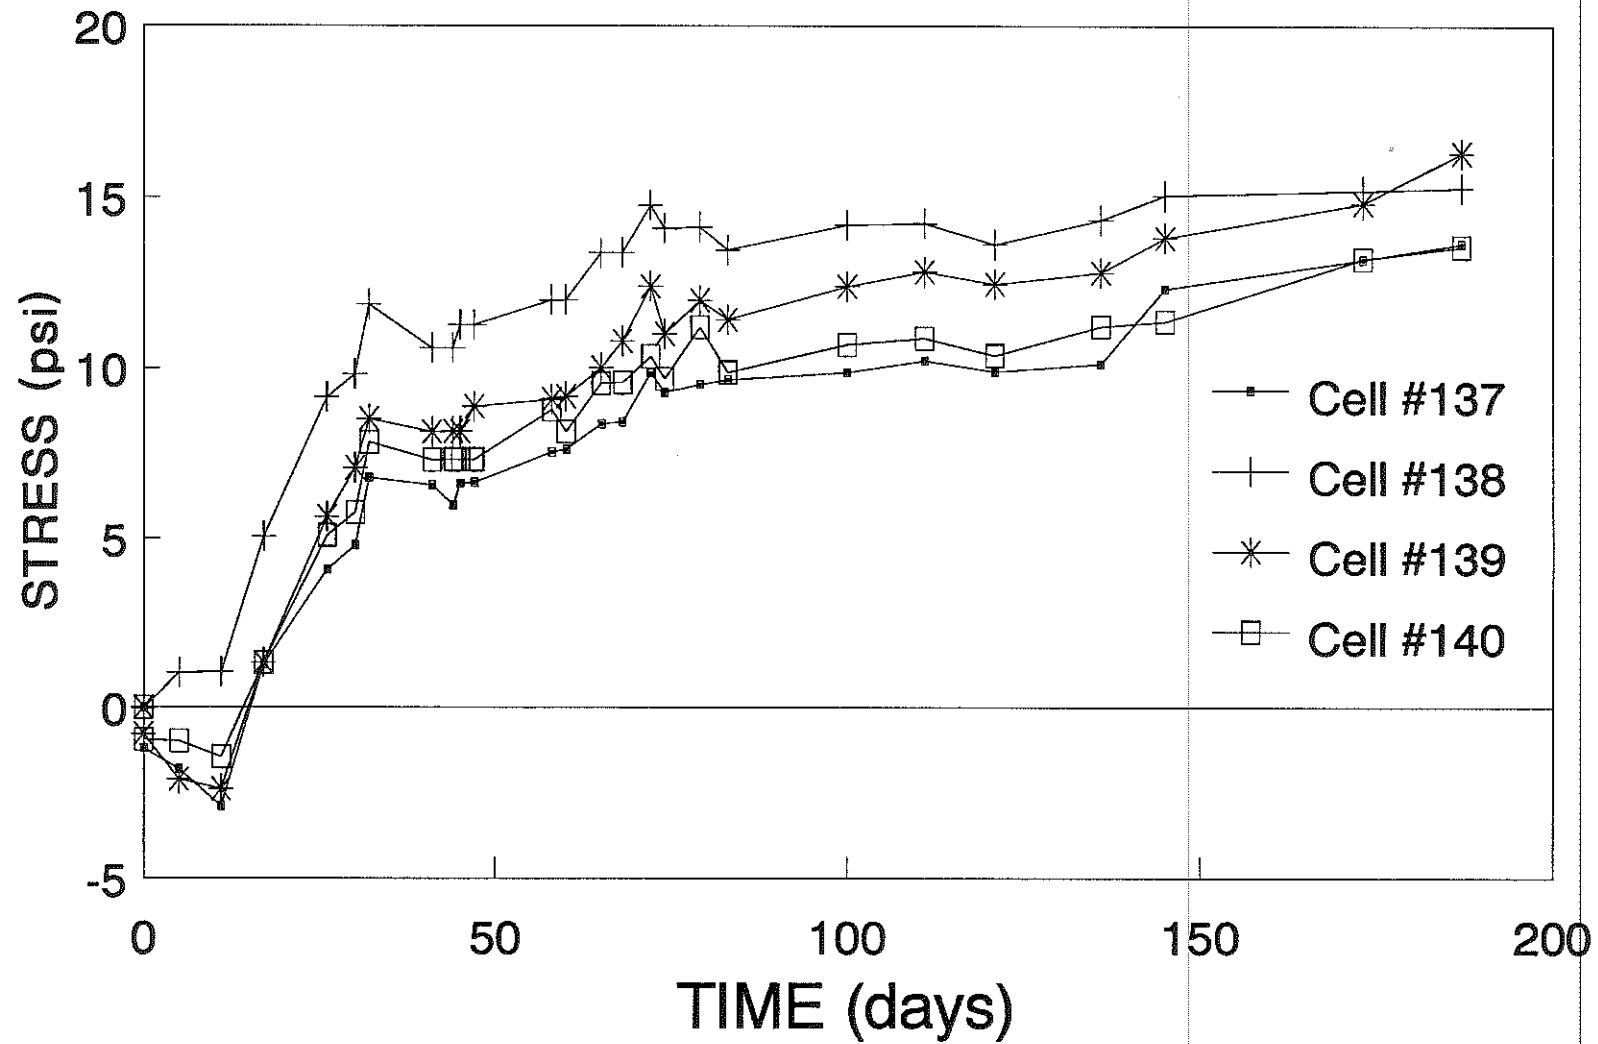
Earth pressure meters indicated very little stress concentration in the stone columns. Meters at the north wall indicate pressures of 16 and 17 psi on stone columns and 14 psi between columns. Meters at the south wall indicate the stone column temporarily carried approximately 3.0 psi more pressure than the surrounding soil, but near the time of failure, the stone column had less load, approximately 1.0 psi, than the soil. Earth pressure data for the north and south abutments are shown in Figures 21 and 22, respectively.

Figure 21. Earth Pressure Data on the Foundation at Abutment 1.

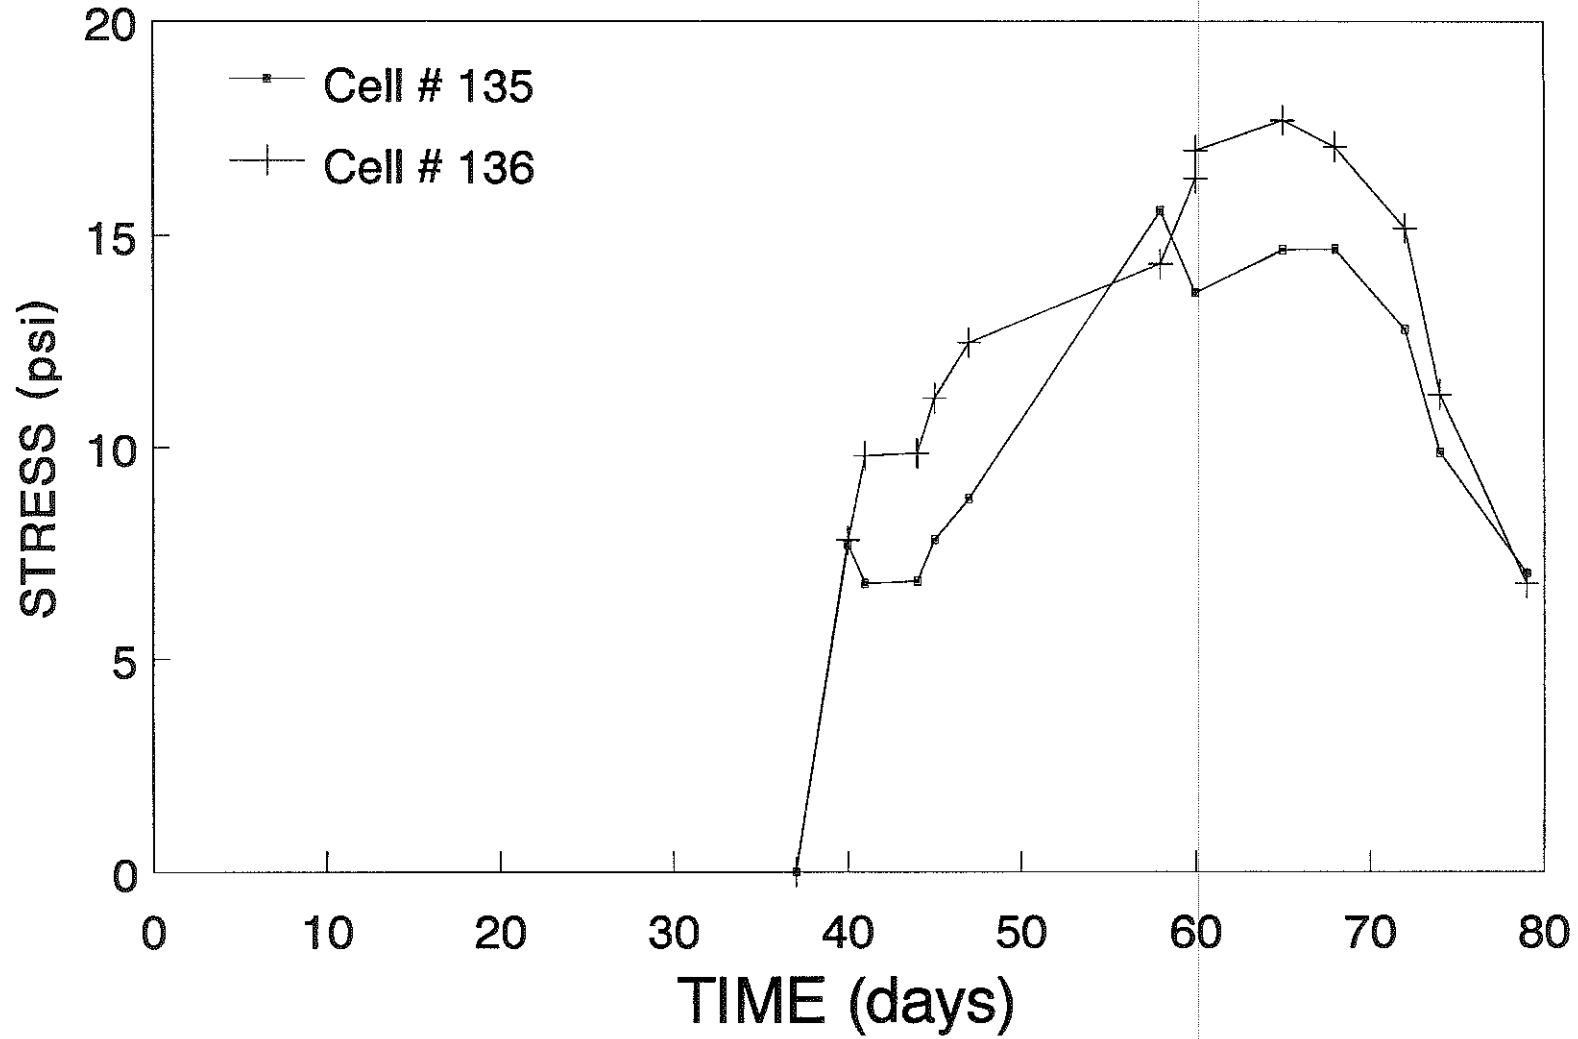
Figure 22. Earth Pressure Data on the Foundation at Abutment 2.
