Research Report
UKTRP-88-7

**EXCESSIVE BEAM DEFLECTIONS ON THE KY-52 BRIDGE
OVER DIX RIVER (BOYLE-GARRARD COUNTY LINE)**

Kentucky Transportation Research Program
College of Engineering
University of Kentucky
Lexington, Kentucky

March 1988

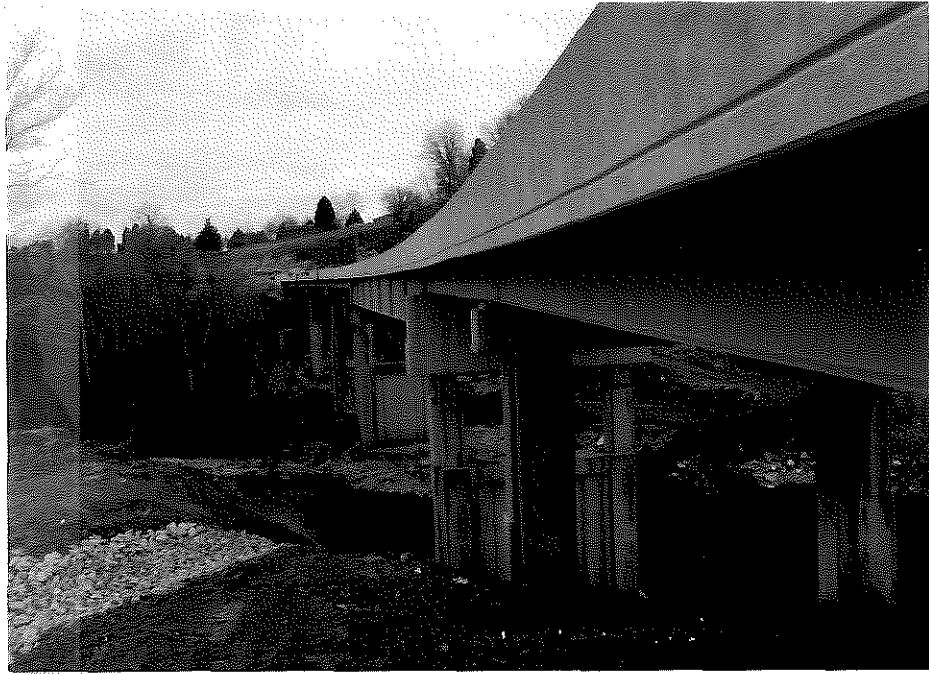
Figure 1. Six-Span Composite Steel Beam Bridge on KY 52 at the Boyle-Garrard County Line (Facing Westward).

In 1985, the Kentucky Transportation Cabinet (KyTC) rehabilitated the KY 52 bridge over Dix River. The bridge is located on the Boyle-Garrard County line (Figure 1). The six-span composite steel beam bridge originally had a 24-foot wide deck that was increased to 32 feet as part of the rehabilitation work. The original rolled beams were used as interior stringers in five simple spans (Nos 1, 2, 3, 5, and 6). Those were removed and cleaned during widening. Studs were welded to the upper flanges to provide composite action with the new deck. New steel beams were used for the exterior stringers. Also, a 150-foot truss in span 4 was removed and replaced by a span containing four welded plate girders.

After the new deck was placed on the stringer spans 1-3, the beams in those spans (including the new exterior beams) were found to possess excessive deflections. Field measurements revealed top of slab (deck) deflections of approximately 1.5 inches at the mid points of the three spans (1). Those deflections created noticeable humps and dips on the bridge deck and caused poor ride quality. Eventually, a smoother riding surface was provided by scarifying the humps and applying an overlay on the deck.

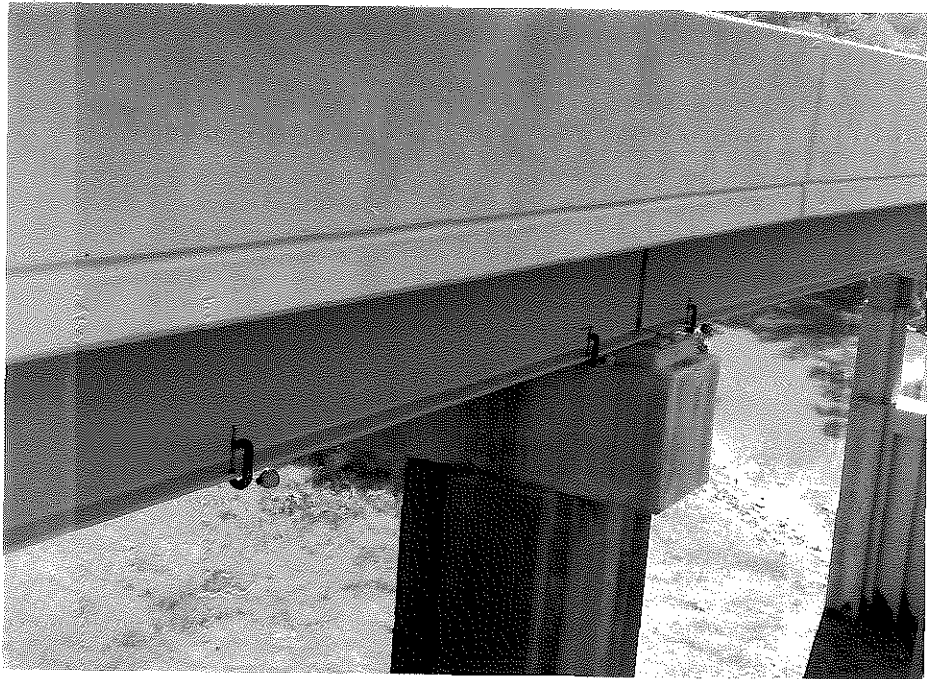
Figure 2. Optical Targets on Lower Flange of a Beam.

In June 1986, KTC personnel surveyed the bridge. An optical theodolite was used to determine the profile of the exterior beams (beams 1 and 8) and elevations of pier caps. KTC personnel established temporary benchmarks on the north and south sides of the bridge. Five control points on the bottom flanges of the exterior beams were selected in each span. KTC personnel placed optical targets attached to C-clamps at those points (Figure 2). Division of Maintenance personnel provided a snoopers allowing access to place an optical target at each of the control points on the exterior beams. KTC personnel measured horizontal sweep and the vertical angle with respect to station points at all control points and on top of pier caps.

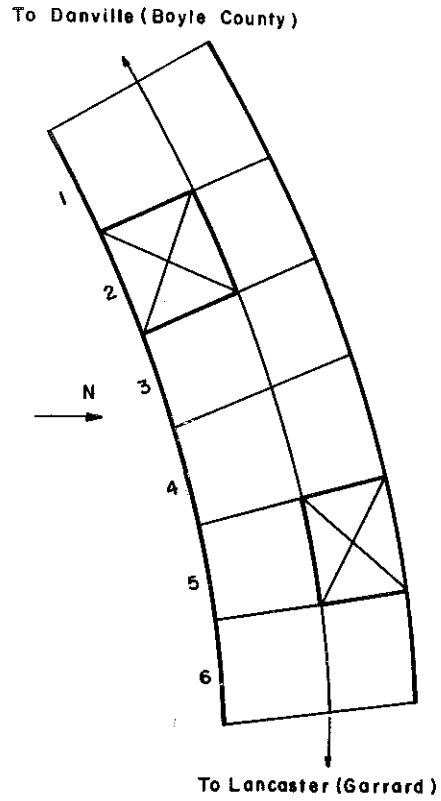
Figure 3b. Core Locations on Span 5, Westbound.

To investigate the possibility that the dead-load deflections were due to excess concrete in the bridge deck, KTC personnel obtained 7 cores from the deck. Core locations are shown in Figure 3. The average thickness of the cores was 8.9 inches. That conforms reasonably well with the design thickness of 8.5 inches.

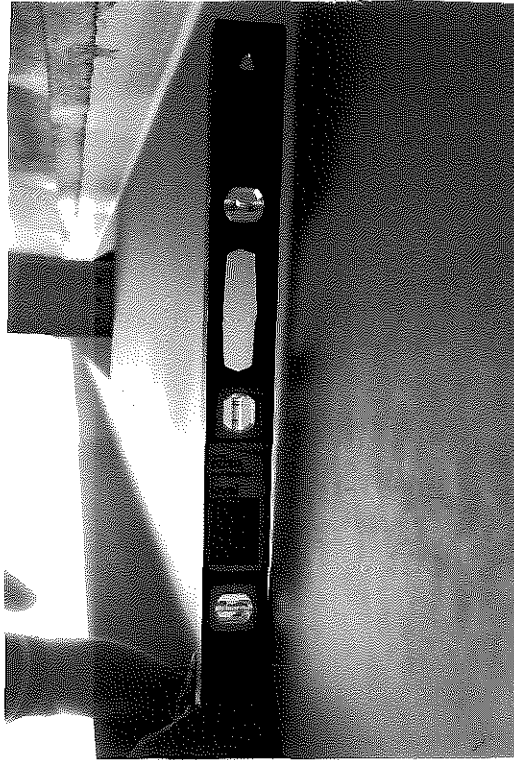
Figure 4. Measurement of Transverse Tilt on a Beam.

Visual inspections revealed transverse tilting in beams of all the stringer spans. The beams were upright at the piers and abutments. Beam tilt was greatest at mid span with the lower flanges rotating slightly in an opposite direction of the upper flange.

KTC personnel measured the lateral tilt in the web areas of all spans including the plate-girder span (Figure 4). A level and ruler were used to measure tilt over a length of 24 inches in the center of the webs. No tilting was detected in the plate-girder span. Measured values of web tilt are listed in Table 1.

On November 9, 1988, KyTC and KTC personnel inspected the bridge. KyTC personnel revealed that though the rolled beams tilted, they maintained their cross-sectional shape and were not plastically deformed. During the inspection, the transverse beam spacing was measured at a center diaphragm in span 1. That diaphragm is located near the upper flange of the beams. The spacing between the webs of two adjacent beams was greater at the top flange than at the lower flange. That indicated the beam tilt probably was due to installation of the diaphragms.

Additional calculations revealed that the tilt measured would have a negligible effect on beam deflection.

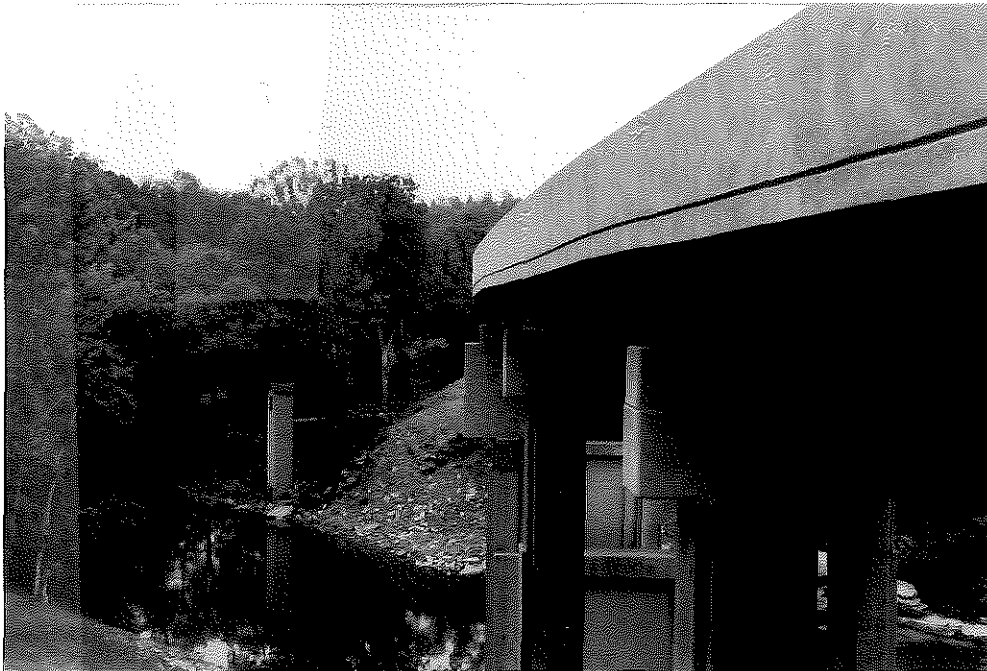
The bottom surface of the deck slabs outside the exterior beams followed the profile of the upper flanges of those beams. A rustication groove was present at the construction joint between the deck slab and the plinth. The groove followed the profile of the beams and exhibited a similar downward deflection since it was located at a constant spacing from the bottom of the slab (Figure 5). The plinths were about one inch higher at the mid points than at the ends on all the spans. That provided a uniform plinth height across each span.

Figure 5. Rustication Groove in Spans 5 & 6 (Facing Eastward).

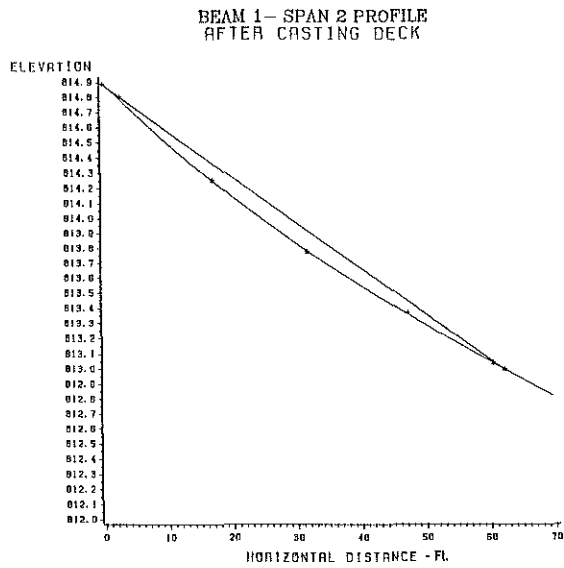
A computer program was developed to convert field measurements of the control points to respective elevations using the known station elevations. The computer program also calculated the deflection of the exterior beams at the center of each span. Computed deflections varied from 0.64 to 1.90 inches. Table 2 lists deflections calculated by that program. Graphs were plotted showing the profile of those beams. Figure 6 is a typical profile for the lower flange of an exterior beam.

The beam deflections were related to an initial downward sag when simply supported and an uncompensated construction dead load. In spans 1-3, the average sag of the exterior beams was 0.40 inch. The uncompensated construction dead load would provide about 0.60 inch deflection for the deck and plinths. The resulting total average deflection of the exterior beams in those spans is 1 inch.

Figure 6. Lower Flange Profile of Beam 1 (Exterior Beam) on Span 2 Showing Deflection after Casting Deck.

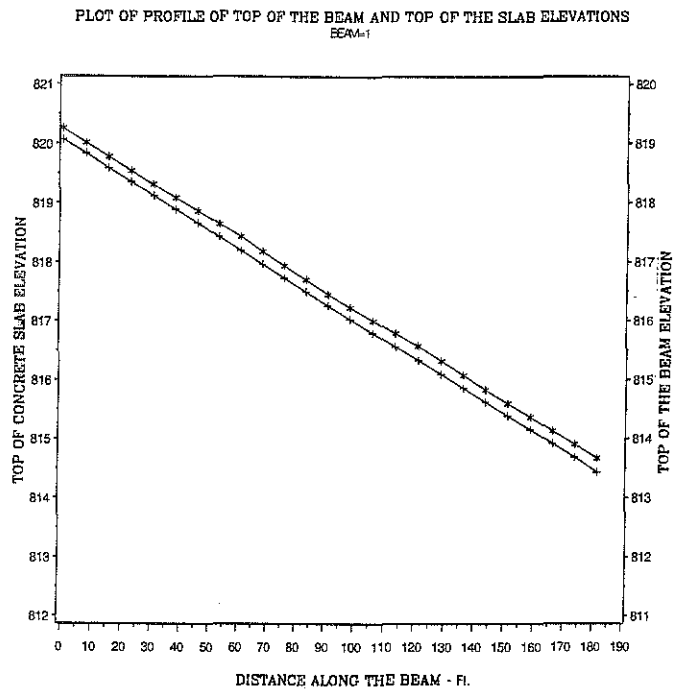
KTC personnel plotted the top of slab elevations and the corresponding top of beam elevations versus distance along the beams in spans 1-3. Figure 7 shows the top of slab construction elevations and the top of beam profile for beam 1. The lower line represents the top of slab construction elevations and relates to the left ordinate. The top of slab elevations were obtained from the design drawings. The upper line represents the top of the beam profile and relates to the right ordinate. The top of beam elevations were obtained from the KyTC field readings.

The top of slab construction elevation points approximate a straight line in spans 1-3. That conforms to correspondence stating the designer had omitted a construction camber (for deck dead load). That construction camber should have been about 0.5 inch for the new rolled beams (op. cit. 1). If the designer had provided for dead loads, the top of slab profiles would arch upward slightly between the beam supports. Those supports are located at the 0-, 60-, 120-, and 180-foot distances along the beam. Pre-existent sags on the top of beam profiles occur between peaks at the beam support locations.

Figure 7. Top of Slab Elevations (Left Ordinate - Lower Line) and Top of Beam Elevations (Right Ordinate - Upper Curve) Versus Their Locations Along the Beam 1 (Spans 1-3).
