Research Report
KTC-93-9

FIELD PERFORMANCE EVALUATION OF
PRECAST CONCRETE BOX CULVERTS,
ALUMINUM CULVERTS, AND GALVANIZED
METAL ARCHES AND PIPE ARCHES

March 1993

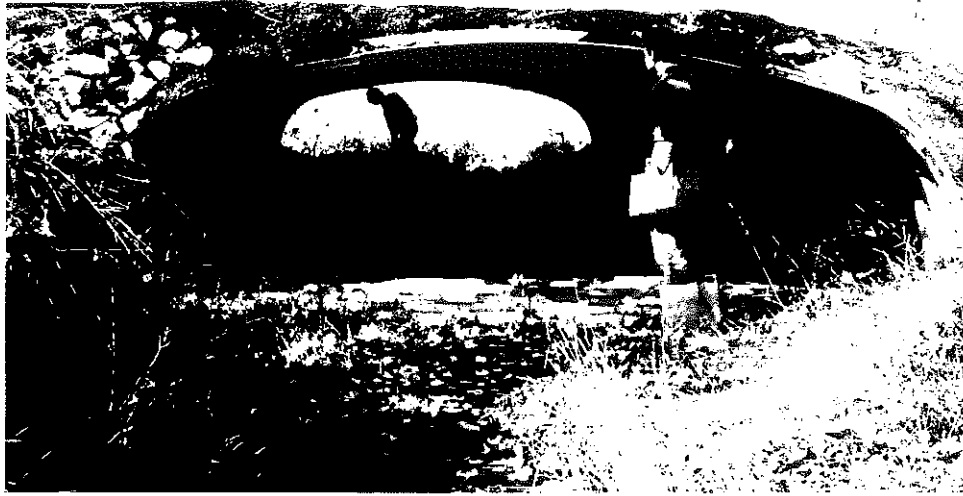
The 11 aluminum structures that were inspected were located in Districts 1, 2 and 3. Distress information is contained in Table 2. Approximately half of the wide span aluminum box culverts had moderate to significant vertical deformation. In most cases, the vertical deflection appeared to be less than 5 percent, and the maximum vertical deflection recorded was approximately 7 percent. This was on KY 266 in District 2 (Henderson County). The culvert had very little, if any, fill over the crown (Figure No. 6).

Figure 6. Long Span Aluminum Box Culvert on KY 266.

Significant vertical deflections were observed in some of the long span aluminum box culverts. The aluminum culverts are flexible structures and are designed to distribute load to the surrounding backfill. The load is distributed to the sides of the culvert when loaded, and this load is then distributed to the fill. When the backfill is not properly densified and can not take the pressures from the distributed load, the culvert may substantially yield. A high shear strength material should be used for backfilling these structures (crushed stone).

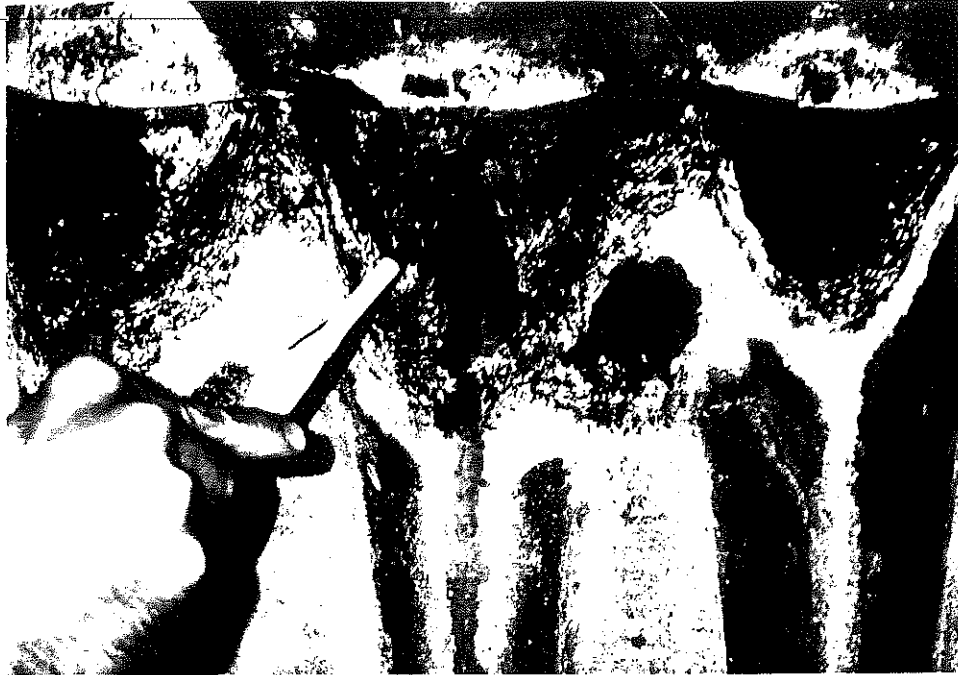
Figures 8 and 9 show severe rusting of bolts and adjacent plates. Figures 10 and 11 show severe invert rusting of pipe arches.

Figure 8. Severe Rusting of Bolts and Adjacent Plate.

It is recommended that spot rusting be treated with a sealant to retard further rusting.

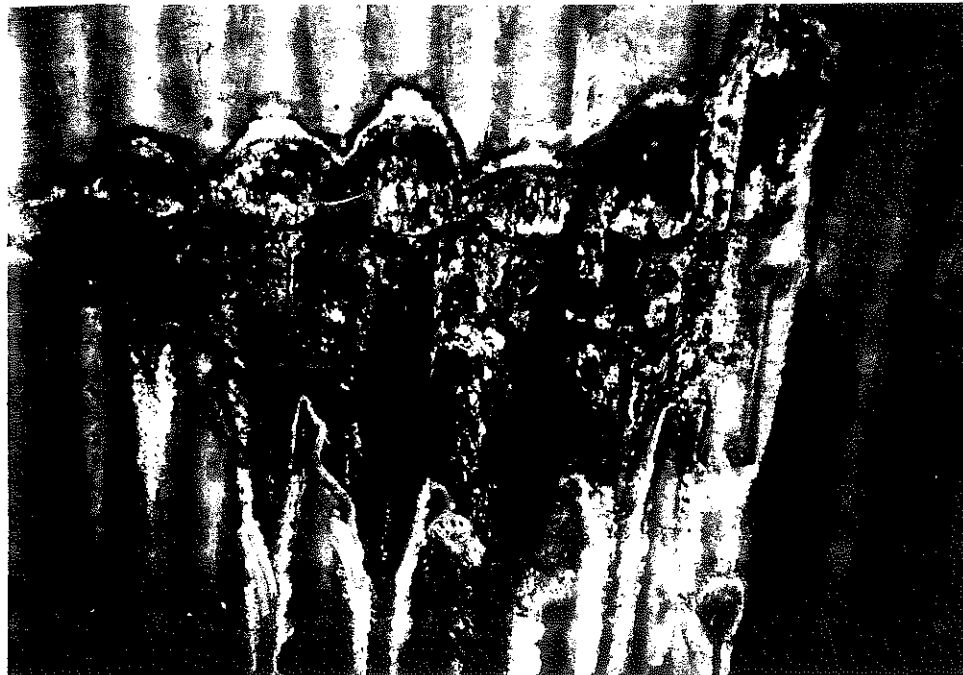
Figure 9. Severe Rusting of Bolts in a Galvanized Arch Culvert.

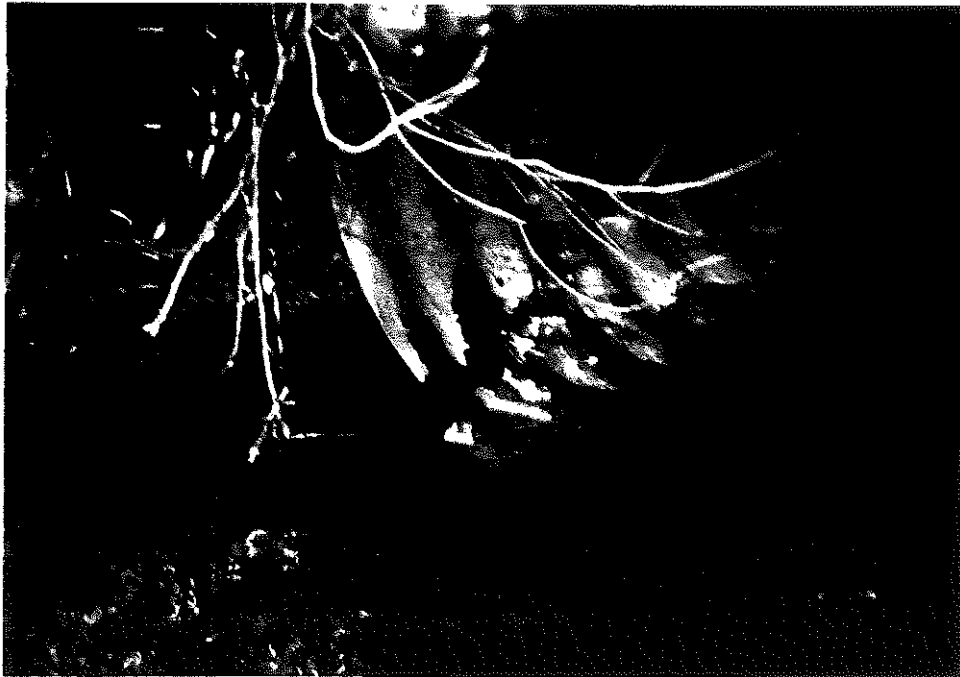
Figure 11. Ends Rusted Through Invert of Pipe Arch, Whitley Co.

Several of the inverts of the pipe arches had rusted through. It may be cost effective to construct a concrete slab in the invert of these structures to extend their life.

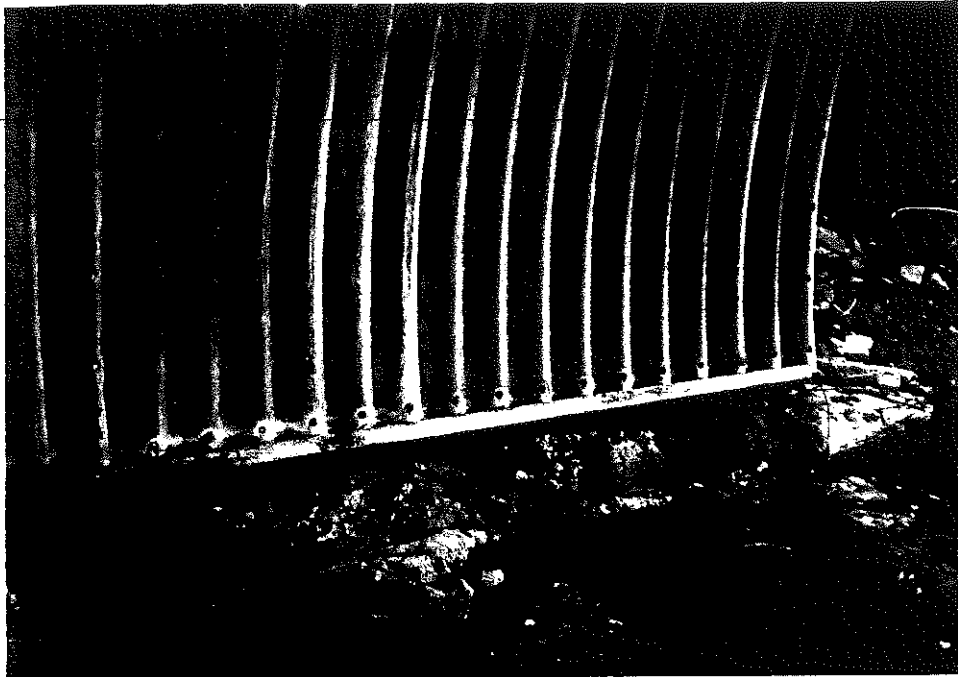
Erosion appeared to be a significant problem in both the arches and the pipe arches. Approximately 18 percent of the culverts had signs of vertical or horizontal distress due to foundation erosion. Approximately 10 percent of the concrete footers for the galvanized steel arches erosion under sections of the arch. The foundation of two culverts on KY 1951 (District 6) had been severely eroded. At milepost 0.4, the concrete footer had been partially eroded allowing the culvert to displace approximately five inches laterally on the outlet end, and two inches on the inlet end (Figures 12 and 13). At milepost 2.42, eight feet of the concrete footer was missing on the inlet end (Figure 14).

Figure 12. Severely Eroded Concrete Foundation, Bracken Co.

It is recommended that erosion problems be repaired to insure increased life of the structure.

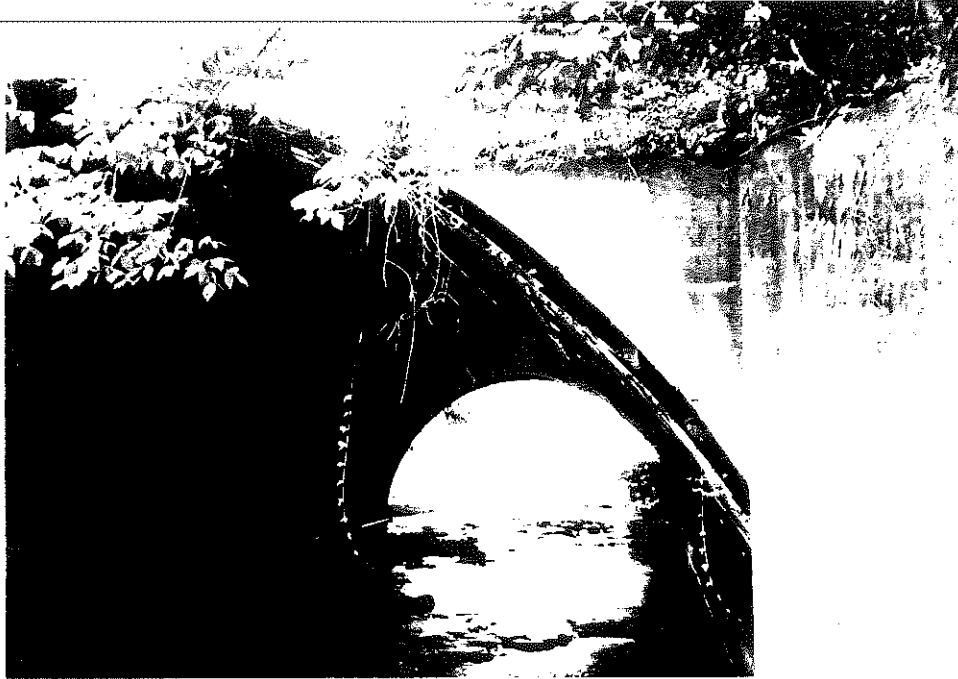
Significant deflections were observed in several of the larger steel arches. Approximately six inches of lateral movement had occurred in a steel arch in District 7, on KY 1986. The movement was visible between the concrete headwall and the walls of the arch. The movement had occurred on the westbound side, on the inlet end (Figure 16). District personnel indicated they have been monitoring the culvert.

Figure 16. Lateral Displacement Observed between Headwall and Culvert Wall.

It is the authors' opinion that most of the deflections observed probably will not seriously affect the service life of these structures; however, maintenance personnel should continue to monitor them at regular intervals.

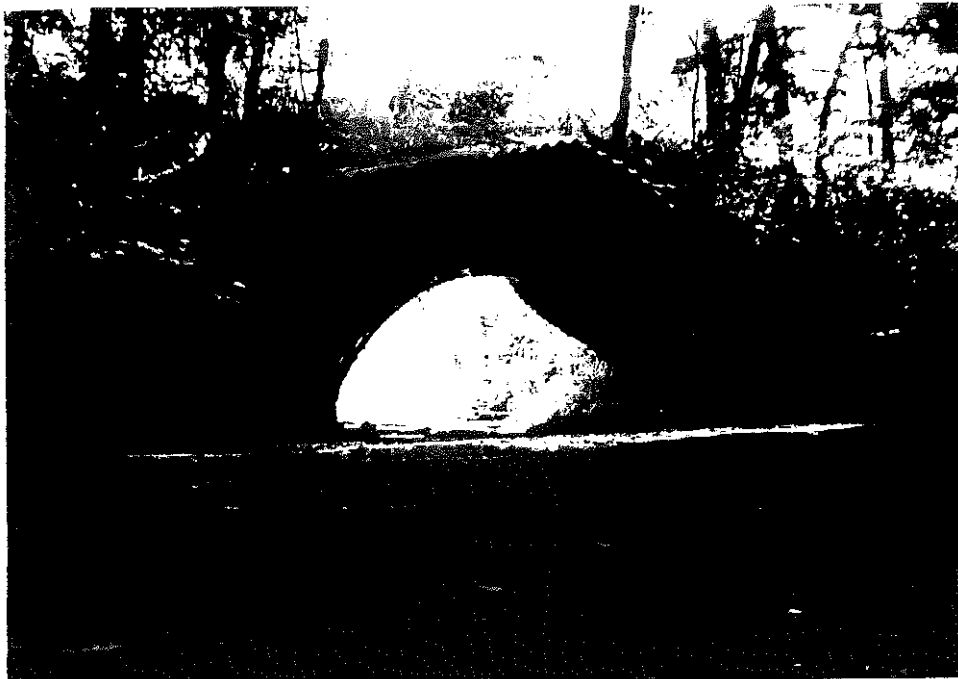
On KY 714, in Shelby County (District 5), a large steel arch had severe vertical deflections on both ends (Figure 17).

Figure 17. Loss of Structural Support on the End of the Culvert as a Result of Cutting the Corrugations on a Skew.

It is recommended that the structures not be installed with the ends skewed unless added strength of concrete abutments and wingwalls are provided.
