Research Report  
KTC-93-~~27~~ 27

FIELD PERFORMANCE REPORT  
ON CORRUGATED  
POLYETHYLENE PIPE ON KY 17  
KENTON COUNTY

October 1993

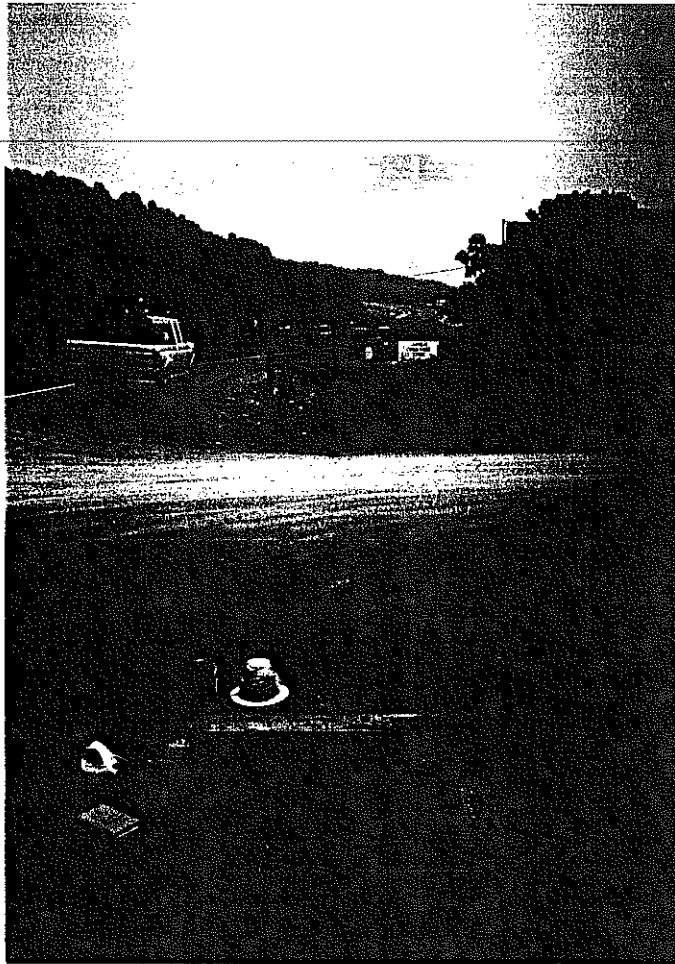
Figures 1 and 2 show the drop grate and storm drain, respectively, at approximate Milepost 19.36 through 19.41 (northbound) where 10 percent vertical deflection was recorded. Figure 3 shows the vertical offset that was observed under a driveway entrance at Milepost 19.432.

Figure 1. Drop Grate Storm Drain (18-Inch) on KY 17.  
(See Figure 2 for View Inside Drain)

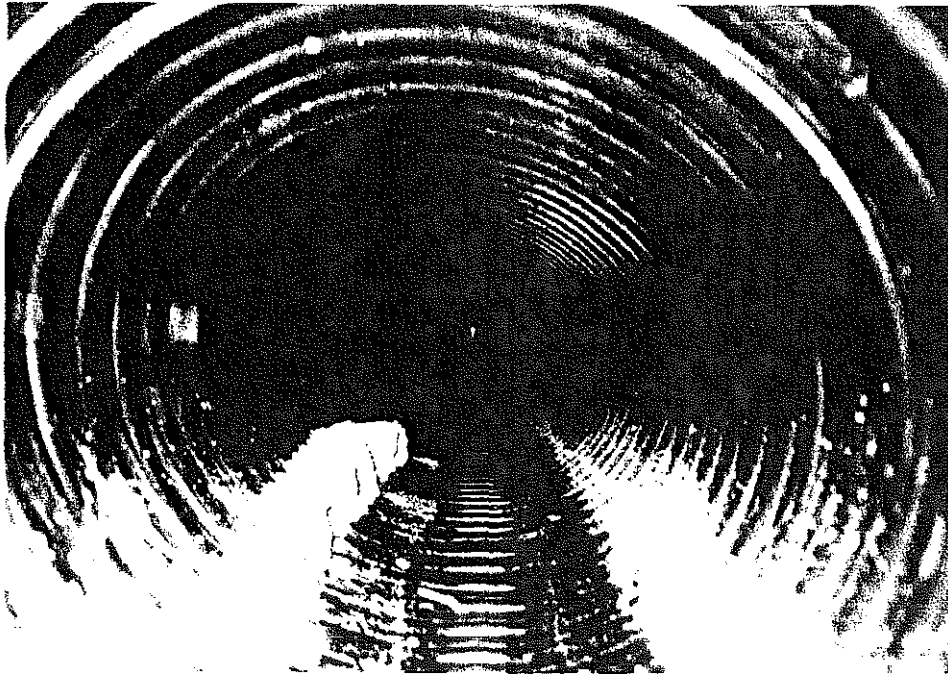
These drains were inspected shortly after installation in the fall of 1991. Approximately 12.5 percent deflection was noted in a 24-inch outfall storm drain pipe which discharges into a large concrete box culvert on the north end of the project. The pipe is approximately 110 feet long. The pipe shape had become elliptical (Figure 4). Approximately 80 percent of the drain appears to be elliptical in shape. The wall of the pipes had buckled in several areas.

Although the deflections on several of the 24-inch drains are greater than 10 percent, it appears they are functioning properly. It appears the backfill around the 24-inch outlet pipes was not uniform on both sides causing the pipe to become egg-shaped. It further appears the backfill around the 24-inch storm drains may not have been properly densified since there was little noticeable pipe deflection immediately after installation but considerable deflections were observed during the final inspection. It appears that the drains probably deflected from a lack of compaction on the side walls and haunches. The pipe deflected vertically and horizontally which forced additional compaction of the backfill at the springline.

Figure 4. Elliptical 24-Inch Outlet Pipe, Deflected 14.5 Percent.
