Research Report  
KTC-89-33

EVALUATION OF HYDRAWAY AND  
ADVANEDGE PAVEMENT EDGE DRAINS  
ON THE MOUNTAIN PARKWAY

May 1989

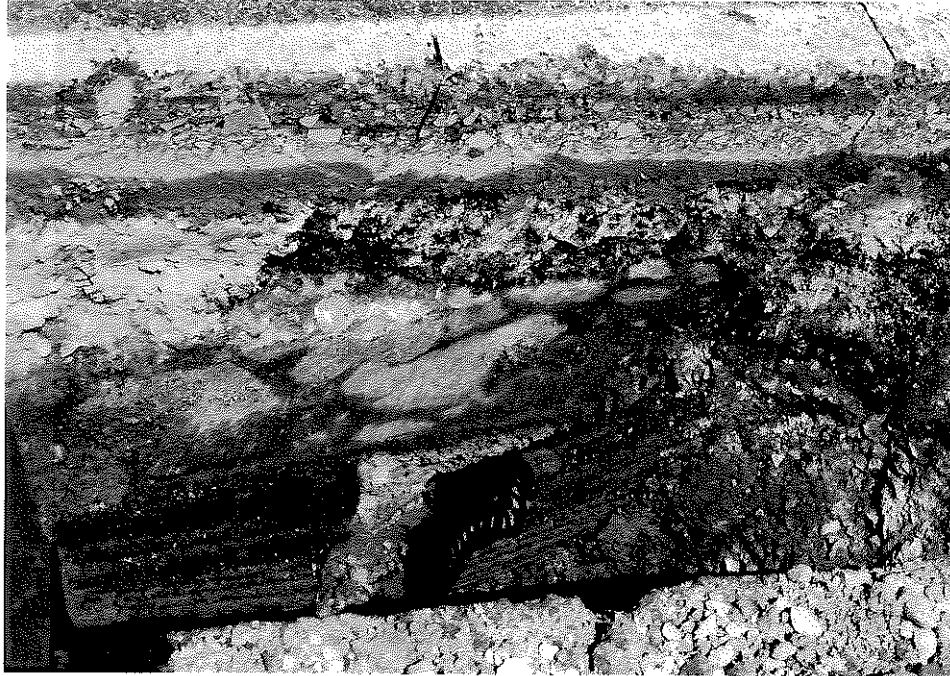
The Hydraway panel removed at milepost 22.65 showed signs of compression in both the vertical and horizontal planes. The panel had been compressed in its vertical plane by approximately three-inches and the horizontal plane had been compressed to approximately half of its original thickness. It appeared that during the backfill operation the stiff Hydraway backing had been forced down relative to the open front side causing the support columns in the inner core to fold up.

The top of the Hydraway core was "rolled over" (J-shaped). The Hydraway product is designed to conform to irregular trench walls; which was noted at

milepost 22.65. It appears the compaction of the backfill causes the "role over" and the columns to stack on top of each other (Photo 1).

**Photo 1.** The top of the fabric "rolled over" and the support columns compressed on top of each other.

1. It is recommended that Hydraway edge drain material (as presently designed) not be permitted on future projects.

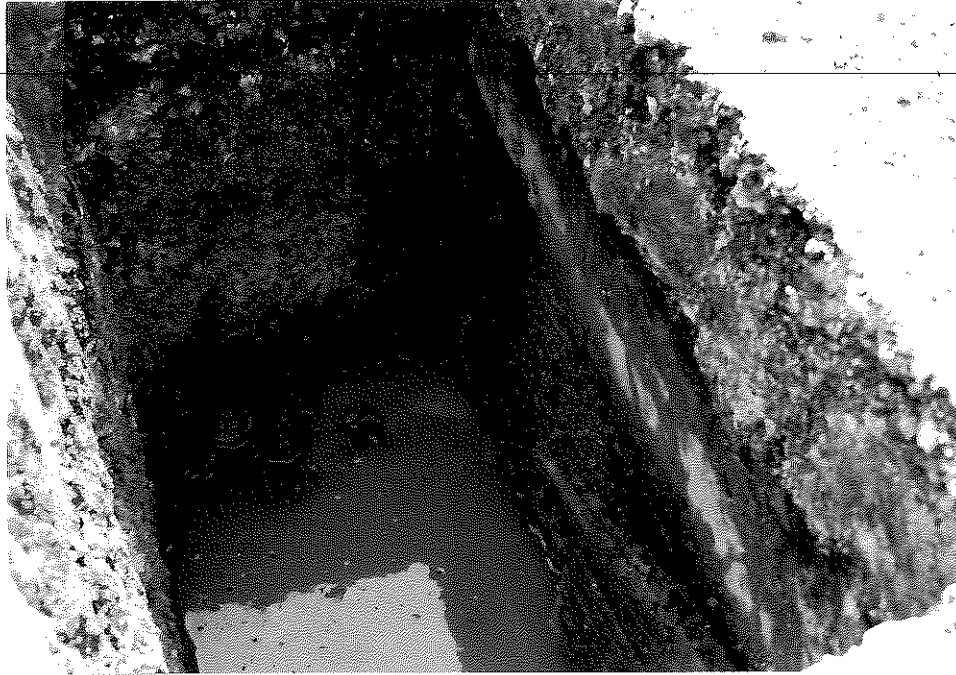
The Hydraway panel removed at milepost 24.71 had been compressed in its vertical plane by 1.75 inches. The support columns were angled up as at milepost 22.65, and the bottom two inches of the inner core was J-shaped (Photo 2).

During the excavation at milepost 24.71, the backfill on the shoulder side was saturated adjacent to the Hydraway panel. The panel was half full of silty water. There was water ponding between the edge drain and the road.

**Photo 2.** The bottom of the Hydraway drain J-shaped, and the trench filled with water.

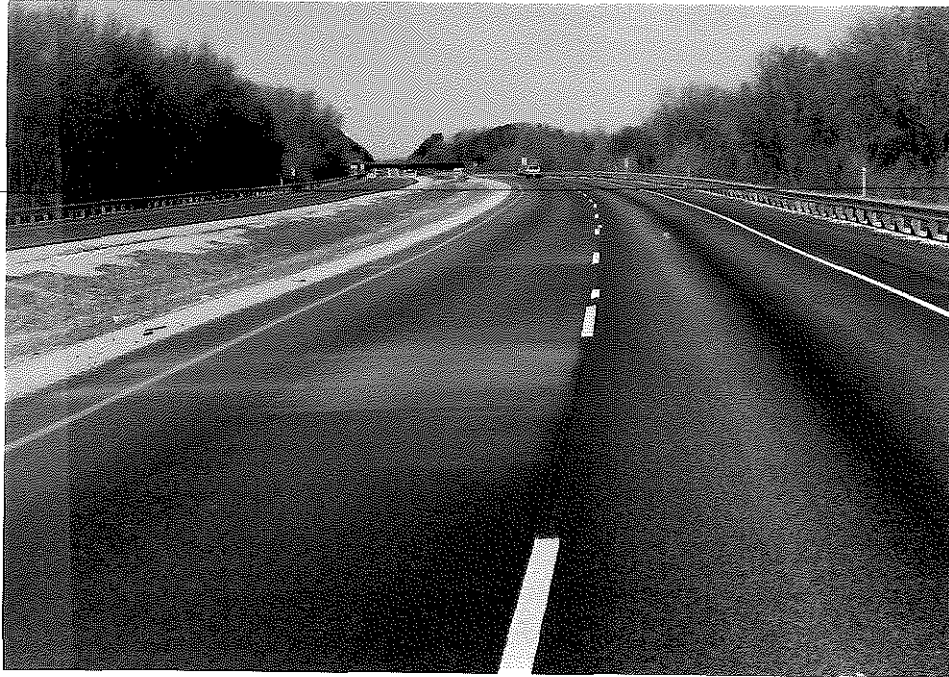
In several areas throughout the rehabilitated section, brown stains have appeared on the surface. From experience on the Pennyrite Parkway (Report No. UKTRP-88-15), it appears water may be standing at the interface between the broken concrete and the asphalt overlay (Photo 3). Laboratory tests performed on this material indicate it is calcium being pumped to the surface.

**Photo 3.** Calcium being pumped to the surface.

6. On breaking and seating projects, installation of an 18-inch panel should be considered. It appears the 12-inch panel may not have sufficient height to properly drain the interface between the broken concrete surface and the bottom of the asphalt overlay.
