Research Report
KTC-89-61

EVALUATION OF WICK DRAIN STABILIZATION OF APPROACH
FILL FOUNDATION (CARROLL COUNTY)

December 1989

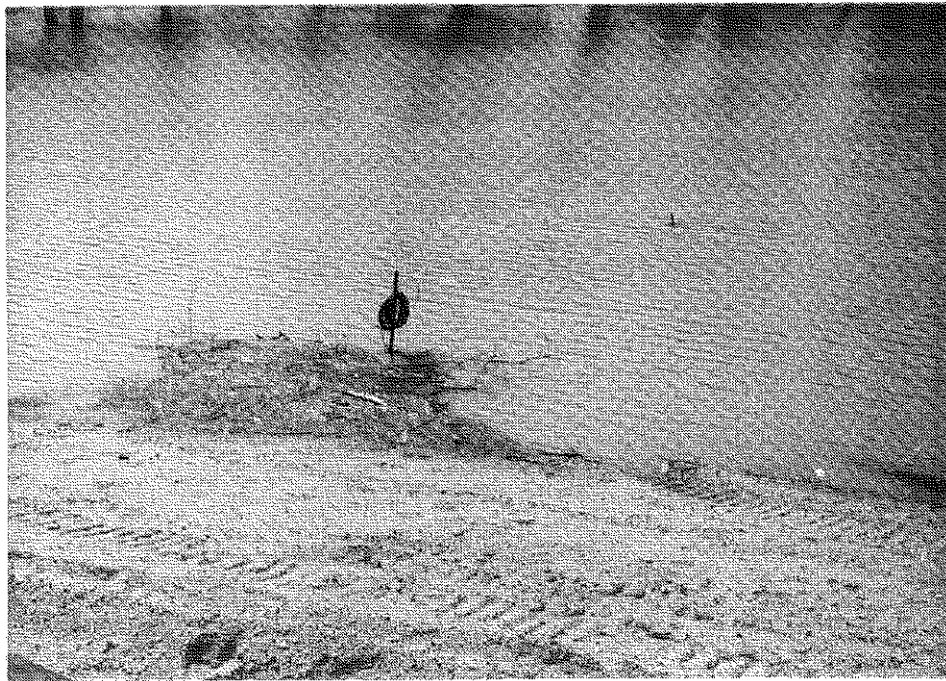
Figure 12. Spring Flooding of the Site.

Only two significant problems relating to the wick drains or drainage blanket were encountered. Flooding of part of the area that was to have wick drains delayed construction (Figure 12). This problem could not be avoided because of a rise in the river level. The other problem was the previously discussed subsurface conditions which restricted installation of wick drains to the upper clay layer.

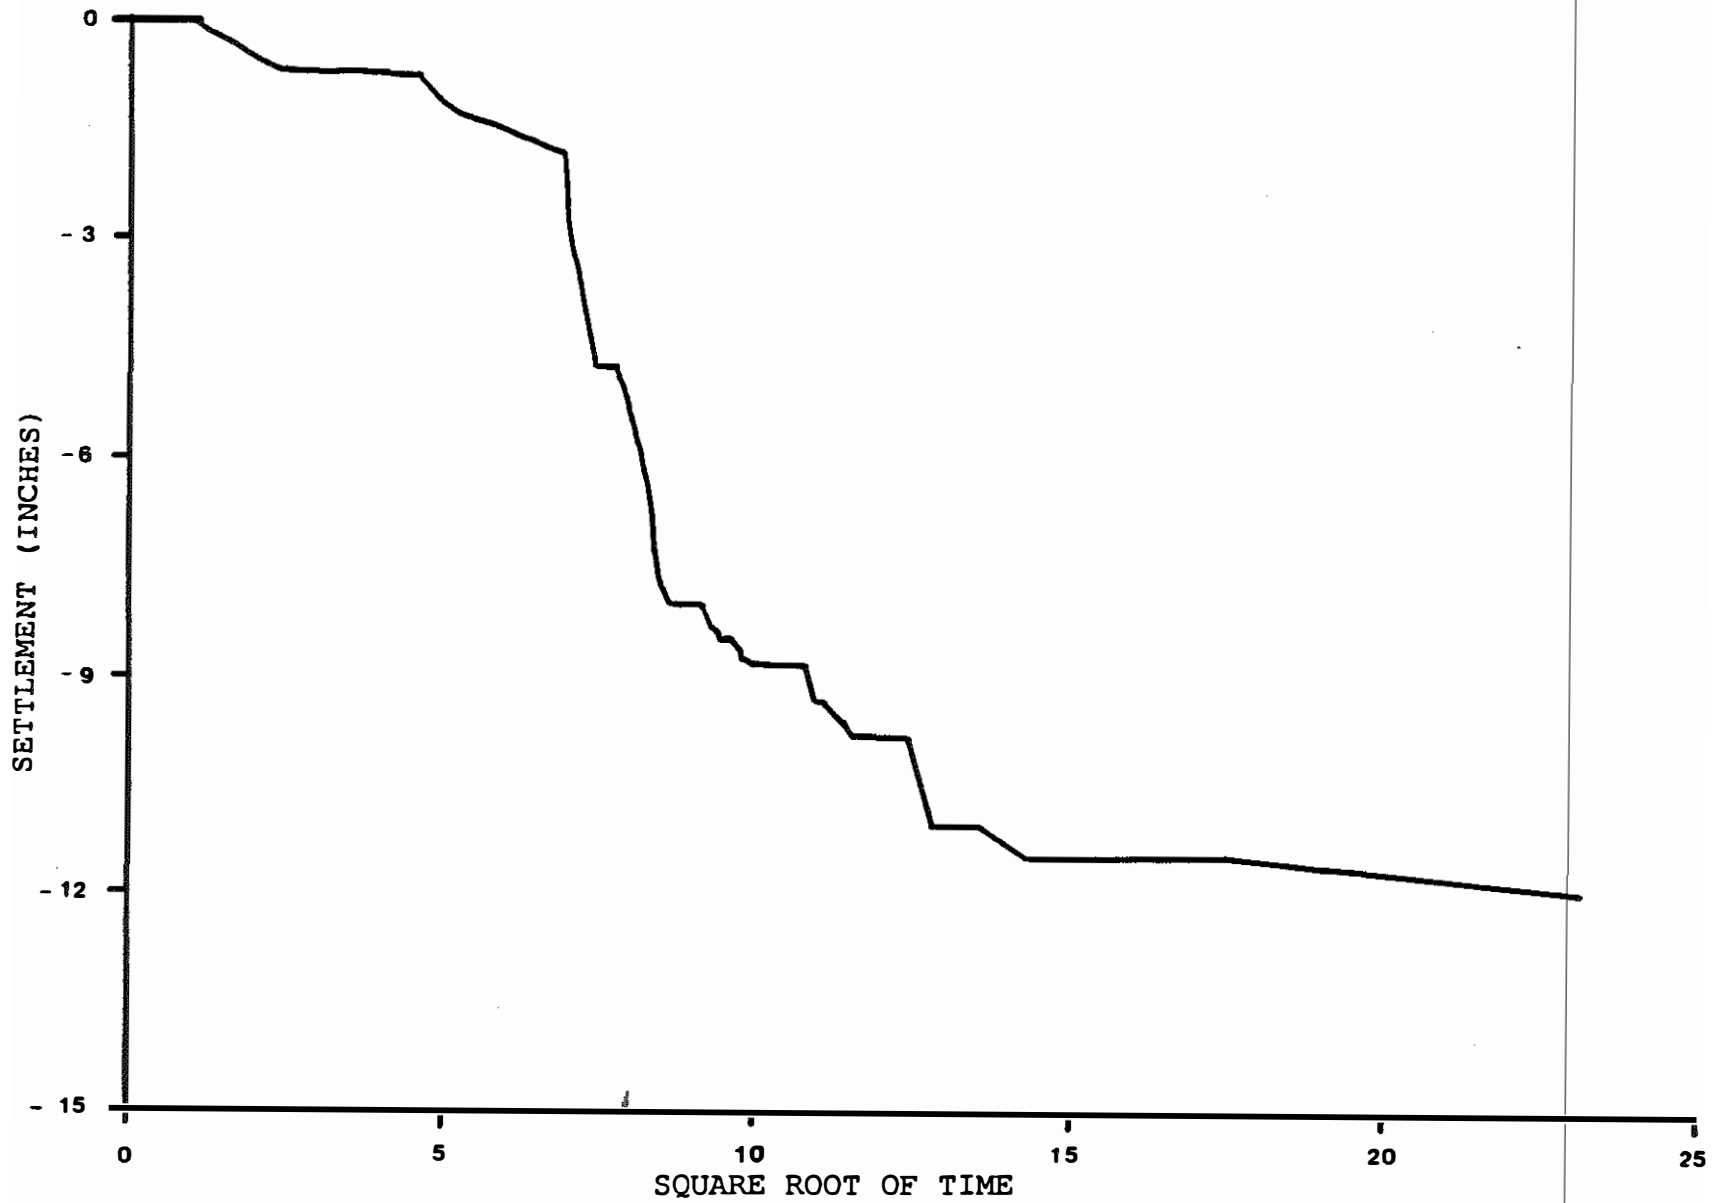
Figure 15. West Foundation Settlement Versus Square Root of Time (Station 31+94).

The settlement platform at Station 31+94 (west approach) indicated total foundation settlement of 12.0 inches by September 1986 or approximately 450 days after completion of embankment construction. Plotting measured

settlement versus the square root of time, 90 percent consolidation occurred within approximately 100 days of embankment completion (Figure 15). Predicted foundation settlement for the west approach was 32 inches. Much of the predicted settlement apparently occurred prior to installation of the settlement platform. Prior to the placement of the settlement platforms, heavy equipment was constantly moving about the site while involved in clearing, drainage blanket placement and installation of the wick drains. It is suspected that the dynamic action of the equipment and dewatering resulting from placement of the wick drains resulted in significant foundation settlement. Settlement platform data and embankment heights are plotted versus time in Figure 16.

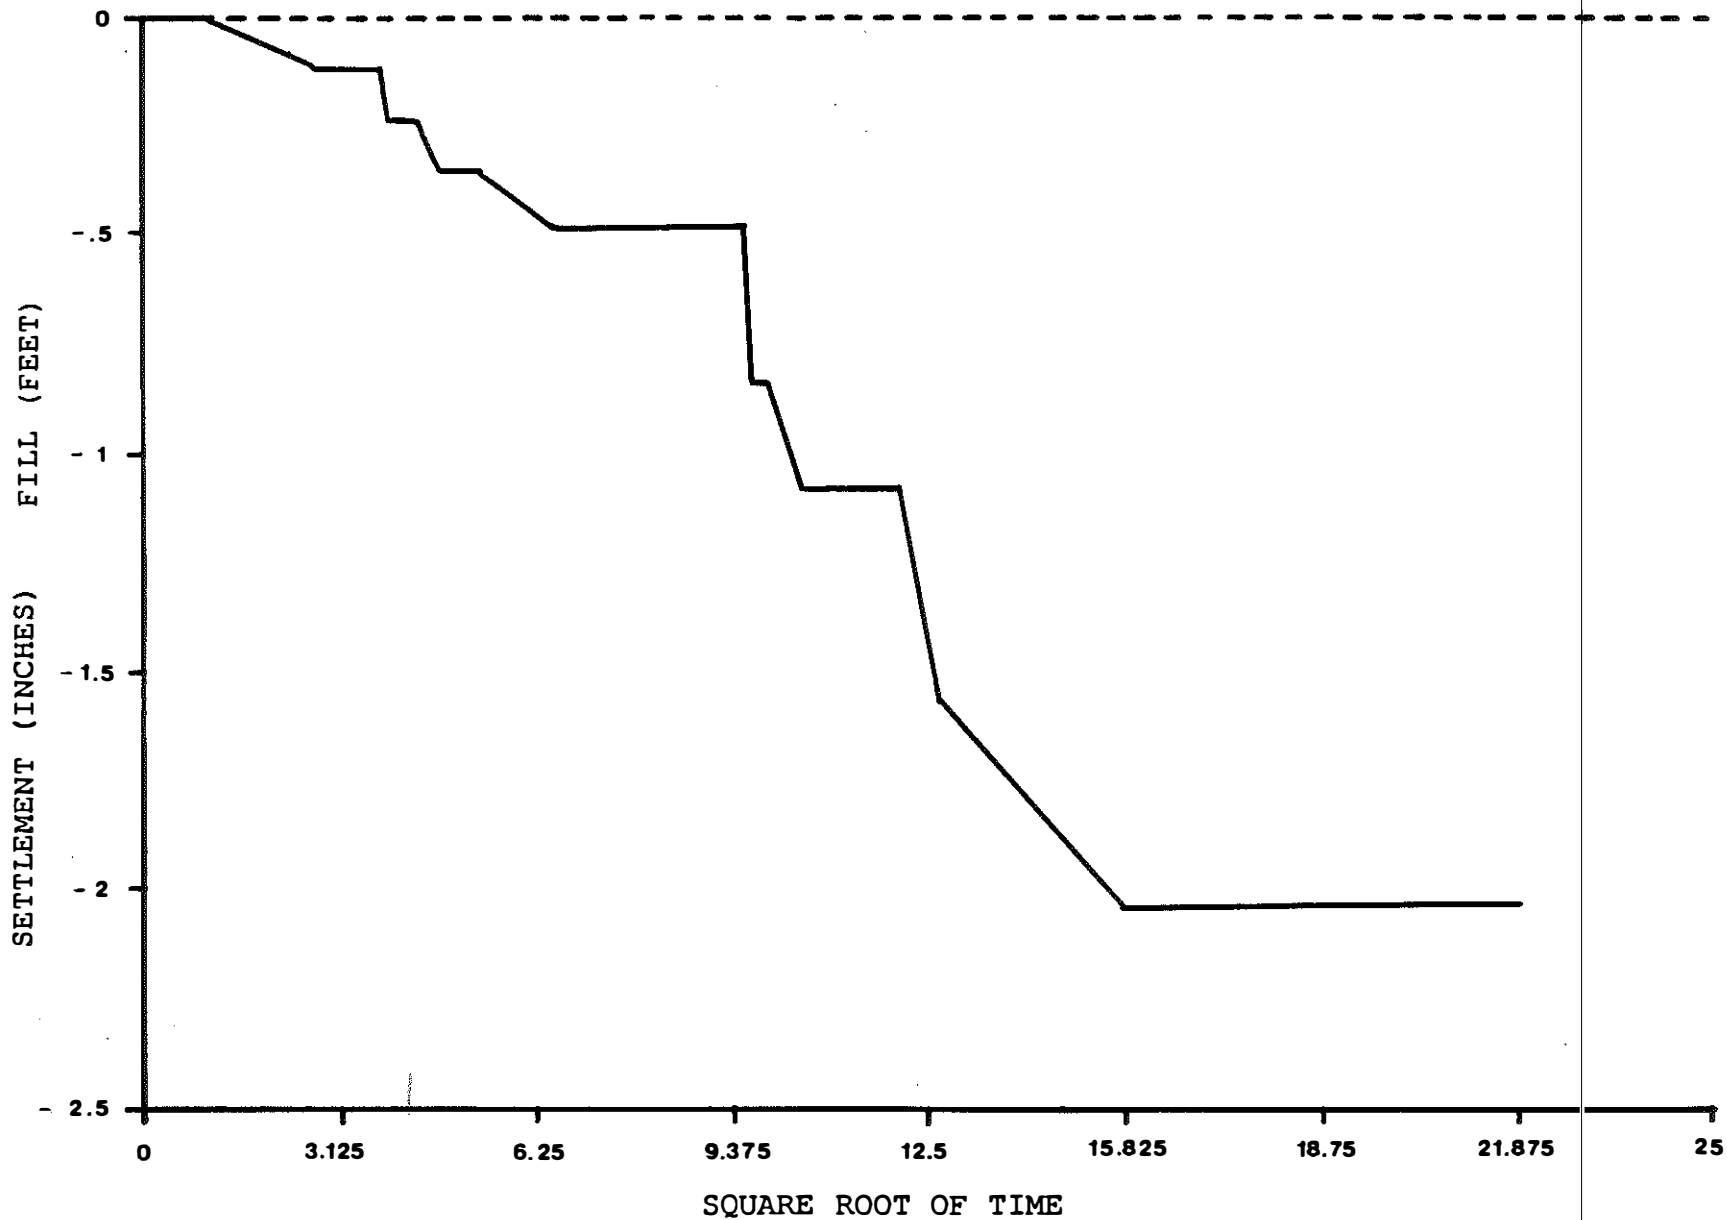
Figure 17. West Foundation Settlement Versus Square Root of Time (Station 35+00).

Settlement of the east foundation, as indicated by the settlement platform, totaled 2.04 inches as of September 1986, approximately 460 days after completion of the embankment (Figure 17). For the east foundation, 90 percent consolidation was achieved approximately 220 days after completion of the embankment (Figure 18).

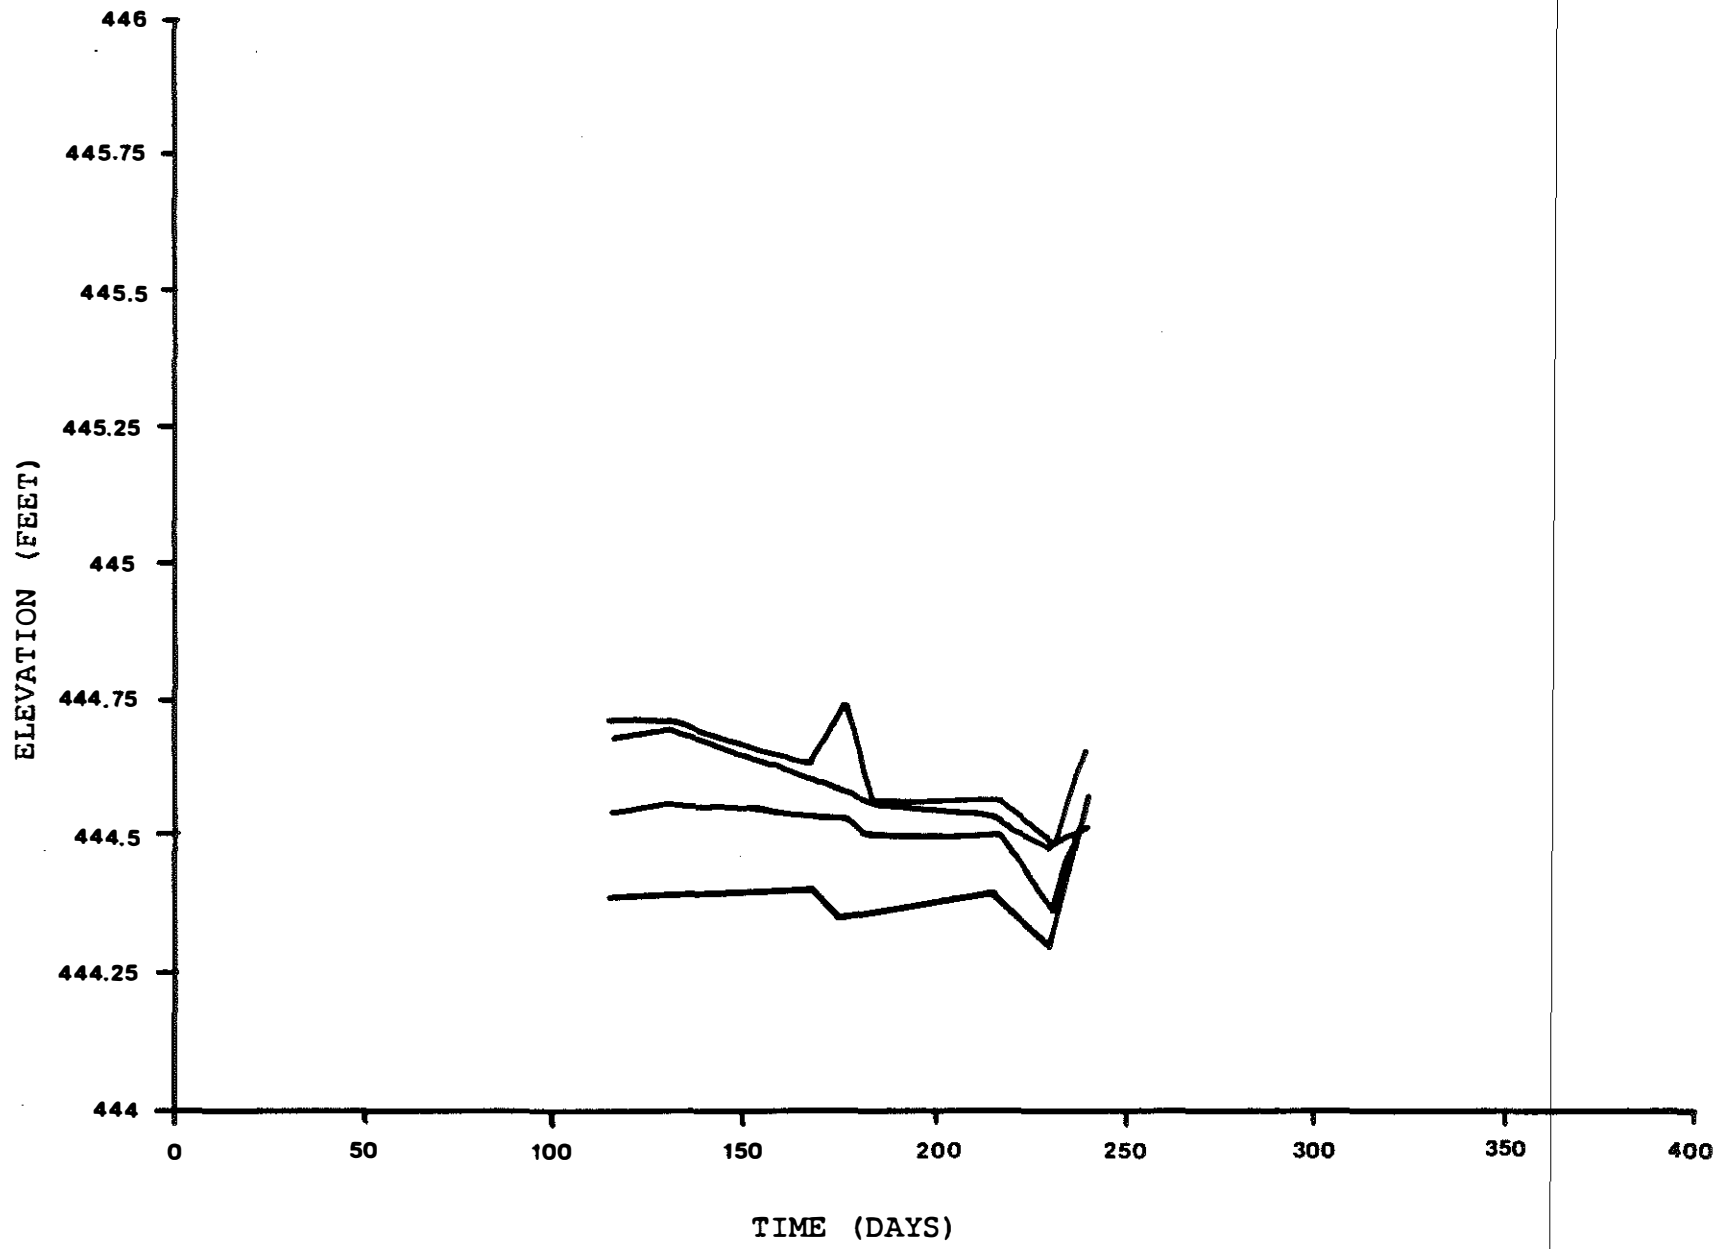
Figure 19. Settlement Gage on West Foundation.

Settlement gage data from Station 30+86 are inconsistent but indicate that little settlement occurred at that location after installation of the gage. The gage was installed after the wick drains, drainage blanket, and some fill was in place. The embankment height was 15 to 16 feet at the settlement gage location. Settlement gage data are plotted in Figure 19.

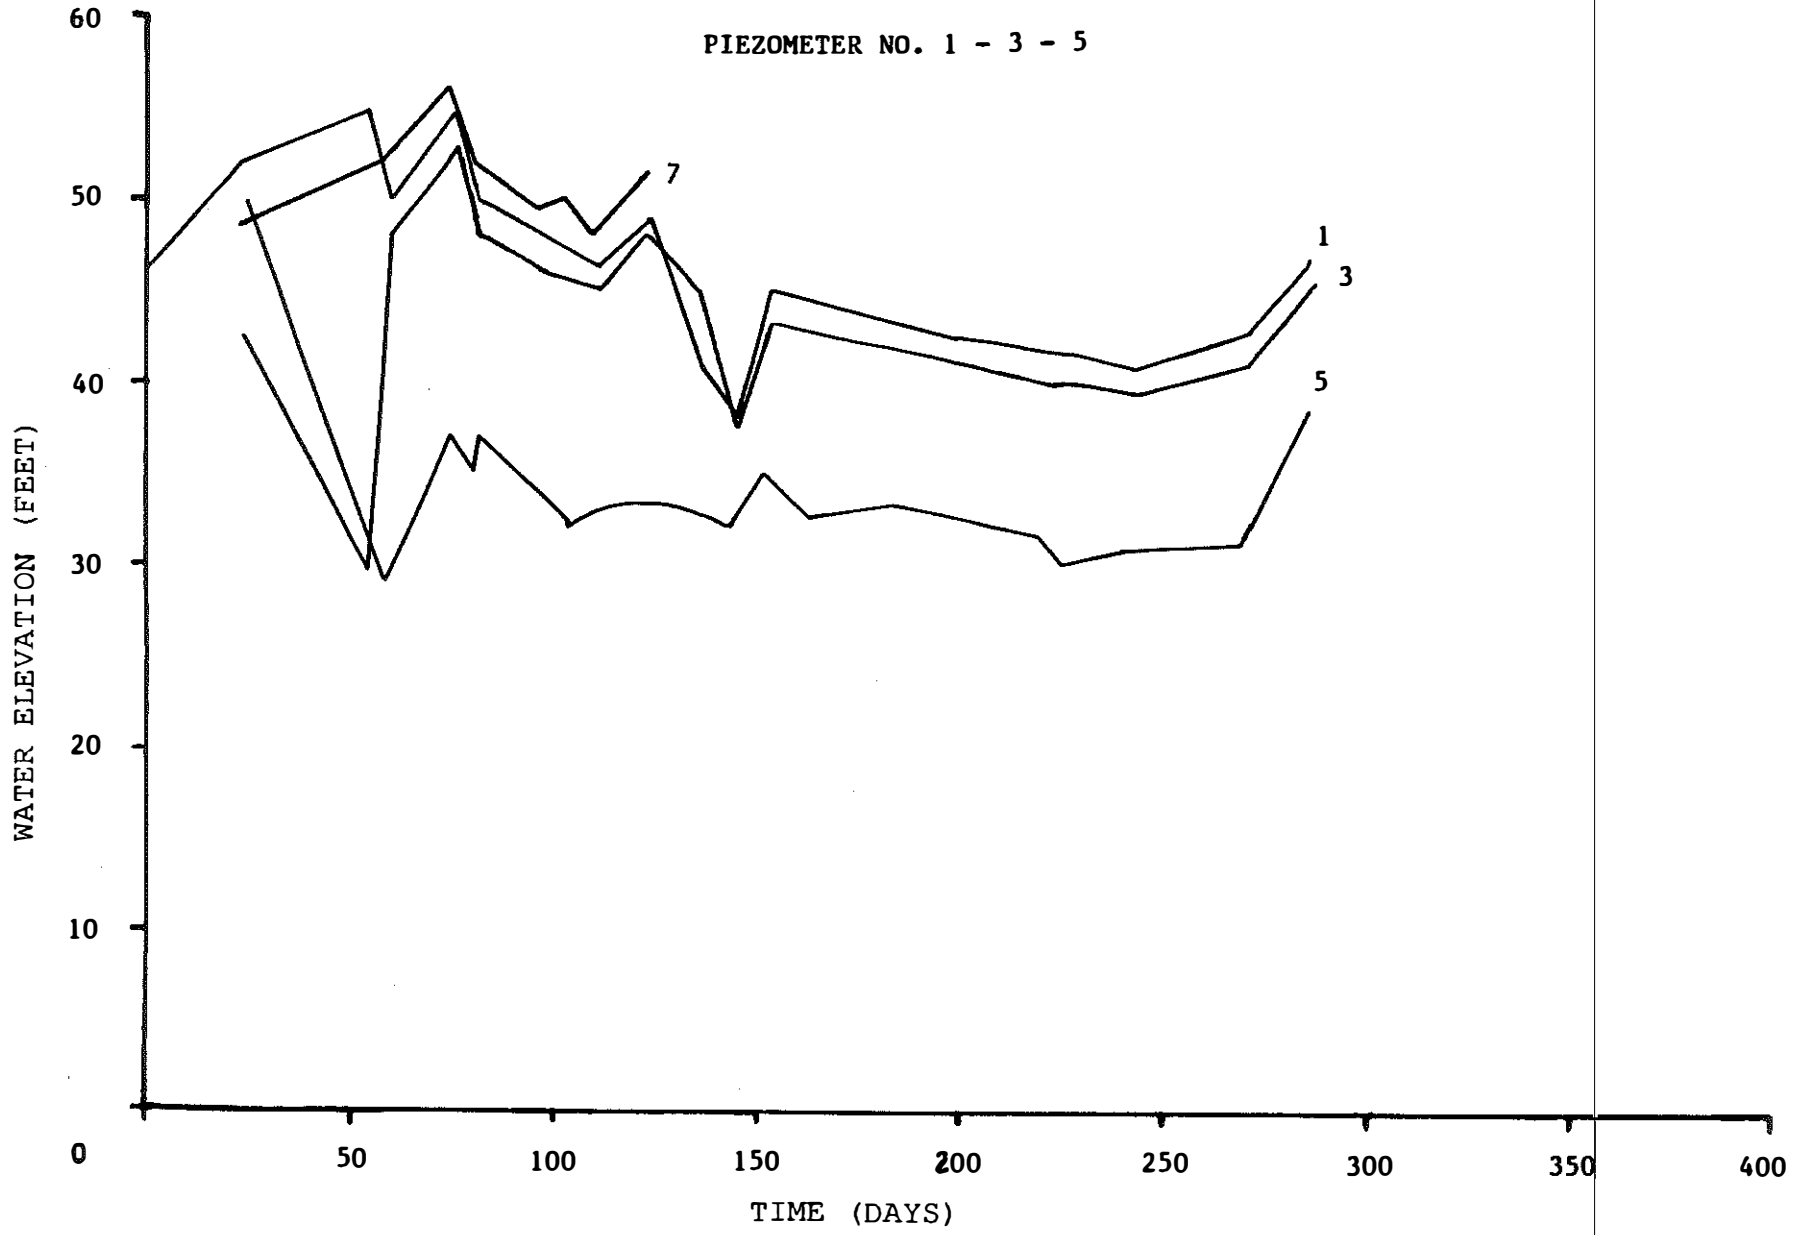
Figure 25. Pore Pressure In the Lower Clay Layer.

Piezometer data are graphically displayed in Figures 20 through 24. Pore pressure as indicated by these data fluctuates. However, as seen in Figure 25, the fluctuations in pressure in the lower clay layer occur approximately at the same time. Much of this fluctuation is traceable to precipitation and river pool level. Pool level of the river is plotted with Piezometer 3 data in Figure 26. Many of the pressure increases reflect river pool elevation increases.

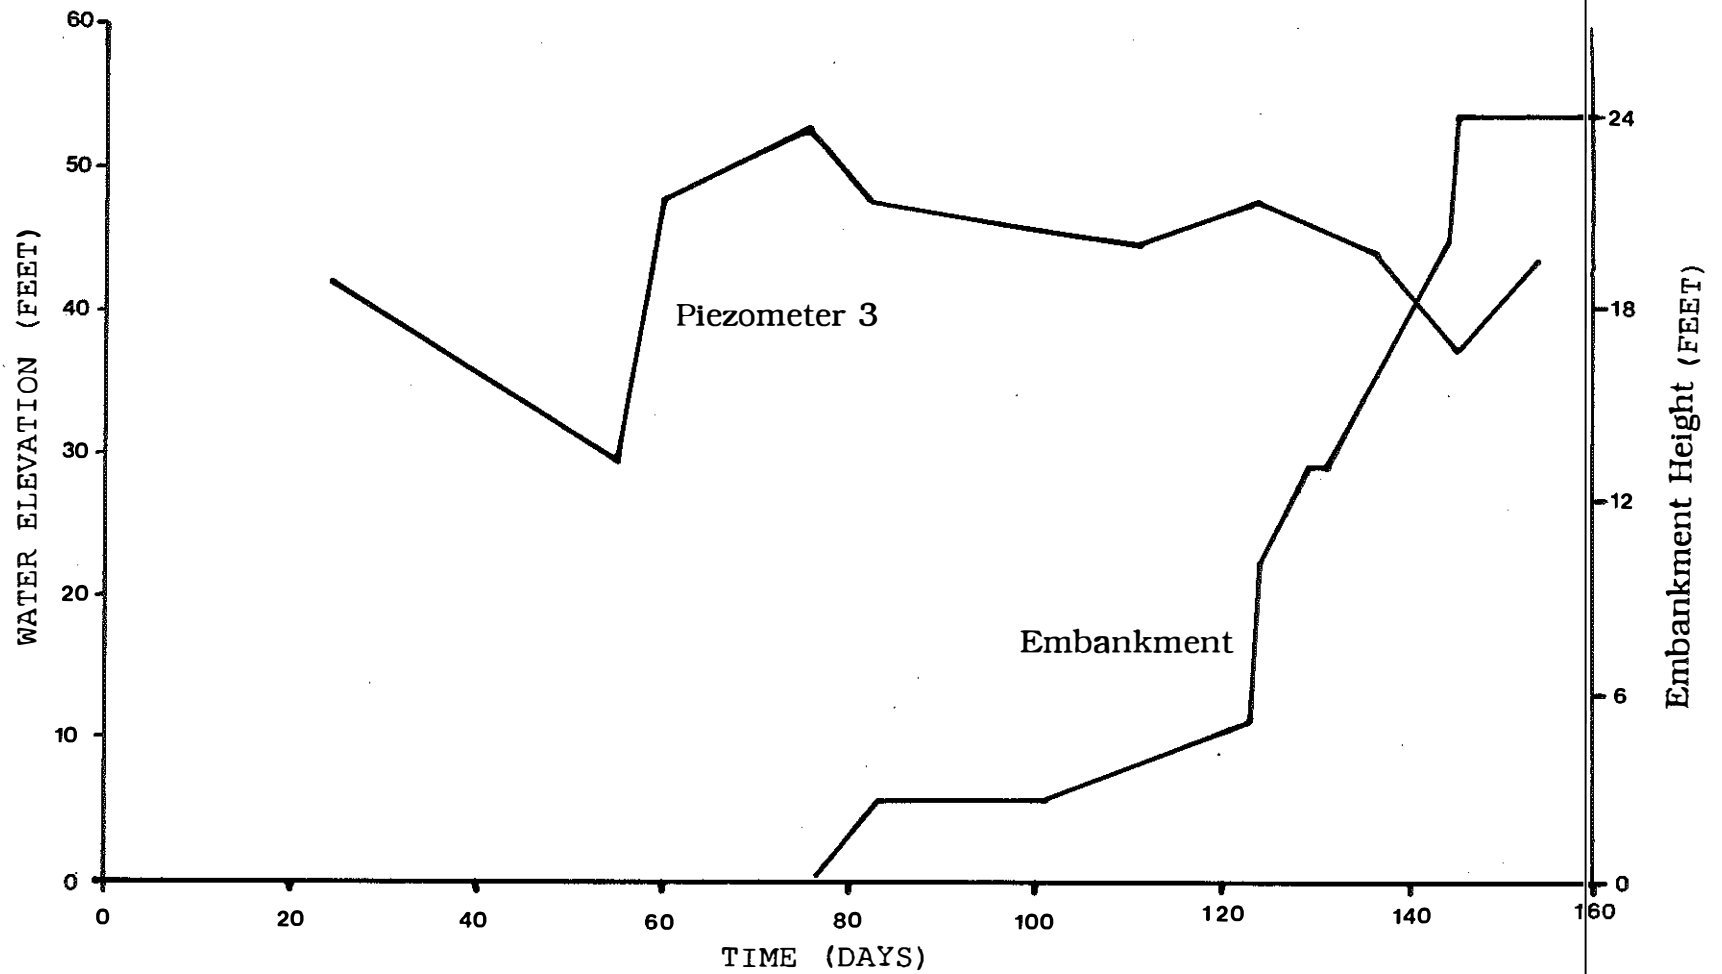
Figure 27. Pore Pressure at Piezometer 3 Compared to West Embankment Height.

Precipitation, water table changes, and embankment construction are reflected in pore pressure data. At the time that significant amounts of material were placed on the foundation (April 11, 1985), pore pressure in the lower clay layer rose from the equivalent of 4 feet of water (Piezometer 7) to the equivalent of 8 feet of water (Piezometer 5). Little material was placed until May 29, 1985. Pore pressures decreased the equivalent of 5 to 8 feet of water during this time. Placement of additional embankment again was reflected in a pore pressure rise of 2 to 3.5 feet of water on May 19, 1985. This pattern continued until the embankment was complete. Embankment heights and pore pressure (during the embankment construction period) are shown in Figure 27.

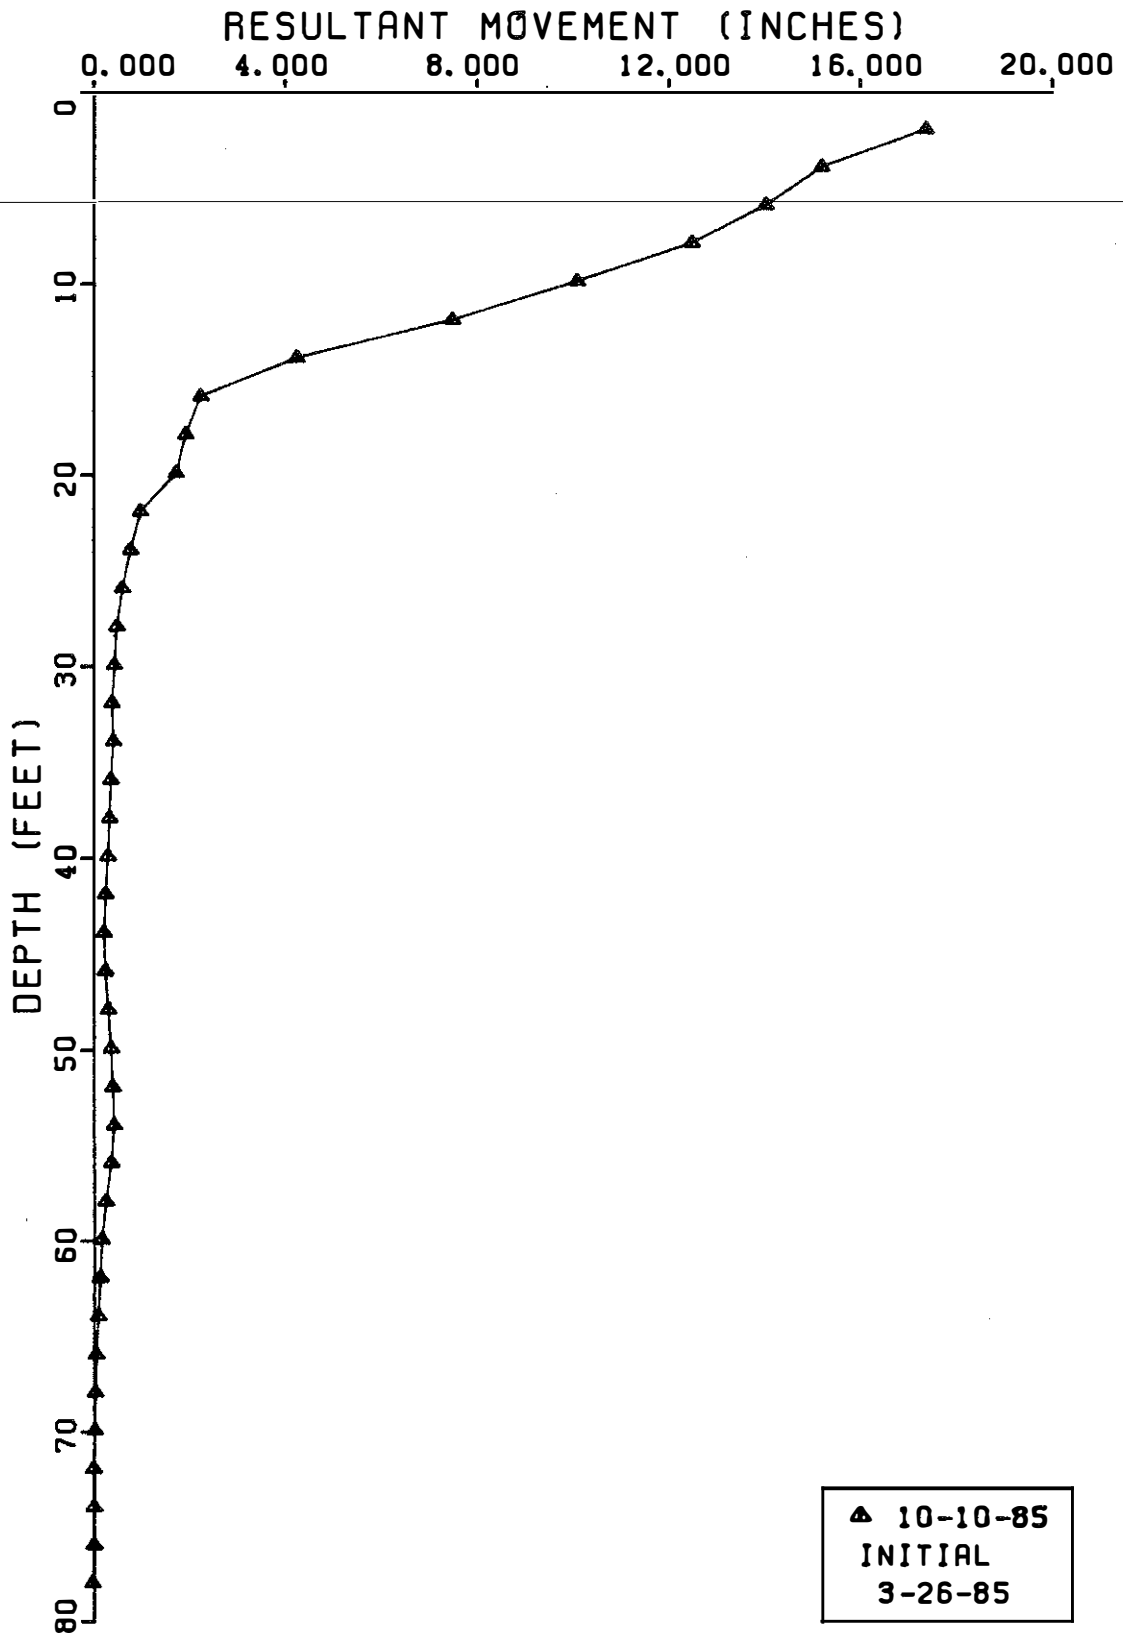
Figure 28. Lateral Movement at Slope Inclinerometer 1.

occurred on the river bank, resulting in the closing of the inclinometer 23 feet from the surface during the winter of 1985 and 1986. The failure was outside the area receiving wick drains, however data from the instrument indicated an area of lateral displacement at a depth of 45 to 69 feet. This would be the approximate depth of the lower clay layer. Total lateral movement as of October 10, 1985 was roughly 0.5 inch. Data for inclinometer 1 are shown in Figure 28.

The slope failure that closed Inclinometer 1 was outside the wick drain area. This failure was not an indication of the failure of the wick drains to

perform adequately but rather was a possible indication of their effectiveness. The foundation at the site is of a nature to permit this failure yet the wick drained foundation is presently stable. The slope failure that closed Inclinometer 1 was probably due to rapid drawdown when the native soils did not drain quickly. This same soil comprises the approach foundation upper clay layer and where drains were installed the foundation soil drains quickly. Slope inclinometer data indicate that some instability along the river bank still exists.

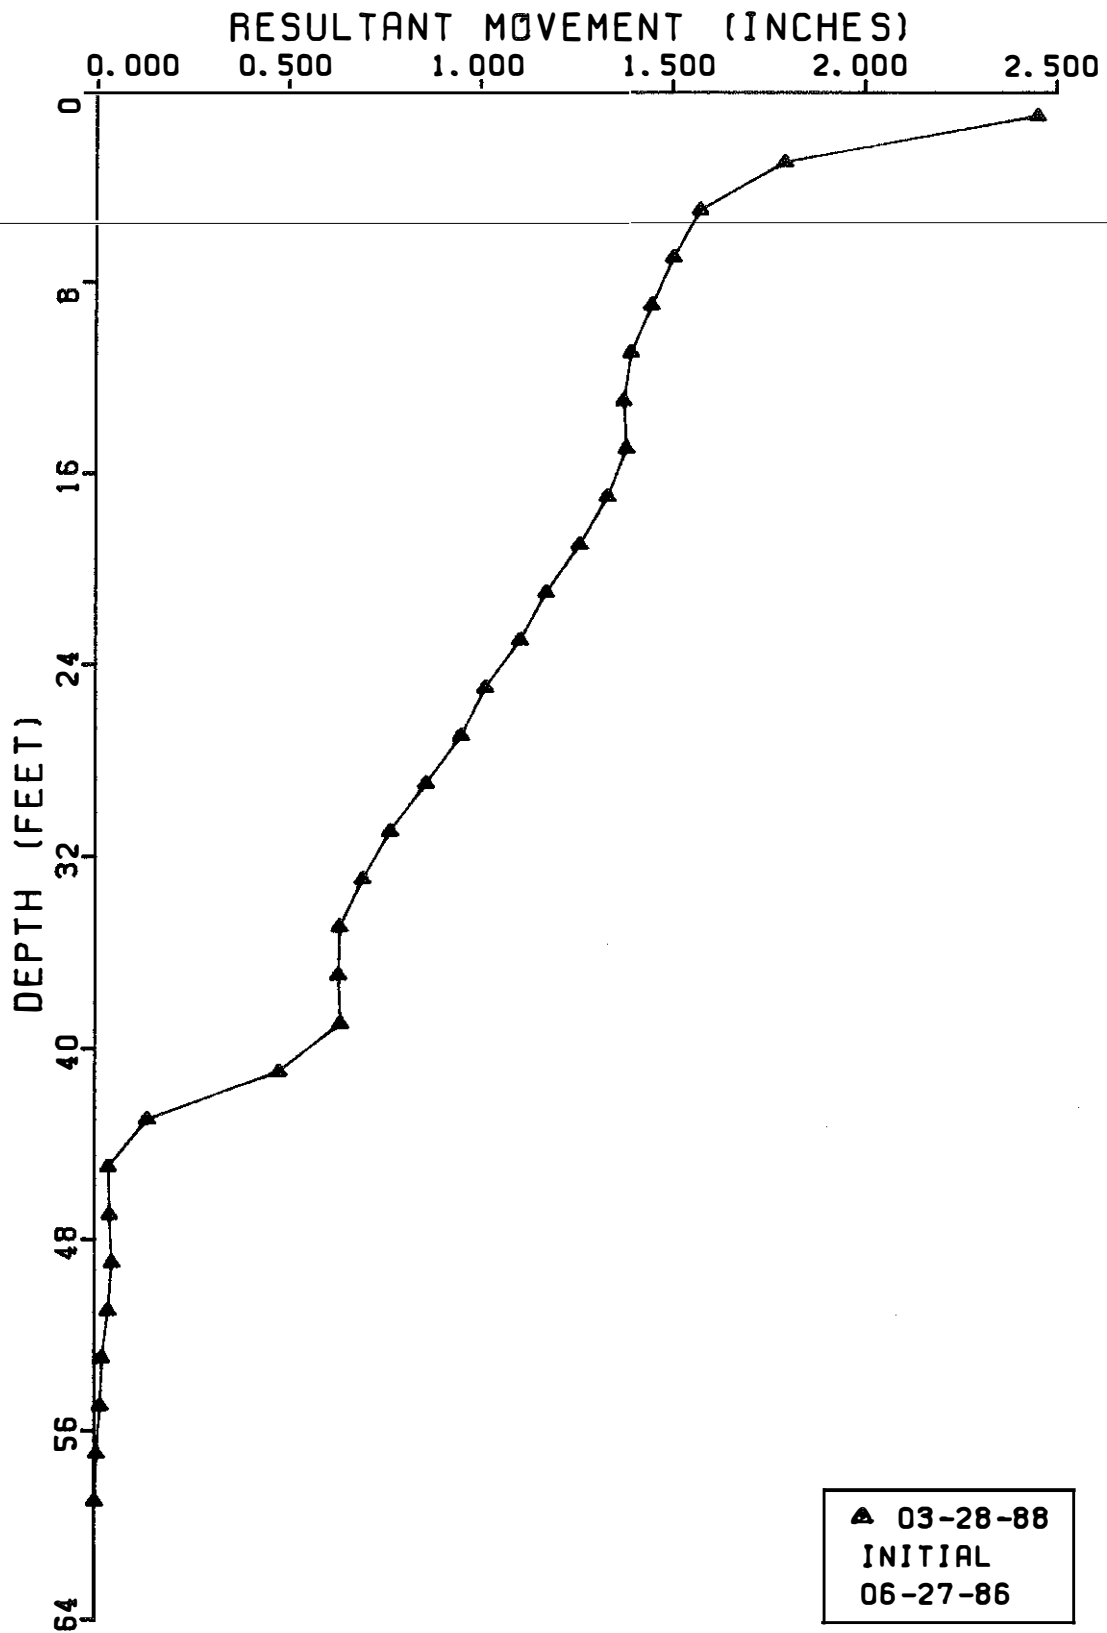
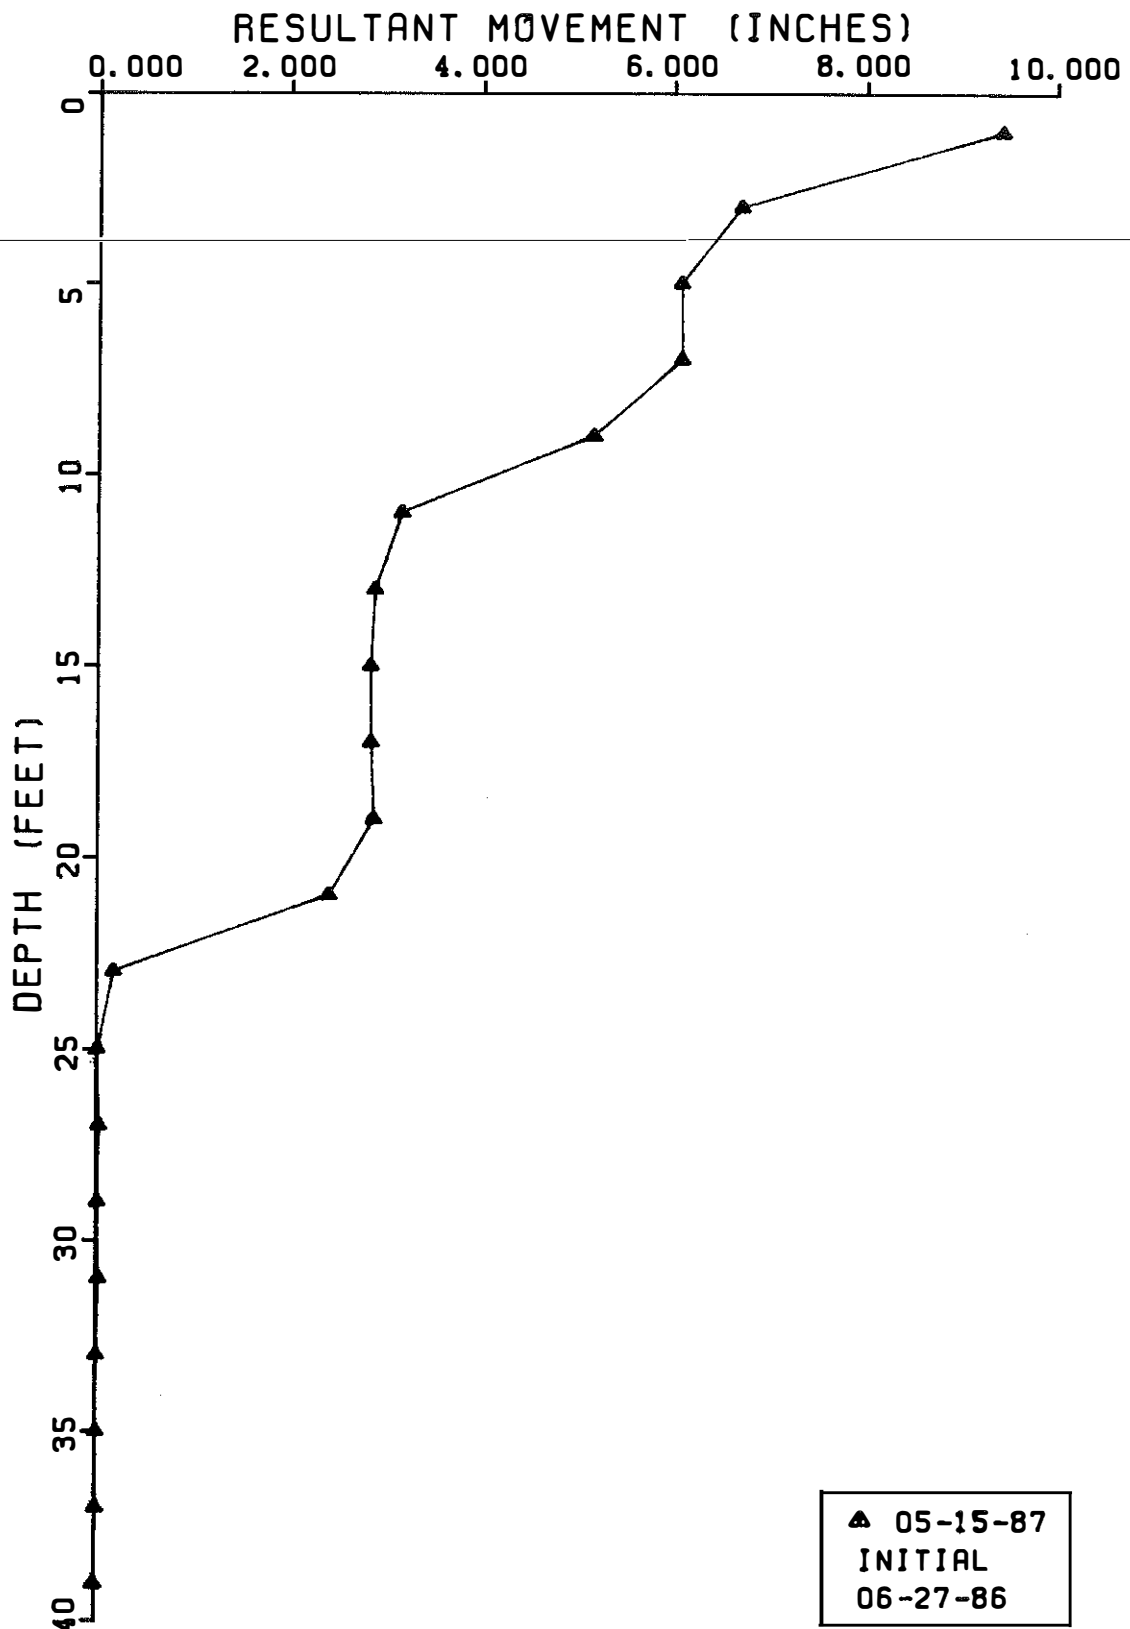
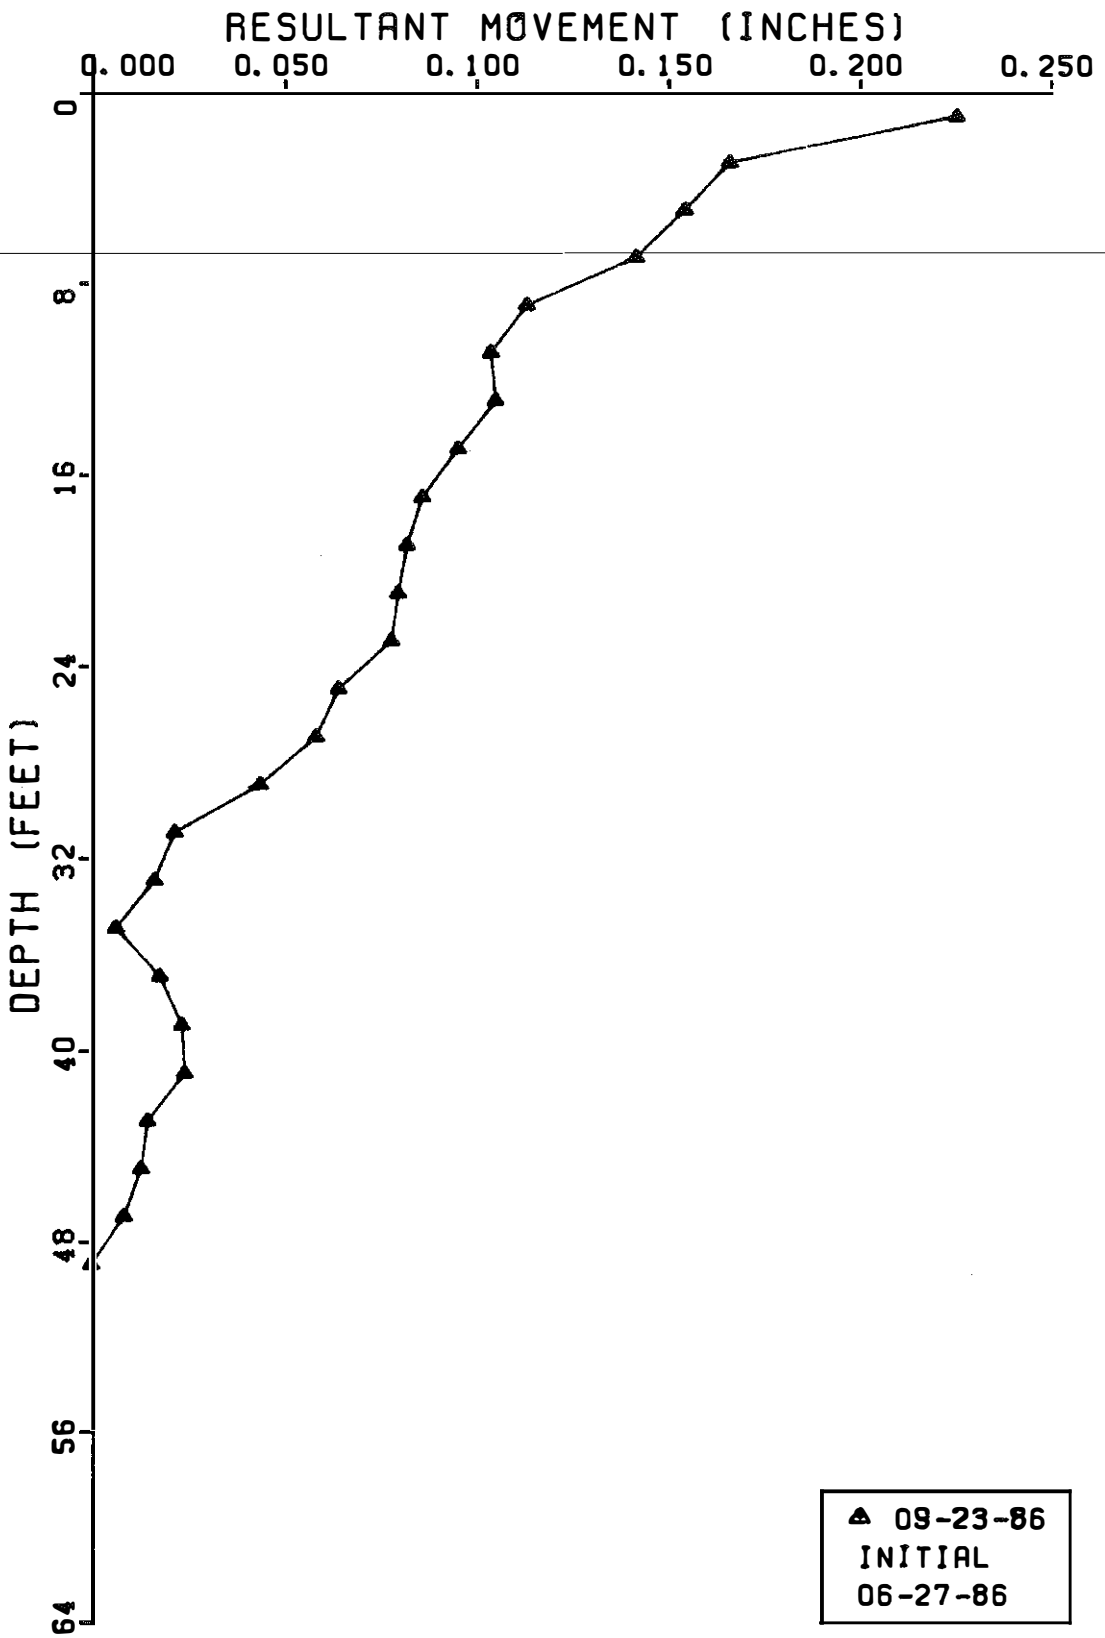
After Inclinometer 1 closed, Inclinometers 3 through 5 were installed in June 1986. Inclinometer 5 was destroyed 3 months after installation with approximately 0.2 inch of movement near the surface. Inclinometer 3 indicates continuing movement with approximately 1.5 inches of movement in the upper clay layer and an additional 0.9 inch in the top 6 feet of the embankment. Inclinometer 4 closed approximately 24 feet below the surface within a year of installation. A total of 9.5 inches of lateral movement had occurred. Data for Inclinometers 3, 4, and 5 are shown in Figures 29, 30, and 31.
