Research Report
KTC-91-19

CONSTRUCTION EVALUATION OF
HYDRAWAY EDGE DRAIN AND OUTLET PIPES
ON INTERSTATE 64

December 1991

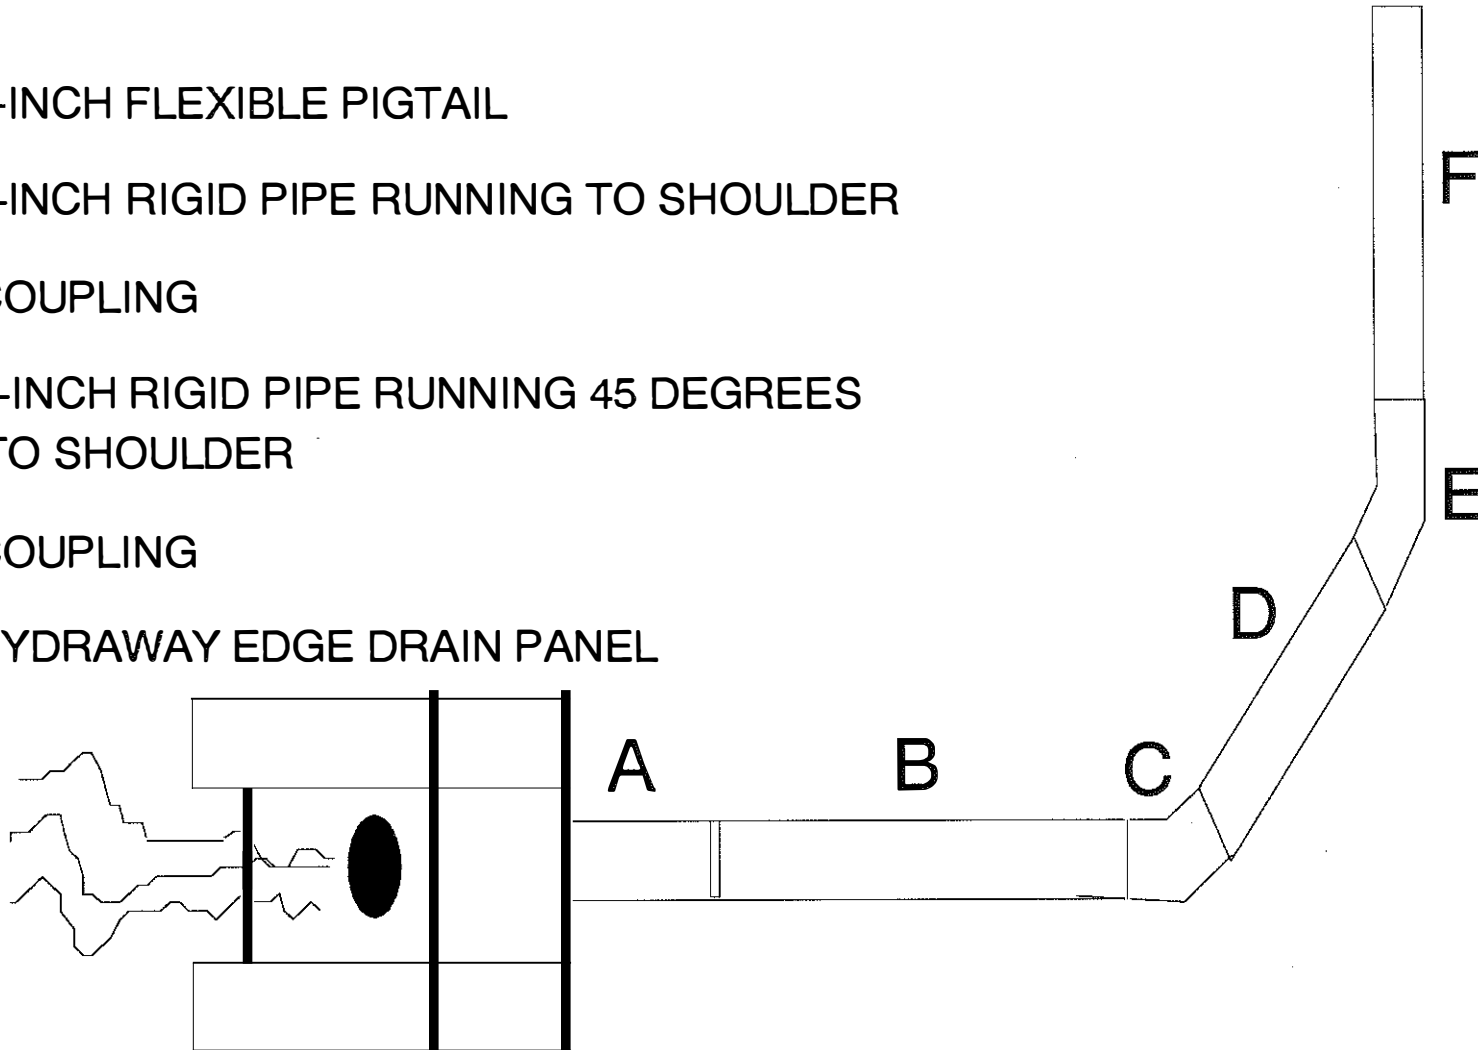
FIGURE 1. OUTLET PIPE SECTION DESIGNATIONS

In October of 1991, outlet pipes were inspected approximately every one-half mile in both directions of Interstate 64. A total of 68 outlet pipes were inspected. Figure 1 shows designations for the outlet pipe sections. Section A is the 4-inch flexible pigtail that is precast into the headwall. Section B is a 4-inch rigid pipe that runs to the shoulder and Section D is a 4-inch rigid pipe that runs at a 45 degree angle through the shoulder. Sections C and E are connectors and Section F is the mainline (Hydraway edge drain).

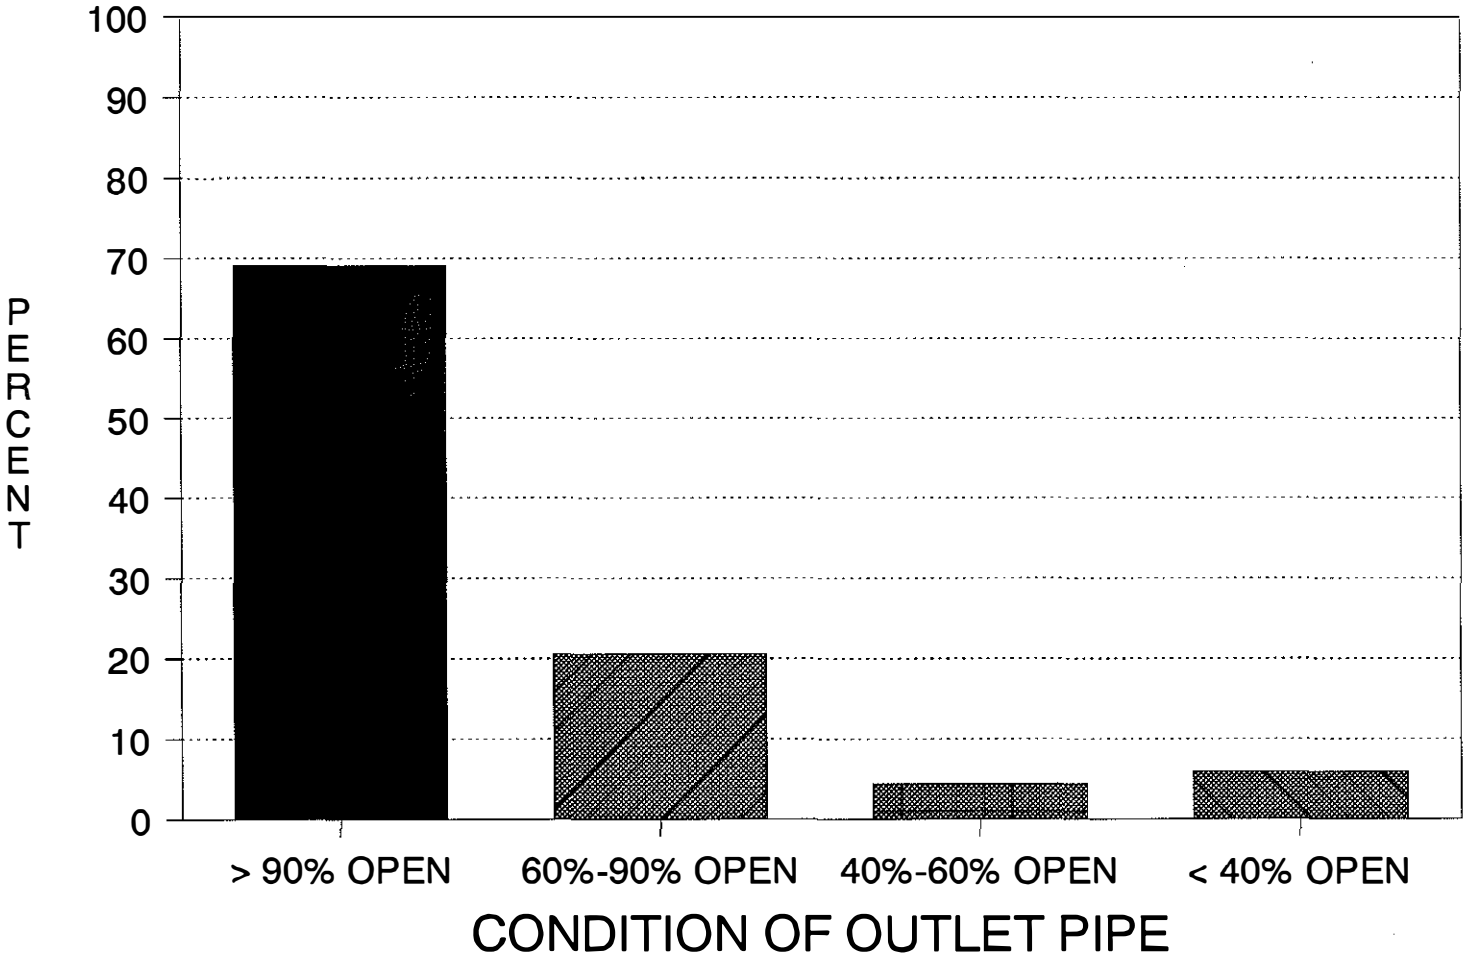
FIGURE 2. OUTLET PIPE FLOW INFORMATION
(I-64, RIGID OUTLET PIPE)

The outlet pipes were inspected for sags, siltation, standing water, compression, rips, and other noticeable distress. As shown in Figure 2, approximately 69 percent of the outlet pipes inspected were more than 90 percent open, 20 percent were 60 to 90 percent open, 4 percent were 40 to 60 percent open, and approximately 6 percent were less than 40 percent open. Approximately 10 percent of the outlet pipes had been crushed significantly during installation. The amount of open area was controlled by the degree of compression in the pipe). Figure 3 indicates where the majority of the distress and the type of distress occurred throughout the outlet pipe section. Figure 3 indicates the largest amount of distress was observed in the 4-inch flexible pigtail (Pipe Section A) which is precast into the headwall. The pig tail is approximately 1 to 2 feet long on the back side of the headwall. Approximately 70 percent of the outlet pipes had noticeable sags in this area. Approximately 45 percent of the rigid outlet pipes had sags through the asphalt shoulder (Pipe Section D).

High density polyethylene pipe having a smooth interior should be used in outlet pipes which are precast into the headwalls instead of the flexible 4-inch single wall.

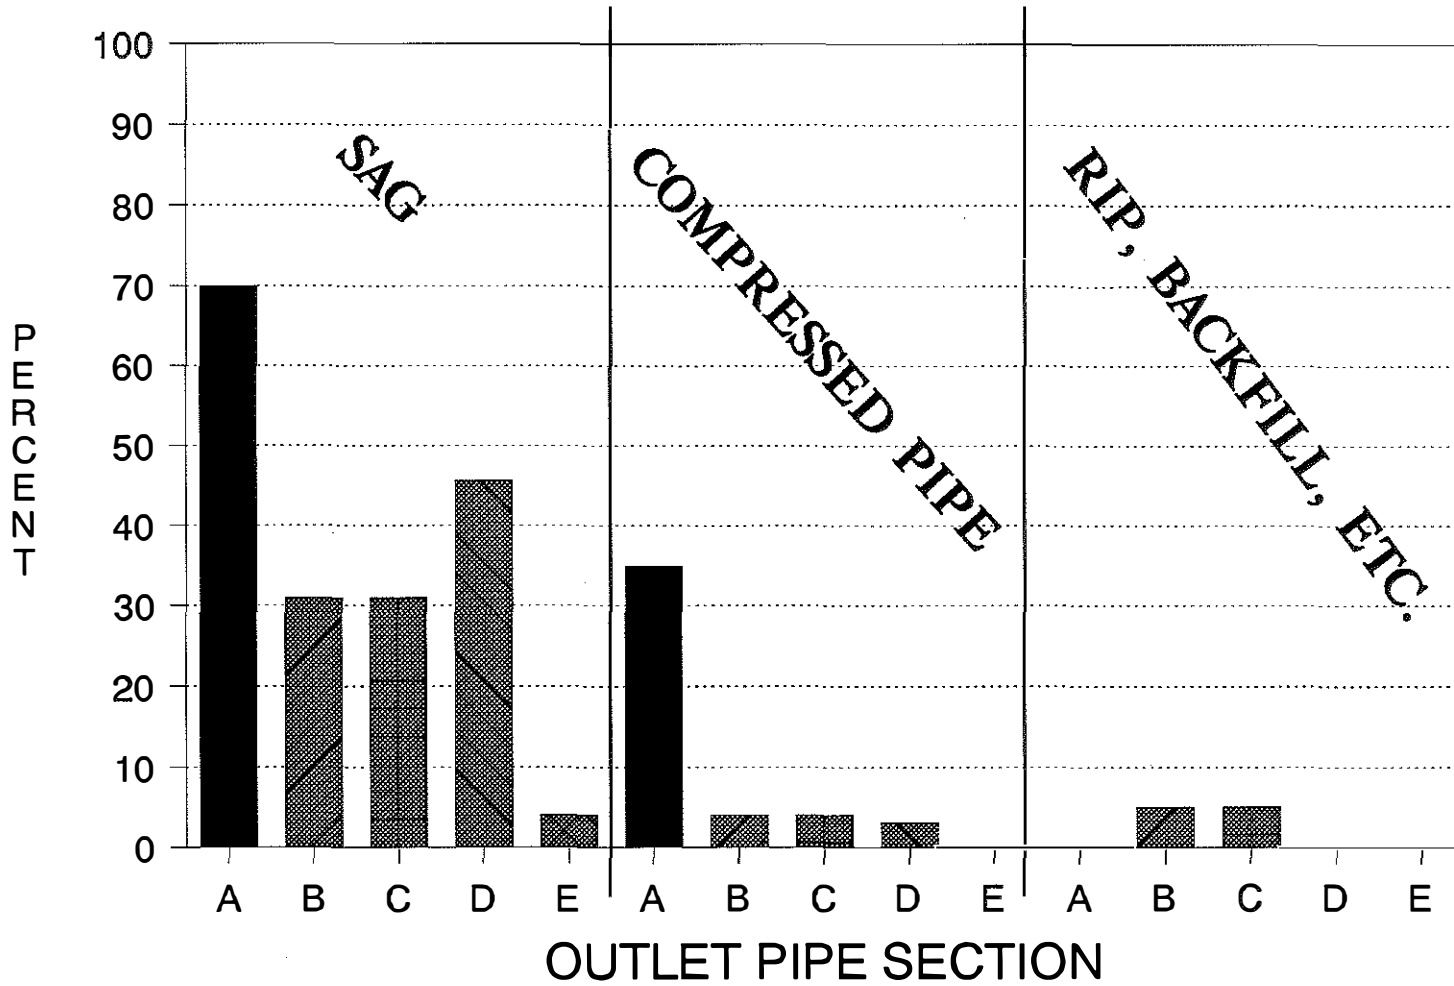
FIGURE 3. RIGID OUTLET PIPE DISTRESS
(INTERSTATE 64)

Figure 3 also indicates that significant compression had occurred in the flexible pigtail (Section A) during installation. Approximately 34 percent of the outlet pipes had noticeable compression in the flexible pigtail (Section A). It appears this is the weakest part of the outlet pipe system.

It is recommended that the outlet pipe be backfilled with a crushed stone or sand to insure a proper installation.

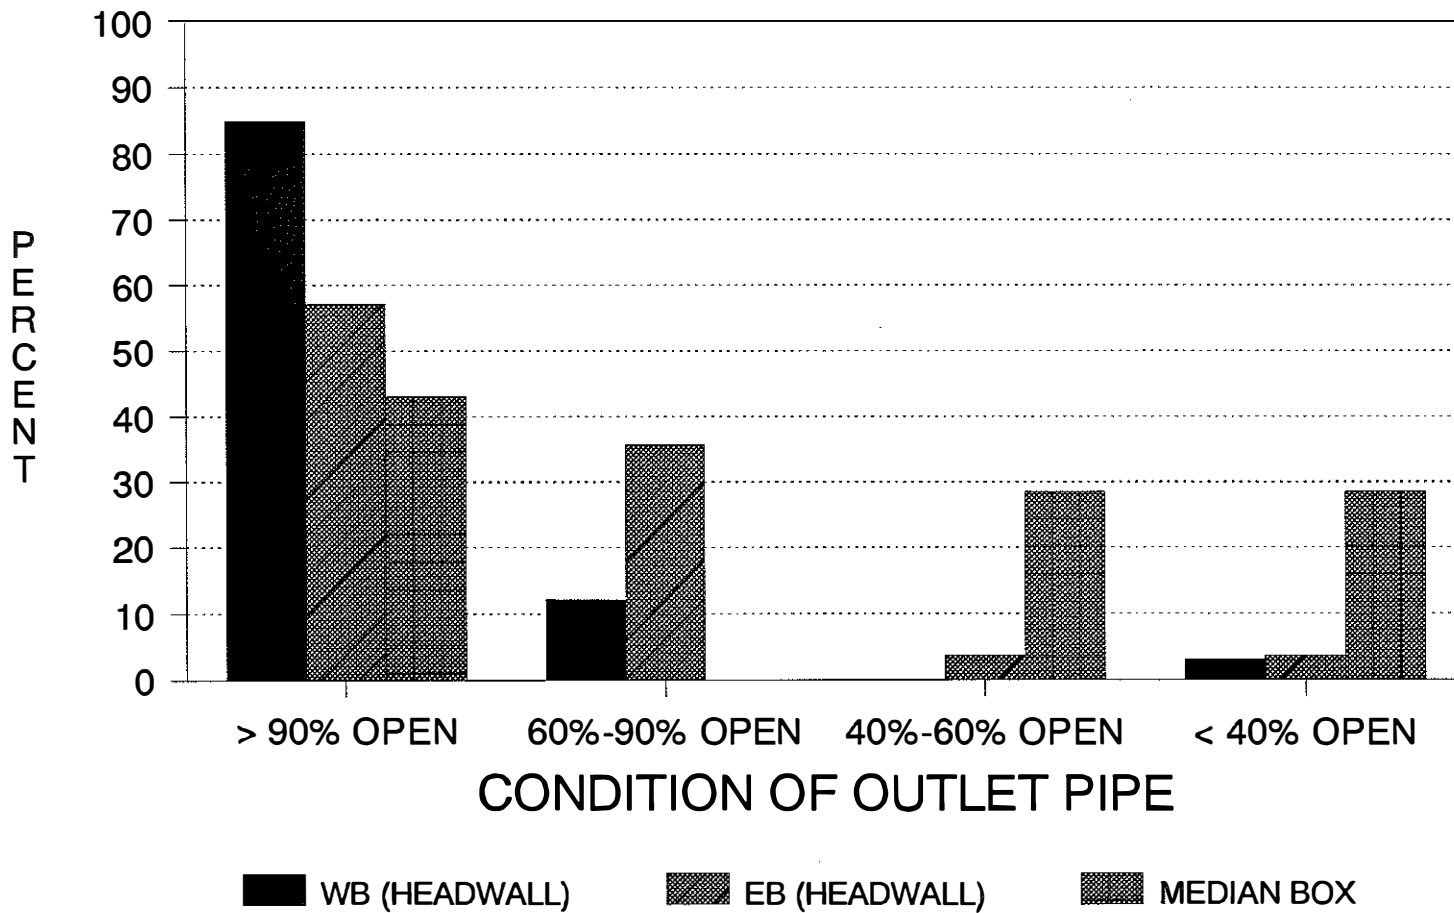
FIGURE 4. OUTLET PIPE FLOW INFORMATION
(I-64, RIGID OUTLET PIPE)

During the inspection, it appeared more distress was occurring in the outlet pipes that were connected to the median boxes than to the headwalls (Figure 4). Approximately 57 percent of the median outlets that were inspected were less than 60 percent open. More distress was observed in the eastbound shoulder headwalls than the westbound shoulder headwalls. A statistical summary and the field data base is contained in Appendix A.

Rodent screens should be placed on all outlets, including median boxes.

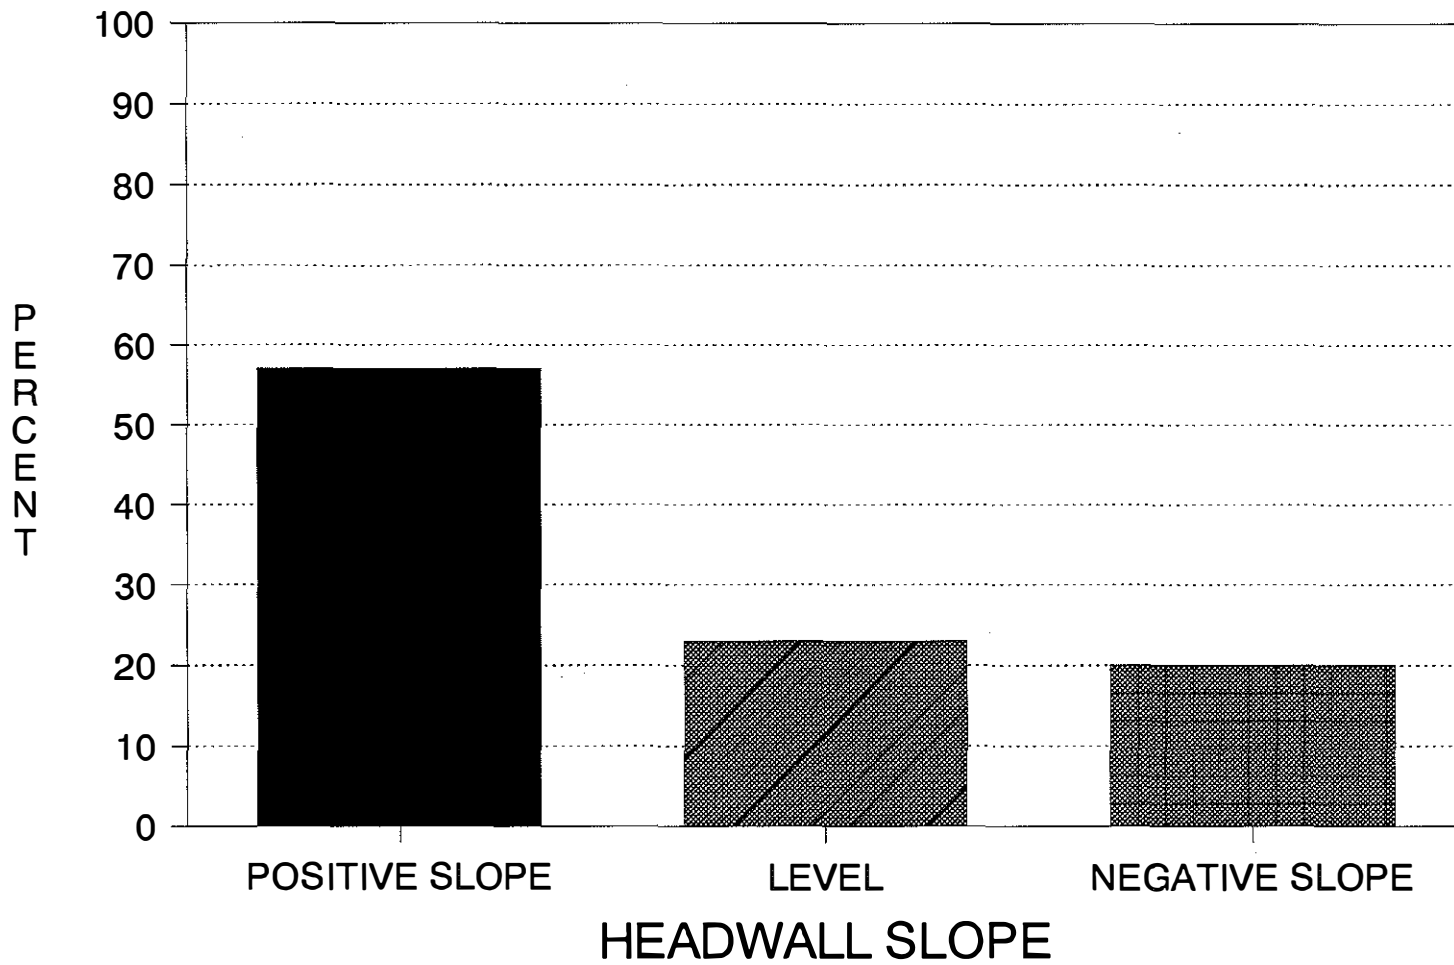
FIGURE 5. HEADWALL SLOPE
(INTERSTATE 64)

Several of the outlet headwalls appeared to be sloped the wrong way. Approximately 148 headwalls were inspected in the westbound direction. The headwalls were inspected between Milepost 74.00 and Milepost 63.0 (shoulder drains only). As shown in Figure 5, approximately 43 percent of the headwalls were not properly sloped. According to the Kentucky Department of Highway Standard Drawing No. RDP-010-04, a 1/2-inch per linear foot of fall should be provided in the headwall to provide positive outlet flow. The headwalls were inspected with

a hand level. Approximately 57 percent of the outlets had a positive slope, 23 percent were level, and 20 percent had a negative slope.

Headwalls should be inspected before they are accepted. Headwalls should be constructed so that the outlet pipe is free of concrete. The patching material in the hoisting dowel hole in the

trough of the headwall should be no higher than the height of the trough.
