Research Report  
KTC-91-17

FIELD PERFORMANCE REPORT  
ON CORRUGATED  
POLYETHYLENE PIPE

November 1991

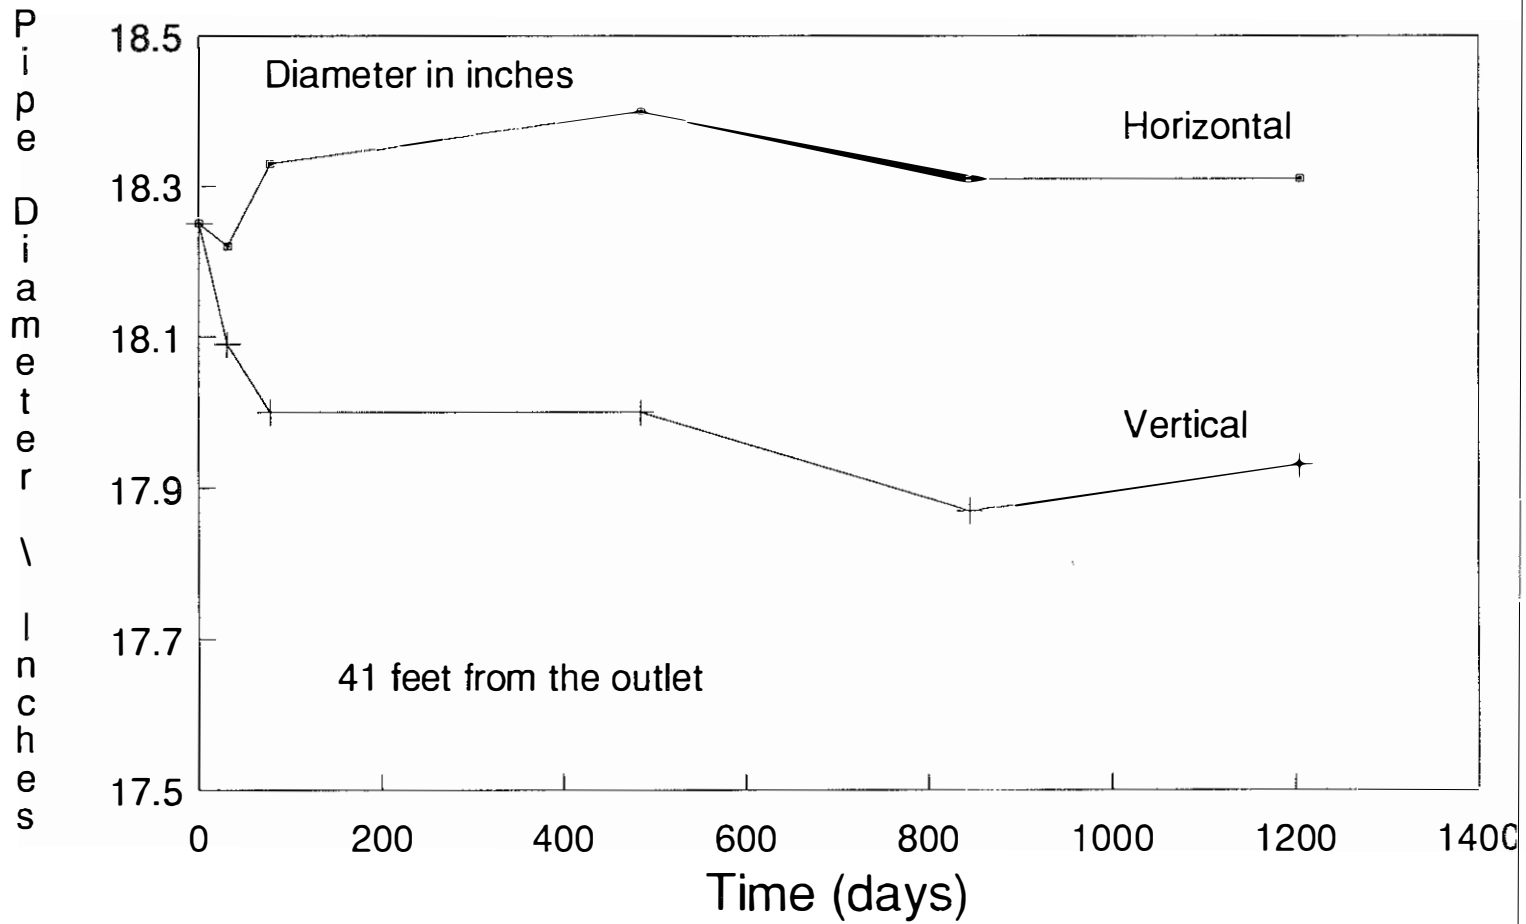
# Figure 1. 18-Inch CPEP

Two sets of monitoring points were placed in the 18-inch pipe at Station 137+88 prior to installation. The monitoring points were placed at 41 feet and 61 feet from the outlet. The points were monitored three times during 1988, once in 1989, once in 1990 and on October 3, 1991. Since installation, the interior of the pipe at 41 feet had deflected approximately 0.32 inch (Figure 1), and approximately 0.22 inch at 61 feet (Figure 2). The fill height above the 61-foot monitoring point was 6 feet, and the fill height at the 41-foot monitoring point was 8 feet. During the inspection of the cross drain on October 3, 1991, noticeable deflection appeared to be occurring at the upgradient end of the pipe. After further inspection, it was found that the pipe had deflected 18-percent in the vertical direction and 12.7 percent in the horizontal plane. This compressed area is occurring approximately 55-inches from the junction box. This is occurring under the right wheel path of the overlaying road. The pipe is covered by approximately 28-inches of fill. No surface distress was noticeable. No distress had been noticed until this date. Overall, approximately 3 percent of the total amount of 18-inch pipe that was installed had deflected over 10 percent. Table 2 is a summary of deflections at this

KY 54, Daviess County, Station 137+88

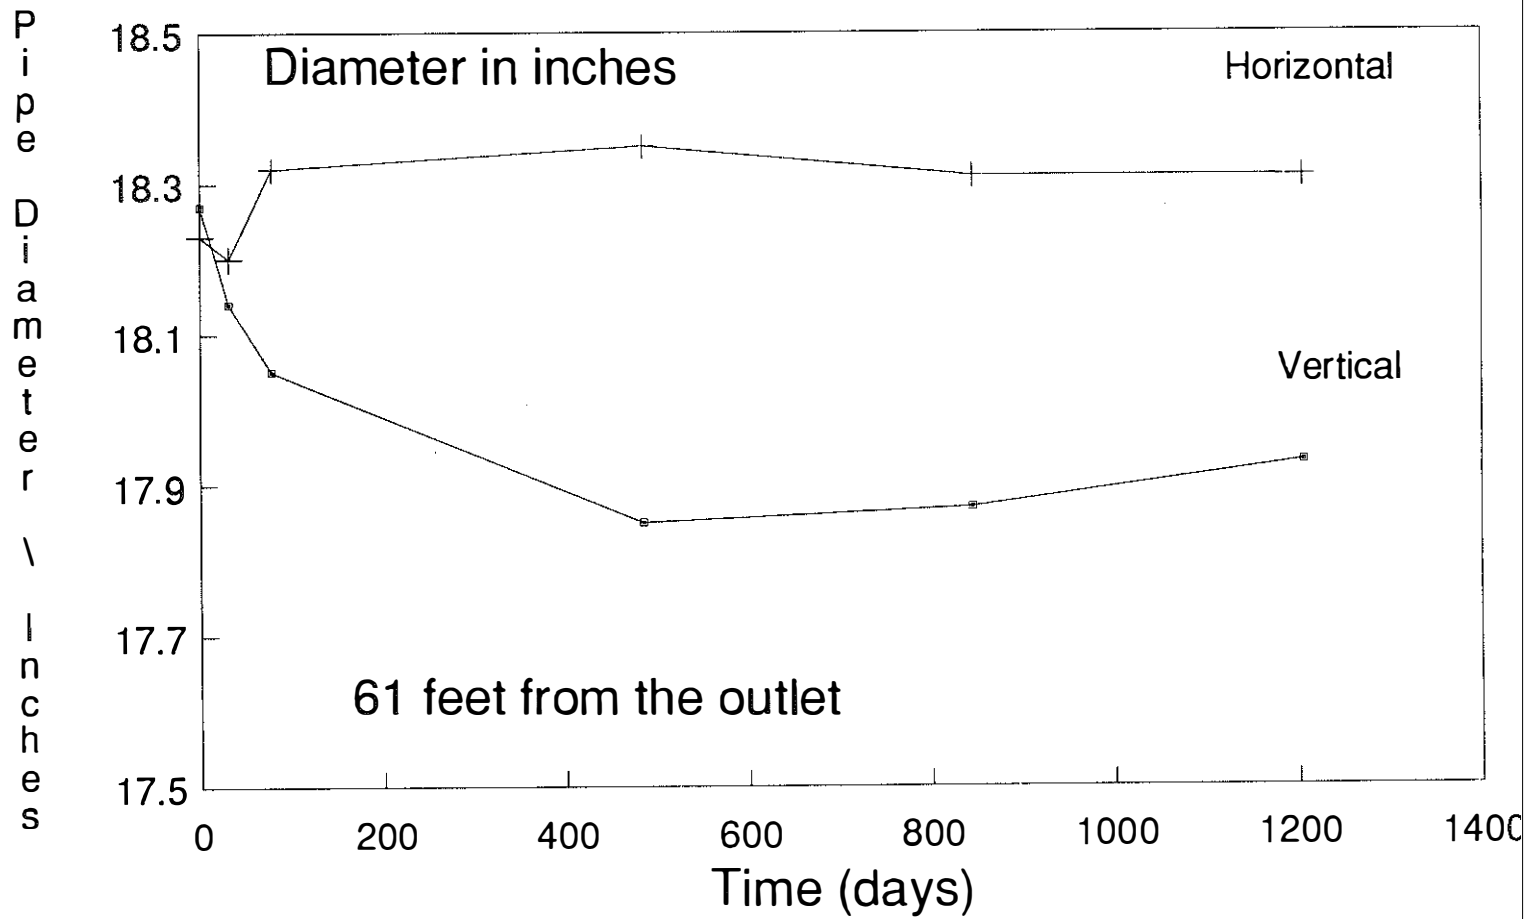
# Figure 2. 18-Inch CPEP

KY 54, Daviess County, Station 137+88

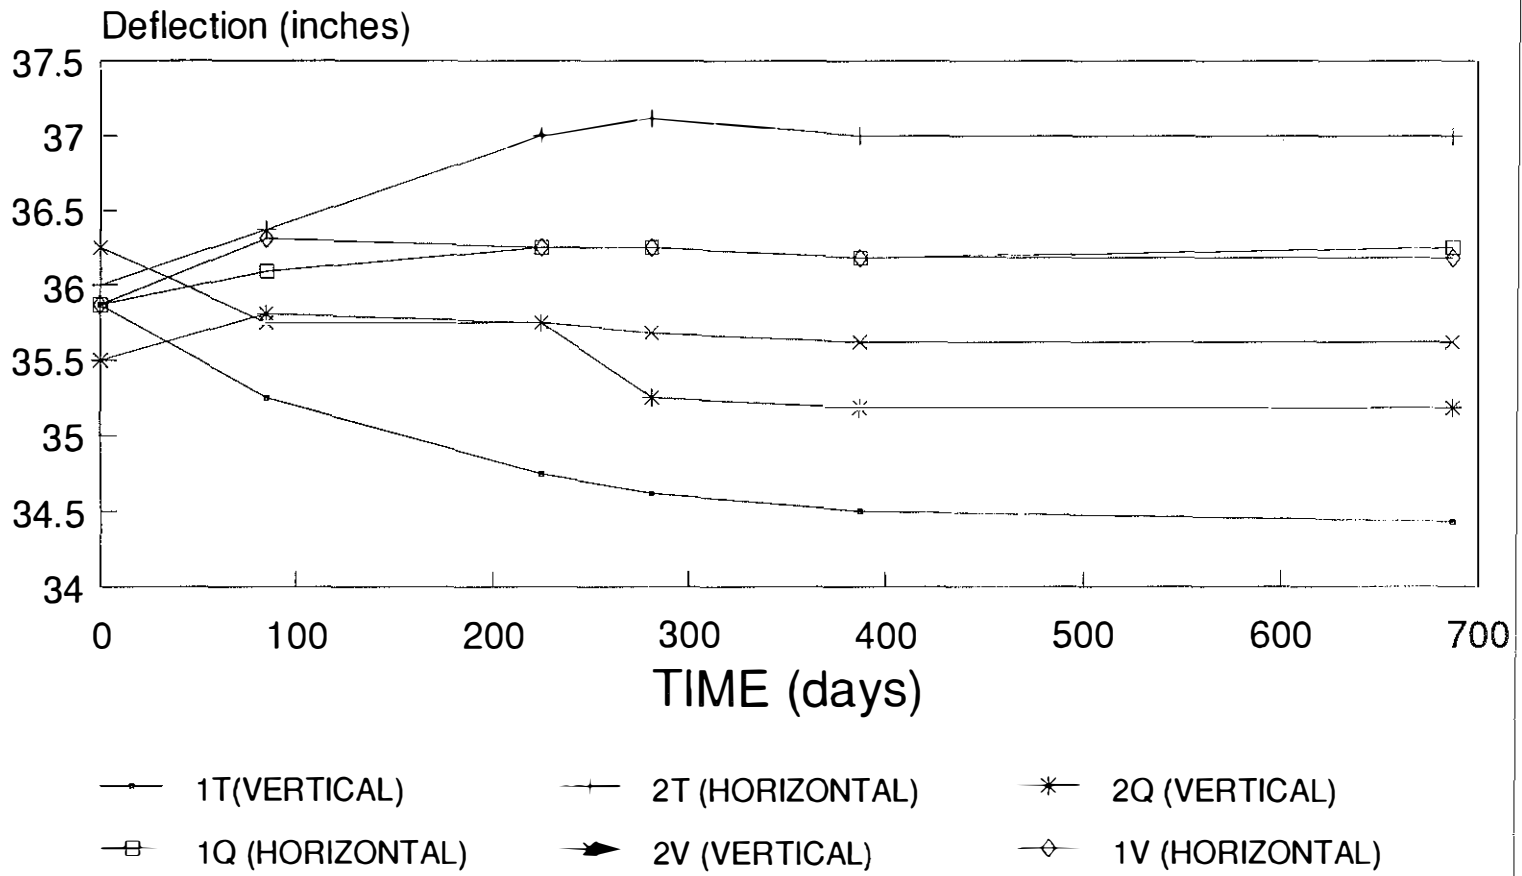
# Figure 3. 36-Inch CPEP

## US 68/KY 80, Bowling Green (Storm Drain)

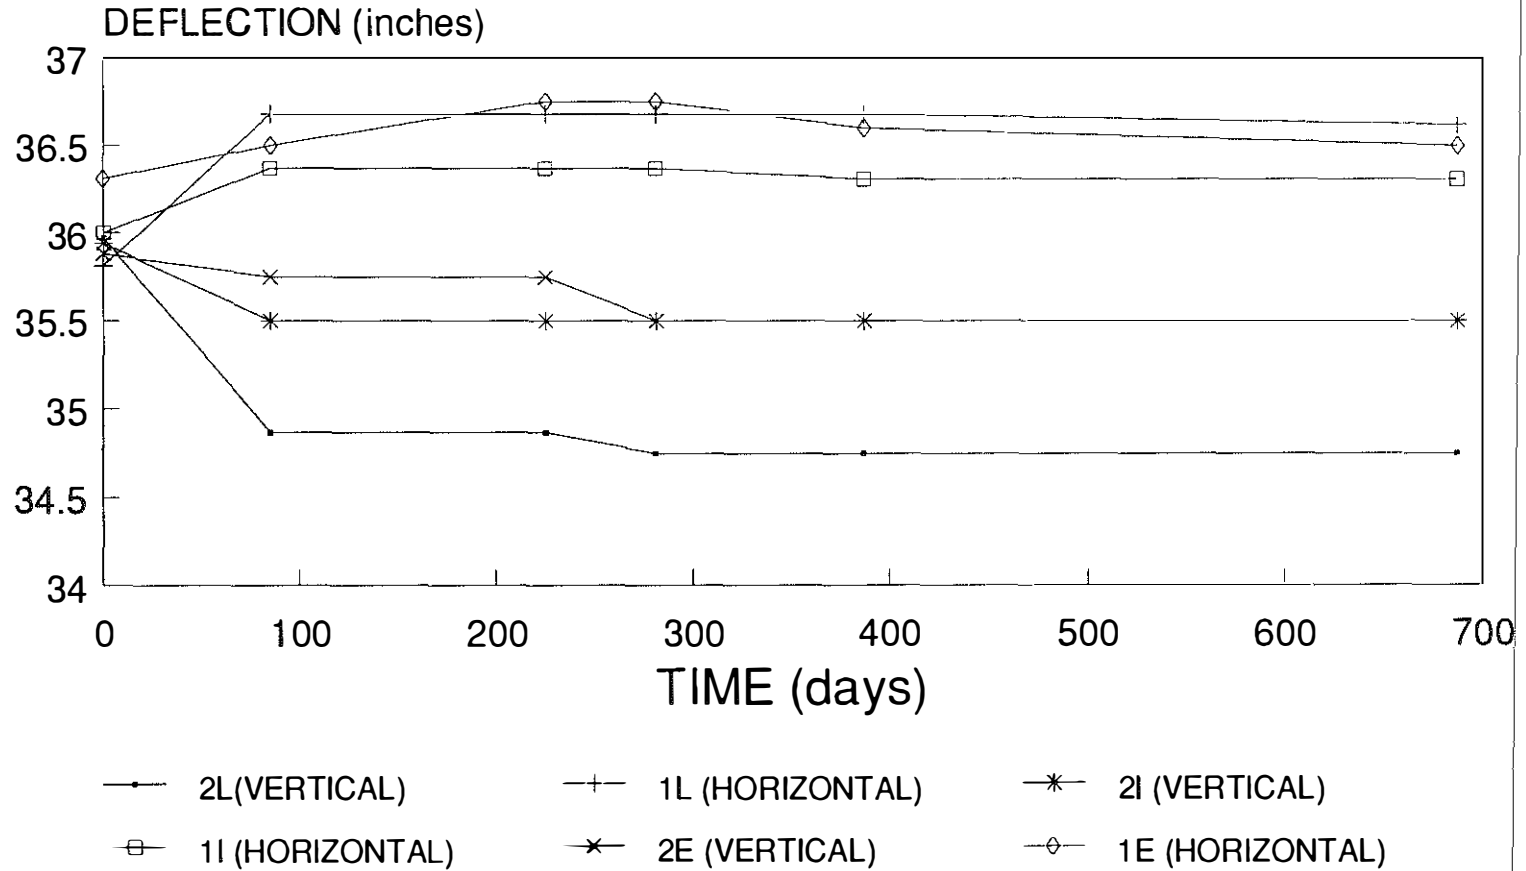
# Figure 4. 36-Inch CPEP

US 68/KY 80, Bowling Green (Cross Drain)

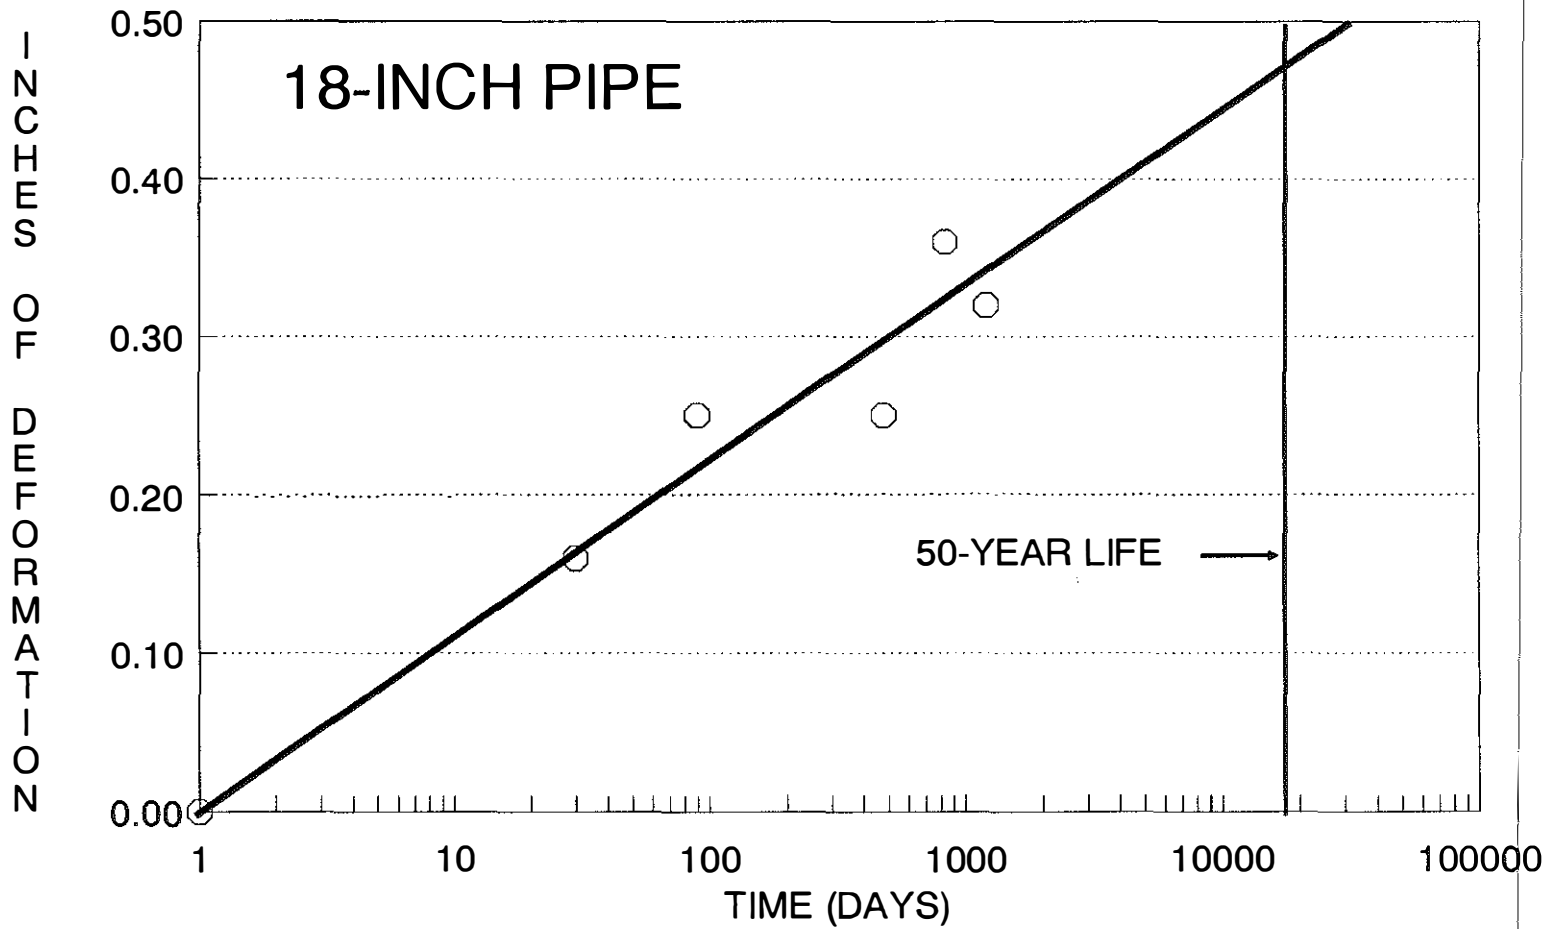
FIGURE 5. KY 54, DAVIESS COUNTY  
STATION 137+88, 41 FEET FROM OUTLET

The vertical deflections from Figures 1 and 2, and the largest vertical deflections from Figures 3 and 4 (locations 1T and 2L, respectively) are plotted semi-logarithmically in Figures 5 through 8. A straight line has been constructed through the data to estimate magnitude of deflections in 50 years. It appears this may overestimate the deflection somewhat because the deflection appears to have ceased in two of the cases. However, assuming the deflections will continue in a semi-logarithmic fashion, the two pipes in Daviess County will not reach five percent strain in 50 years, and the two pipes in Warren County will deflect approximately six percent in 50 years. Again, it should be emphasized this is probably a slight overestimate. In general, it appears long-term deflections probably will not be a problem (assuming proper backfill material and construction procedures).
