Research Report
UKTRP-87-9

EVALUATION OF DRAINAGE ON NICHOLASVILLE BYPASS

EVALUATION OF DRAINAGE ON
NICHOLASVILLE BYPASS (US 27)

KENTUCKY HIGHWAY INVESTIGATIVE TASK NO. 5

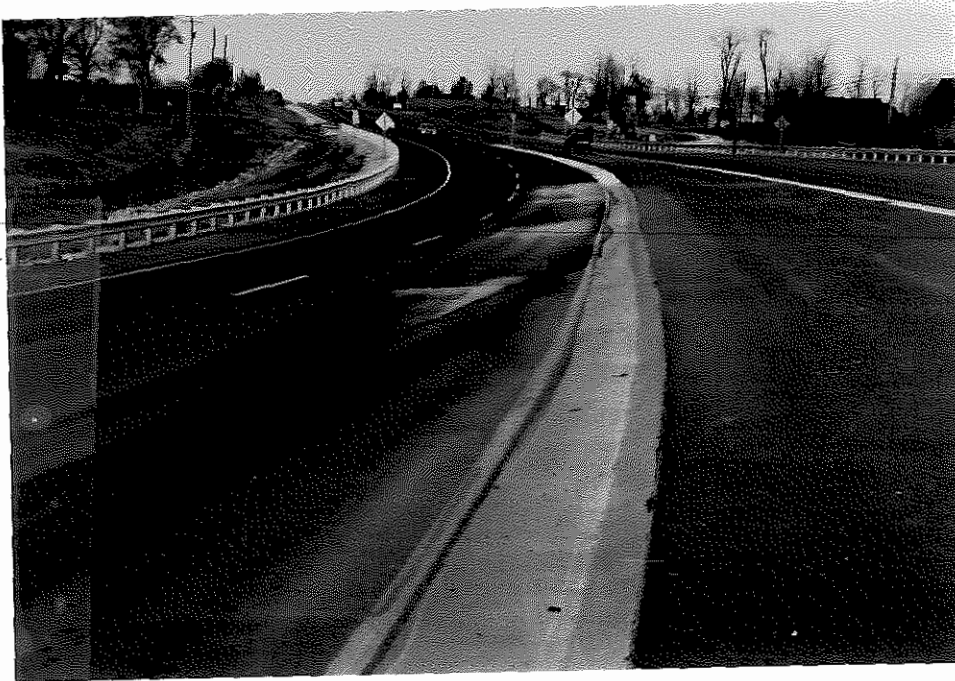
Construction of the Nicholasville Bypass (US 27) was completed in 1986. At the north end of the bypass is a raised, paved traffic median (Figures 1 and 2). The median was constructed with a lip curb and gutter. The roadway at that location is in a superelevated section. A raised, paved traffic median also is located at the southern end of the bypass. Figures 3 through 5 are photographs of that median. The median is located on a tangent section therefore, the roadway has a normal crown. The section of roadway at the southern end is located on a slight grade. The south median also is constructed with a lip and curb gutter.

Figure 1. Median, Northern End, US 27.

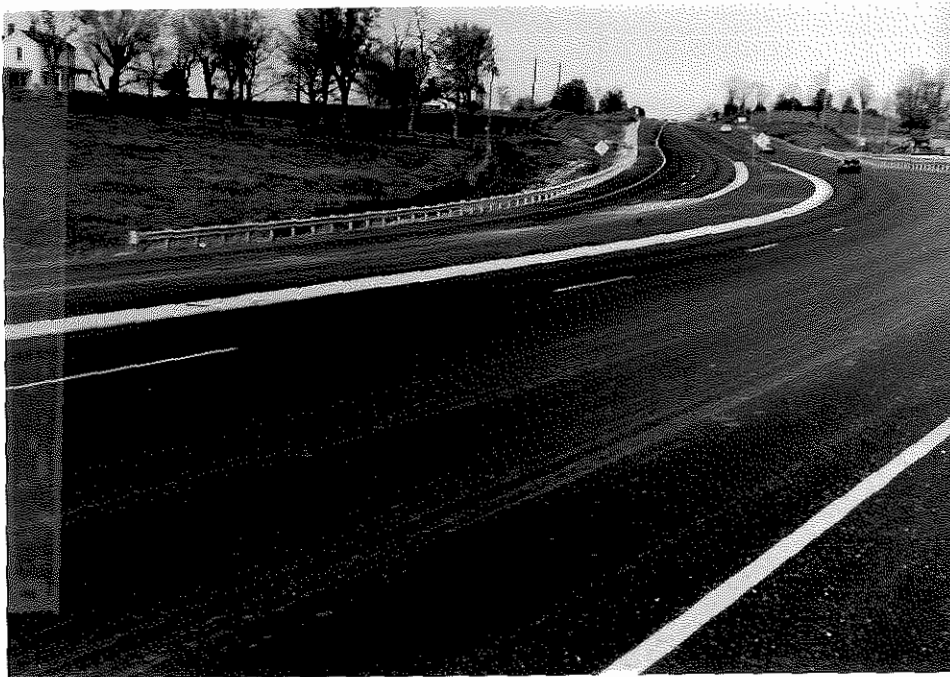
Figure 2. Overall View of Northern End of Project.

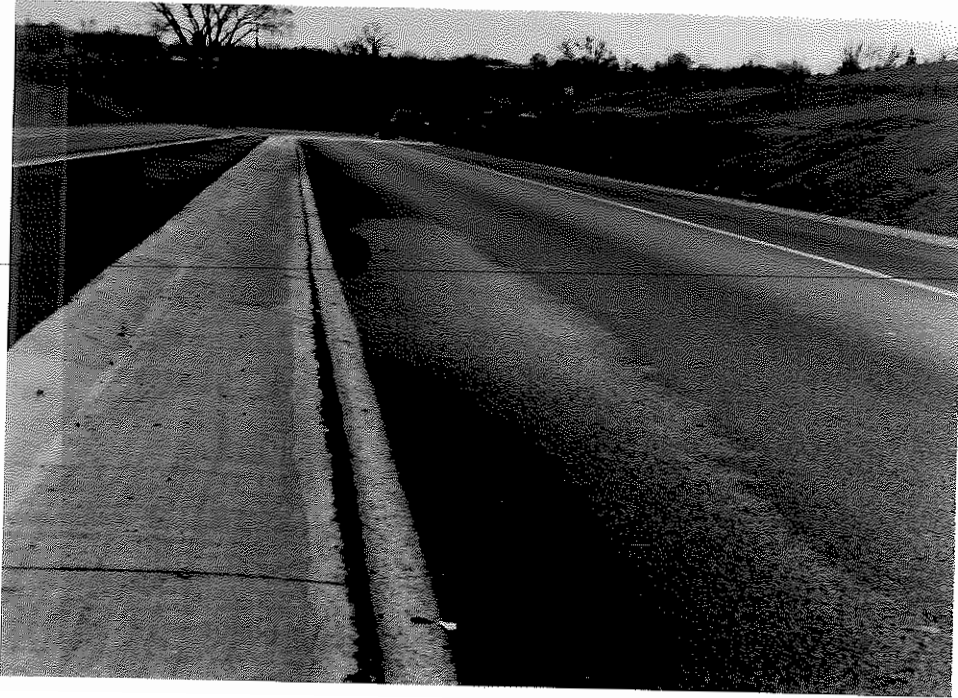
Most of the water at the southern median was emerging at the construction joint between the concrete gutter and the asphalt pavement. The only location where this was occurring was at the southern nose of the median (Figures 12 and 13). There appeared to be a considerable head, since water was flowing freely across the pavement. Additionally, a small amount of water appeared to be emerging from the pavement surface approximately 20 feet upgrade from the end of the median. That water may be seen in Figures 3 and 4.

Figure 3. Raised Median, Southern End.

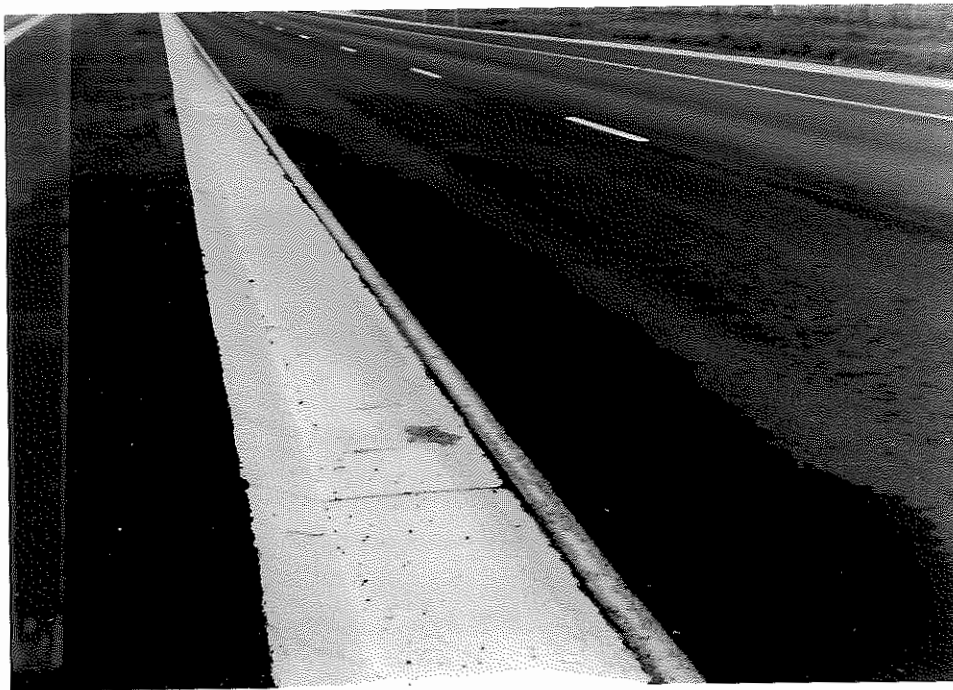
Figure 4. Overall View of Raised Median, Southern End.

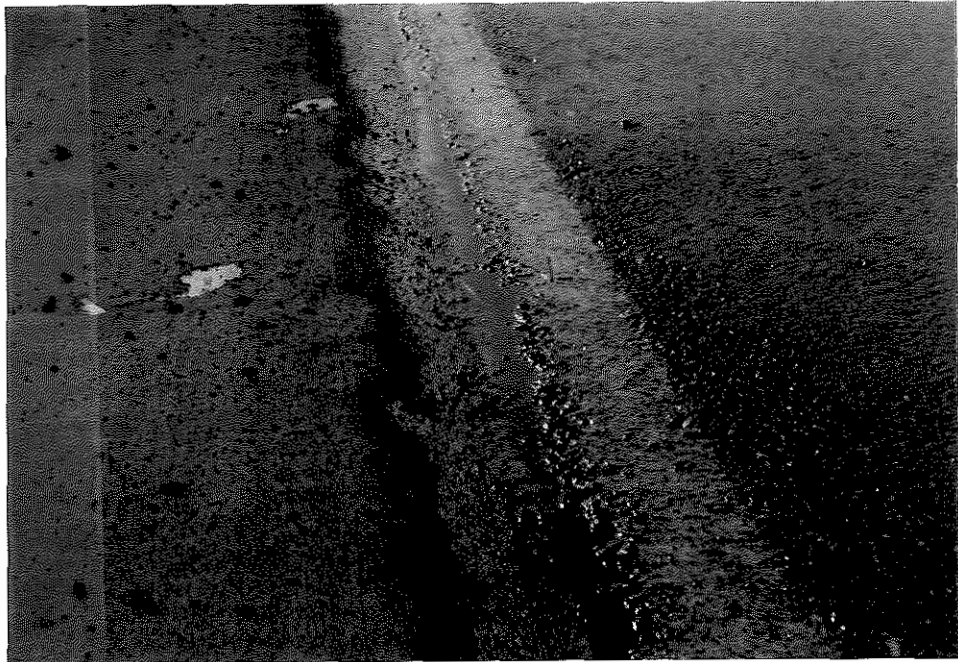
At the north-end median, water was emerging at the interface between the concrete gutter and the asphalt pavement (see Figures 6 through 8) on the west side of the median (lower side of the superelevation). Also, water was emerging through the pavement surface as shown in Figure 9.

It is difficult to determine the exact source of the water. Because of the geometrics of this site, it does not appear that groundwater is a source. The northbound lanes on the high side of the superelevation are on a fairly high fill and there are no hills in the immediate area that could provide sufficient head to force the water up into the embankment. Therefore, it appears the source is surface water that has fallen on the shoulder and driving surface of the northbound lanes. Subsequently, this water has penetrated part or all of the asphalt bound layers of the northbound lanes and is moving laterally toward the low side of the superelevation. The

Figure 6. Close-up of Water Emerging, Northern End.

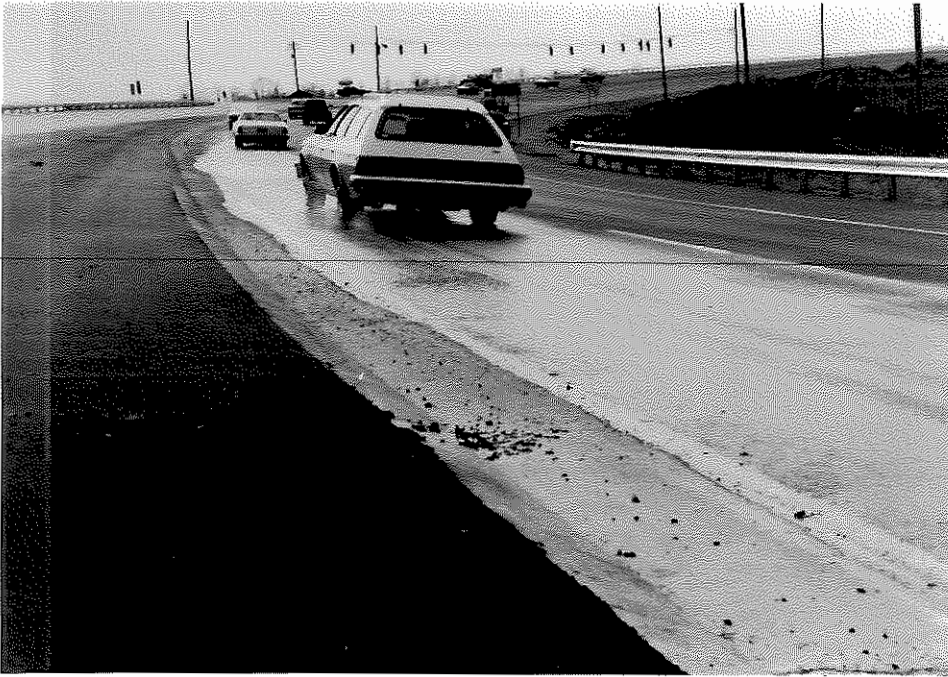
Figure 7. Water Emerging from Gutter Flows onto Pavement.

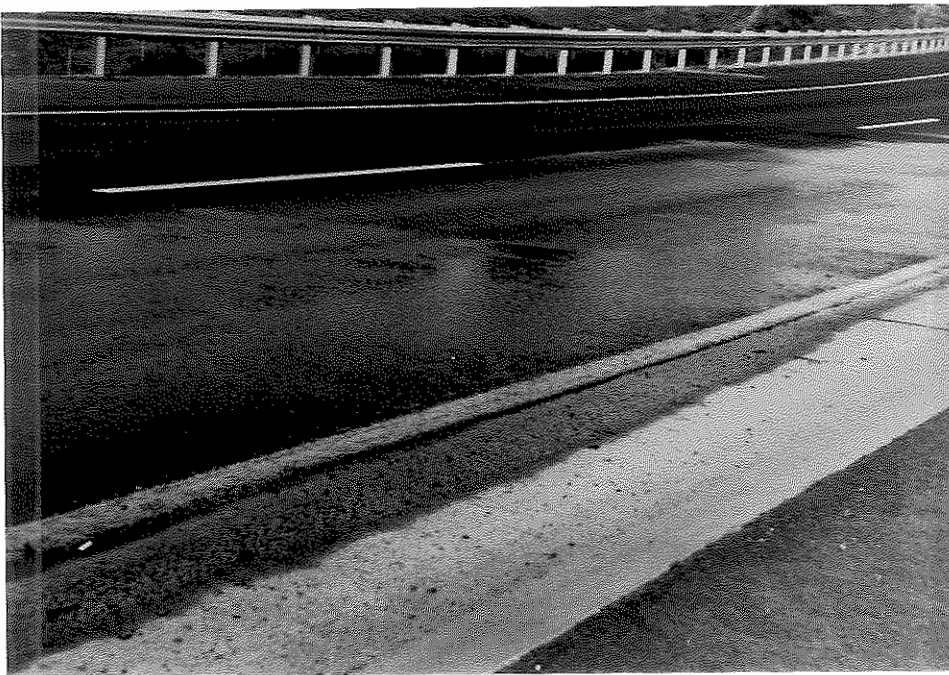
Figure 8. Pavement is Wet due to Water from Gutter.

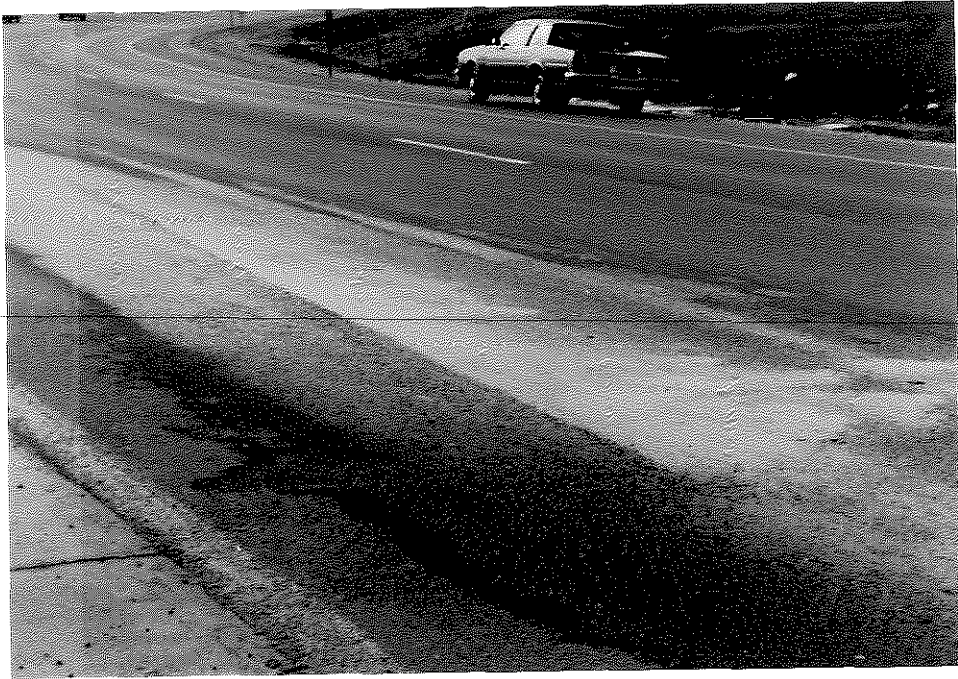
Figure 9. Water Emerged through Pavement Surface.

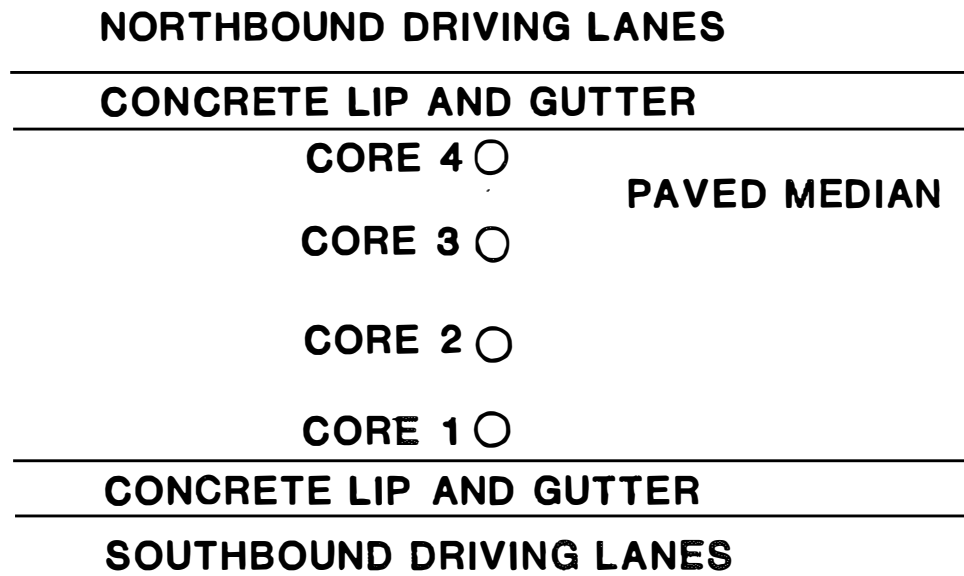
The median was cored in November 1986 in a pattern similar to that shown in Figure 10. From information gained from drilling, it appeared that water was moving from the high side of the median to the lower side. The dashed line in Figure 11 indicates what appeared to be the general configuration of the phreatic surface in the median. The concrete lip and gutter section appeared to be damming the water. Consequently, water was flowing under the concrete gutter and was being forced upward at the joint between the pavement and the gutter, as indicated in Figure 11. In addition, some of the water was bypassing the joint and was being forced up through the pavement surface.

Figure 10. Coring Pattern, Northern End.

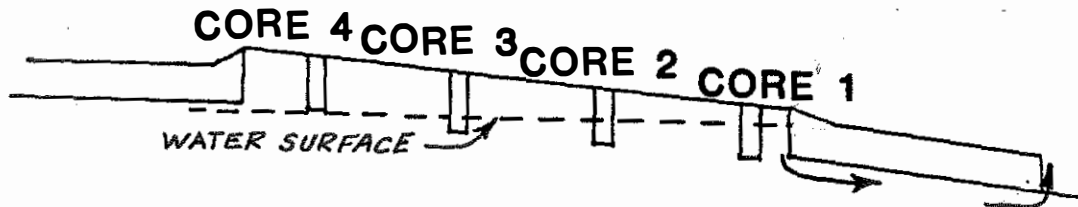
Figure 11. Phreatic Surface in Median, Northern End.

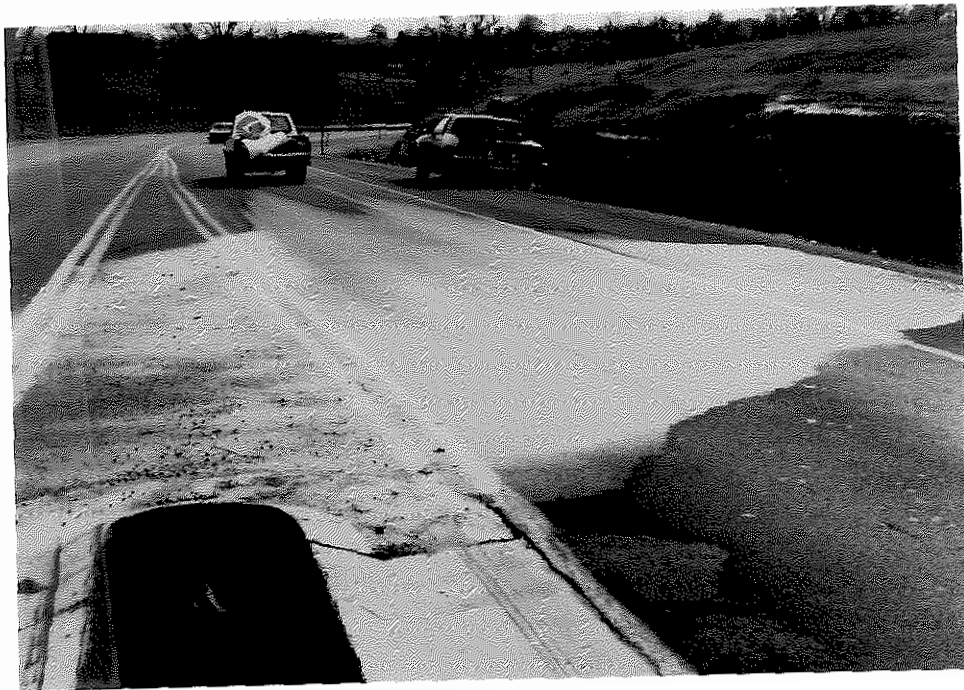
It appears there are two sources of water at the south end. Some surface water is almost certain to be penetrating the asphalt layers of the pavement and median. However, the rate of flow and the extent of time of flow after rain indicate ground water is probably an additional source of water. The geometrics are also ideal at this site to suspect ground water. The long grade would certainly provide sufficient hydraulic head to force water out through the pavement and construction joints.

Figure 12. Water Emerging at Joint between Pavement and Gutter.

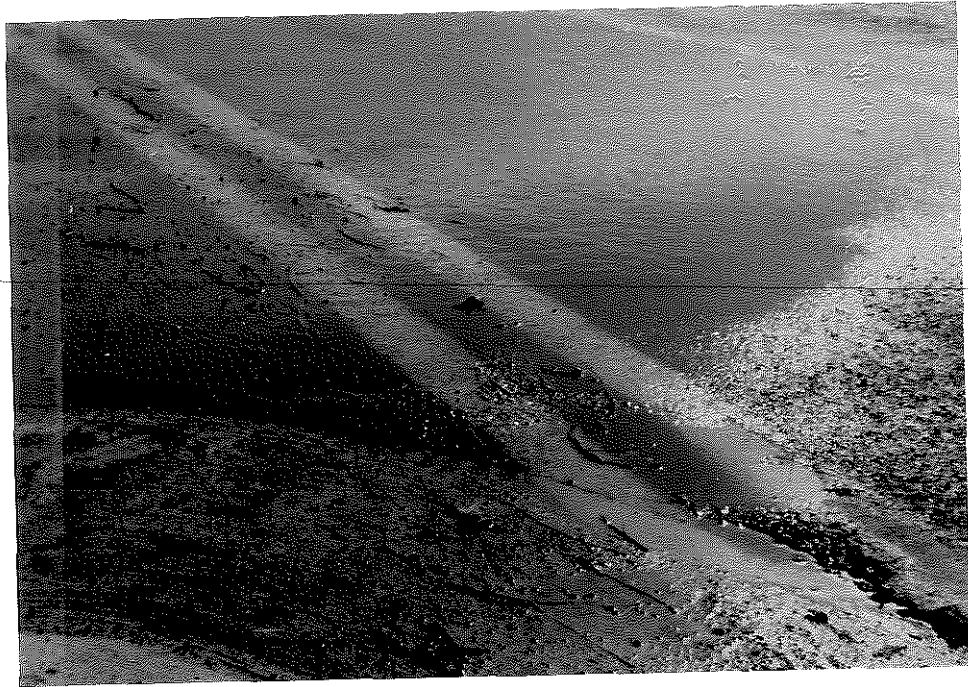
Figure 13. Water from Joint between Pavement and Gutter Wets Pavement.

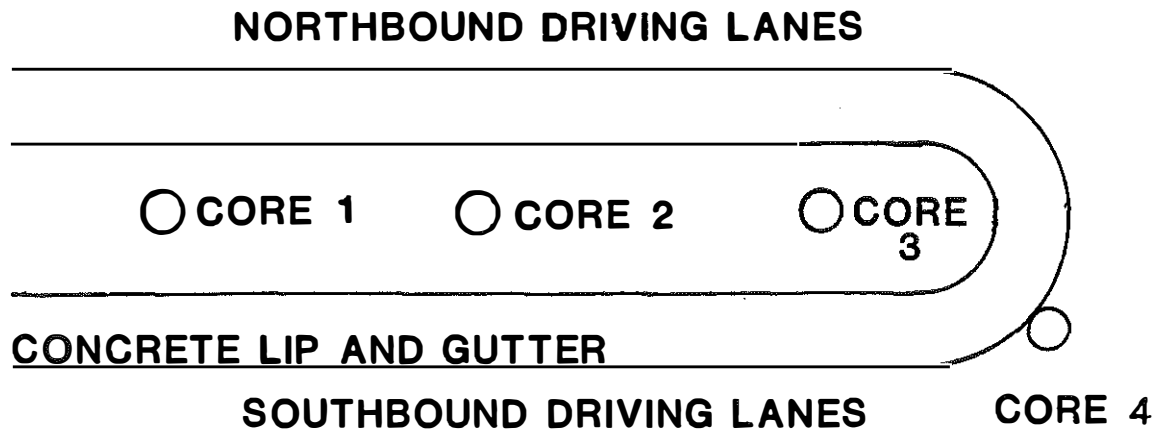
Cores were obtained from each median on the same date. Figure 14 shows the general pattern of coring. A high phreatic surface under the median appears to be the cause of the drainage problem. From the elevations of the water in the core holes, a generalized phreatic surface has been sketched in Figure 15.

Figure 14. Coring Pattern, Southern End.

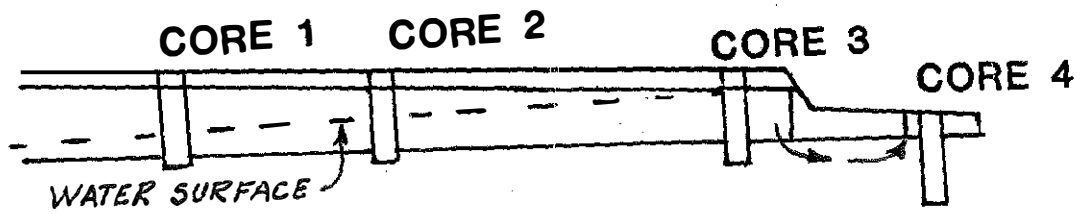
Figure 15. Phreatic Surface, Median, Southern End.
