COMMONWEALTH OF KENTUCKY  
DEPARTMENT OF HIGHWAYS  
FRANKFORT

SUBJECT: Base Stabilization  
Bryantsville - Beuna Vista Road  
Garrard County, RS 40-326

BASE STABILIZATION  
BRYANTSVILLE-BEUNA VISTA ROAD  
GARRARD COUNTY, RS 40-326

Highway Materials Research Laboratory  
Lexington, Kentucky  
February, 1962

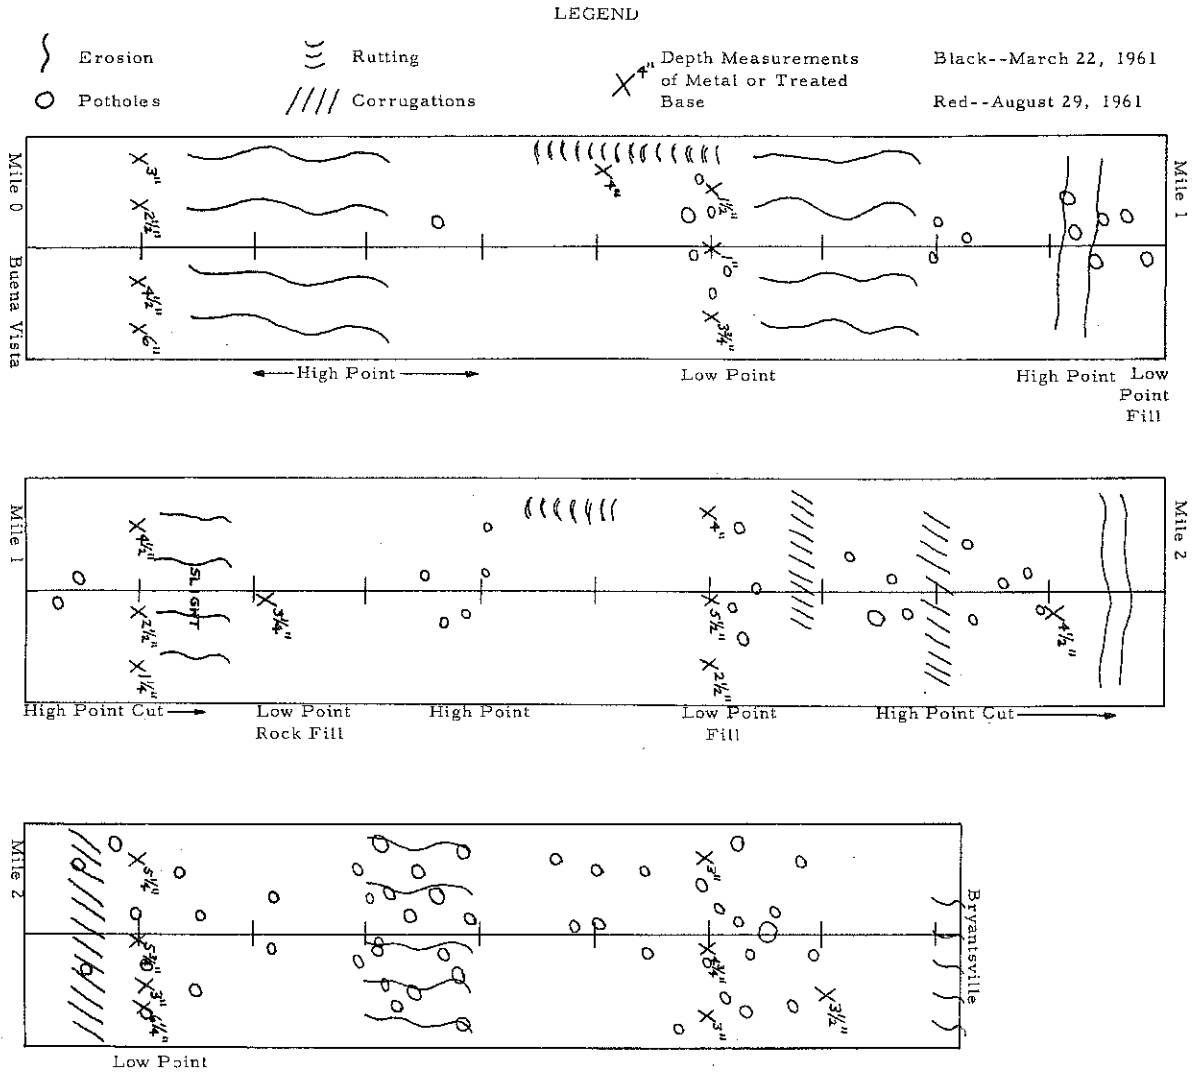
On March 22, 1961, a condition survey (see Fig. 2) was made of the existing roadway. Samples were also taken of the traffic-bound material as well as from the subgrade. A summary of the laboratory test data is given in Table 1.

Fig. 2. Condition Surveys.

On August 29, 1961, a second condition survey was made (see Fig. 2). This survey was approximately five months after stabilizing and shortly before surfacing. The general condition of the base at this time appeared to be rather good. The indications of distress (pot-holes in particular) were those that might be expected in a fairly stable base. There were also several areas where the rapid runoff of surface water had eroded some fines from the surface of the base. The average thickness of compacted base was noted to be about 3-3/4 inches with sufficient amount of loose stone on the shoulders to account for about 1/2 inch of thickness.

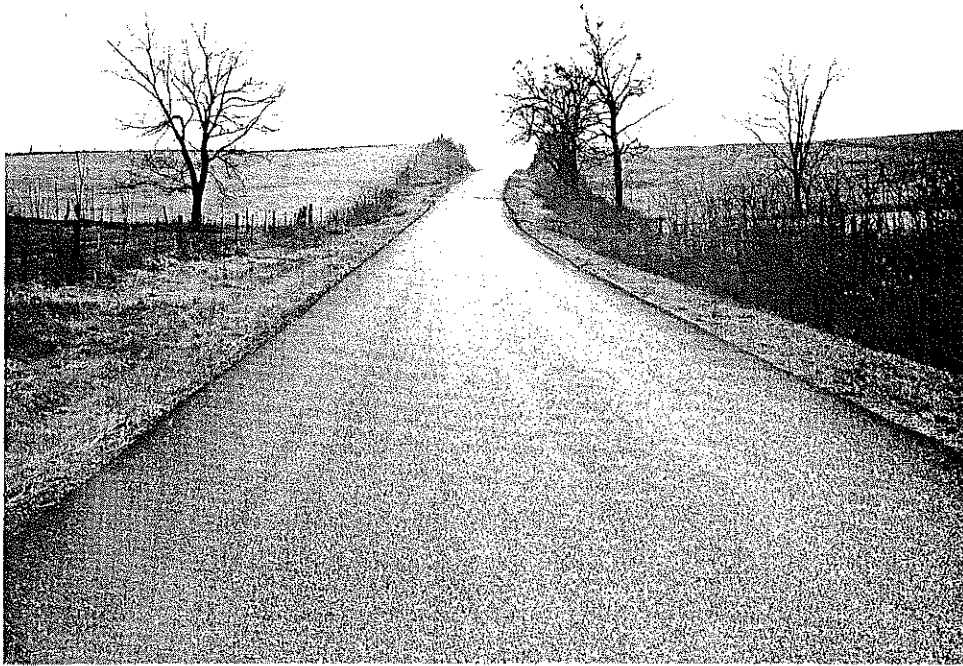
A visual inspection was made of the project on February 13, 1962. The general condition of the project was excellent (see Fig. 3). There were, however, some areas of rutting and base failures in the outside wheel track of the southbound lane (see Fig. 4) over a distance of approximately 0.3 mile near Beuna Vista. These areas of distress coincide with areas of rutting and weakness noted in the previous surveys. Some of this edge distress might also be attributed to the placement of a wider pavement than originally existed and thus the edges have less support in many places. There also appeared to be some water trapped in the pavement system between the surface and base.

Fig. 3. Photograph Showing the Generally Excellent Condition of the Surface over the Entire Project. In the background are indications of some slight rutting in the right hand outside wheel track.

Due to the fact that the C-1 binder-type surface was placed without a seal coat, I believe that it would be advisable to seal this pavement this year. The binder mix is relatively open and is subject to rapid raveling even when placed over a stable base course.

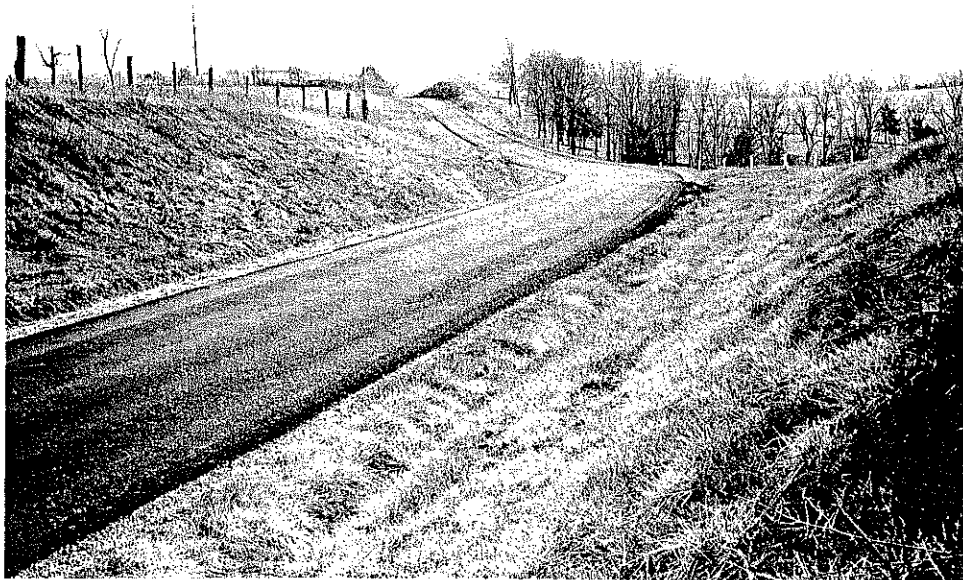
Fig. 4. Photograph Showing Area of Distress in Outside Wheel Track.
