Highway Materials Research Laboratory
132 Graham Avenue, Lexington, 29, Ky.

Re: Study of Acid Water Conditions in Kentucky

Re: Erosion of Longitudinal 40" Corrugated
Metal Pipe, 1-1/2 Miles Northeast of
Princess, Kentucky, on U. S. 60

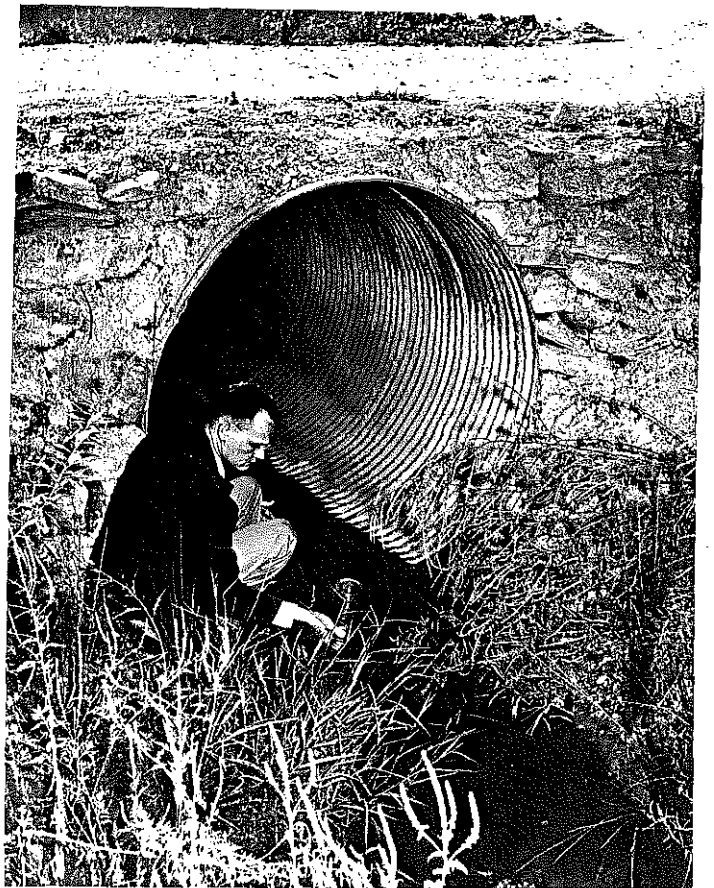
No. 2. General view of Culvert on south side of road showing Mr. Havens obtaining sample of the water. Culverts on this side show only slight corrosion and water still flows through them normally.
