COMMONWEALTH OF KENTUCKY  
DEPARTMENT OF HIGHWAYS  
FRANKFORT

A SURVEY INSPECTION OF PLAIN CORRUGATED METAL PIPE  
ARCHES AND MULTI-PLATE METAL PIPE ARCHES IN KENTUCKY

Eugene M. West  
Research Engineer

March, 1957

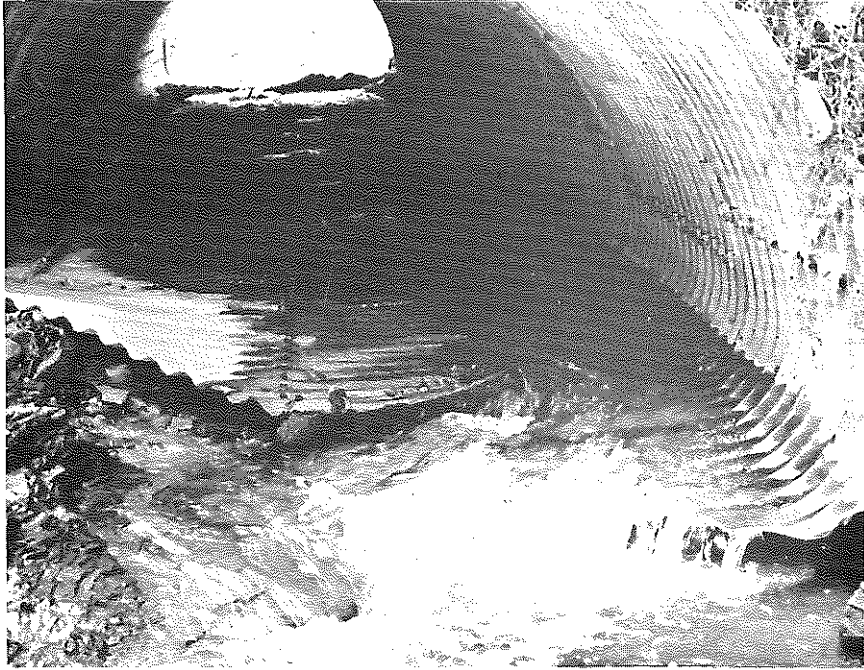
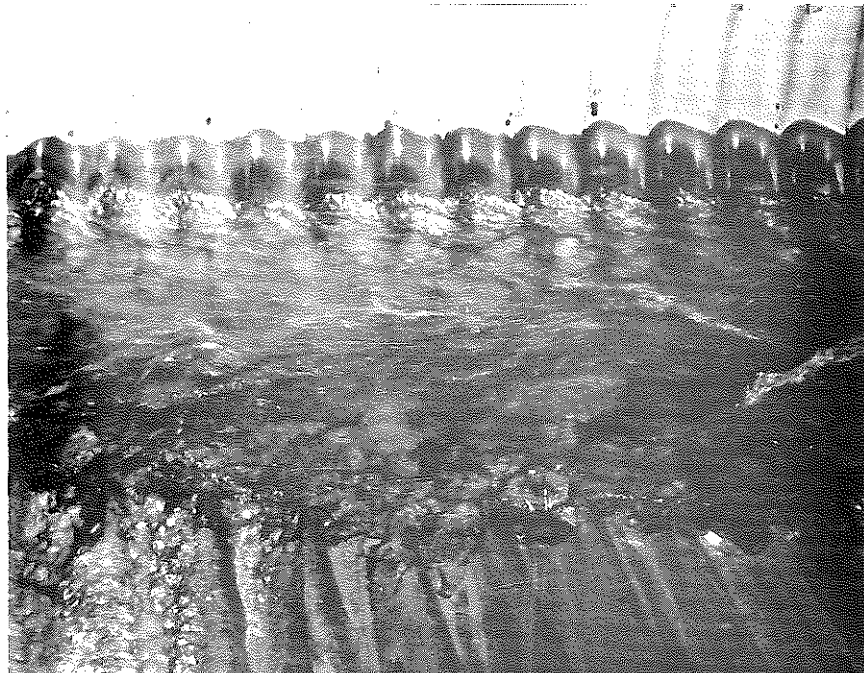
On the Harveyton-Stacey Road (Ky. 267) in Perry County, three un-paved structures were found to have their inverts completely cut by rusting for the entire length of the culvert. One of these, a 159 by 96 in. pipe arch, 70 ft. long, had an unusually wide strip of metal from the invert missing, as shown in Fig. 2; and the arch itself had been deformed by the consequent loss of strength. Another structure on this road, shown in Fig. 3, had been paved with concrete at some undetermined earlier date, probably because of rusting in the invert. There were some signs of deterioration in the concrete; but these were slight, and the arch itself was not deformed. This structure had been placed -- as had all of those inspected on this road -- in 1949.

**Fig. 2 - Unpaved Pipe Arch on Ky. 267, Showing Effects of Highly Corrosive Water.**

In extreme cases, where the invert is already scaling away or becoming perforated, virtually immediate maintenance will be needed to preserve the structure. Such structures were found, in this study, on three roads; and it may be assumed that there are more. Unless attention is given to these very soon, either extreme maintenance or replacement may become necessary.

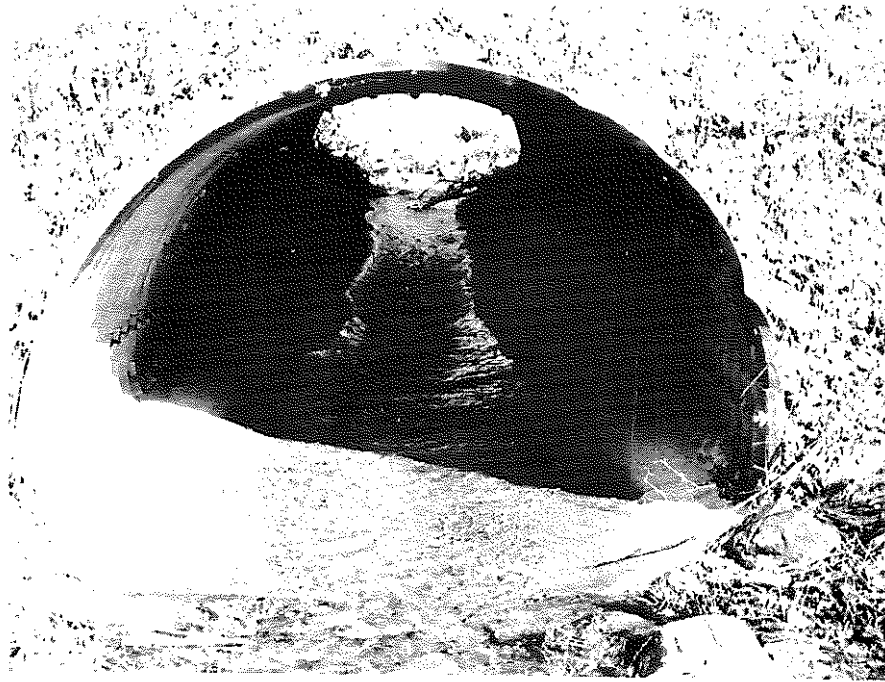
In many cases an effective bituminous coating or something similar should correct the condition. On the other hand, a few arches have corroded so extensively they are becoming structurally unsound. Those may require complete concrete paving, such as that applied to an arch on Ky. 267 in Perry County, as illustrated in Fig. 3 of the report.

**Fig. 3 - Pipe Arch on Ky. 267, Paved with Concrete  
in Invert.**
