SURVEY AND VISUAL INSPECTION OF KEYSTONE BLOCK WALL
AND EMBANKMENT SLIDE AT MIST LAKE PLAZA
IN LEXINGTON, KENTUCKY

Research Report KTC-98-6

March 1998

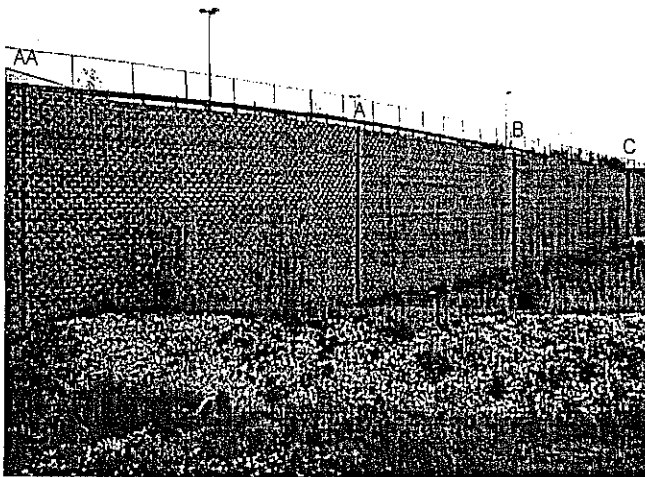
Figure 1

Vertical lines of monitoring points had been installed in five locations. The approximate locations are shown in Figures 1 and 2.

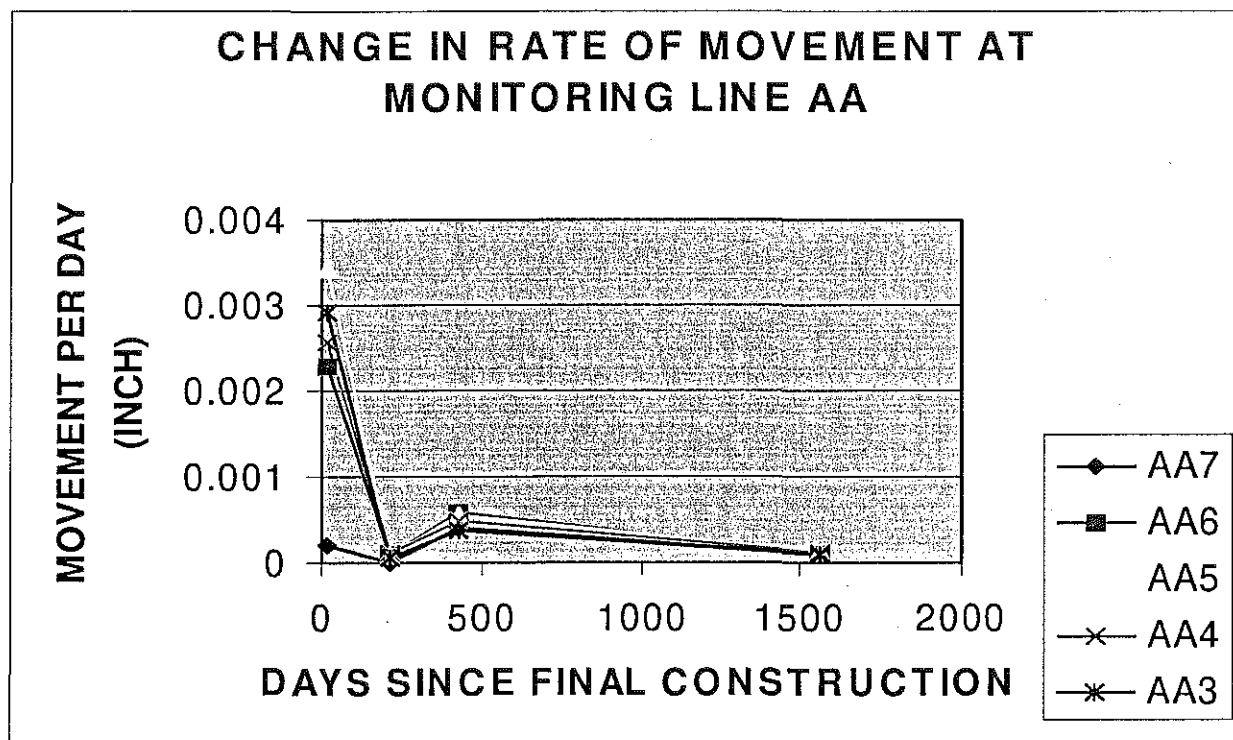
Readings taken by Black Engineering (Appendix A) indicate that the lower portion of the wall at Station A and Station B has moved forward 8 to 9 inches. It is apparent that a considerable amount of this movement had occurred during and shortly after construction. Approximately 1 to 2 inches of additional forward movement occurred between August 1994 and September 1997. To evaluate the rate of movement, data were analyzed back to May 22, 1993 when the wall was completed. The difference between readings has been plotted in Figures 3 through Figure 7. The Figures indicate that the rate of movement appears to have decreased significantly.

Figure 3. Monitoring Line AA

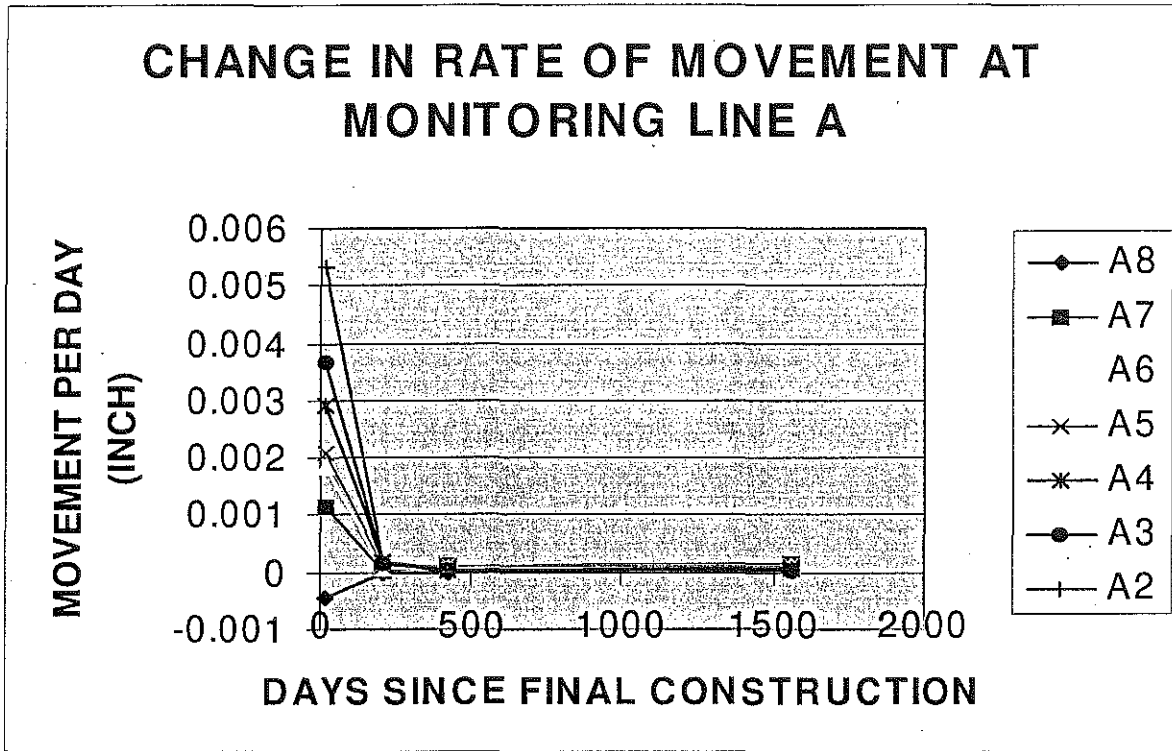
Figure 4. Monitoring Line A

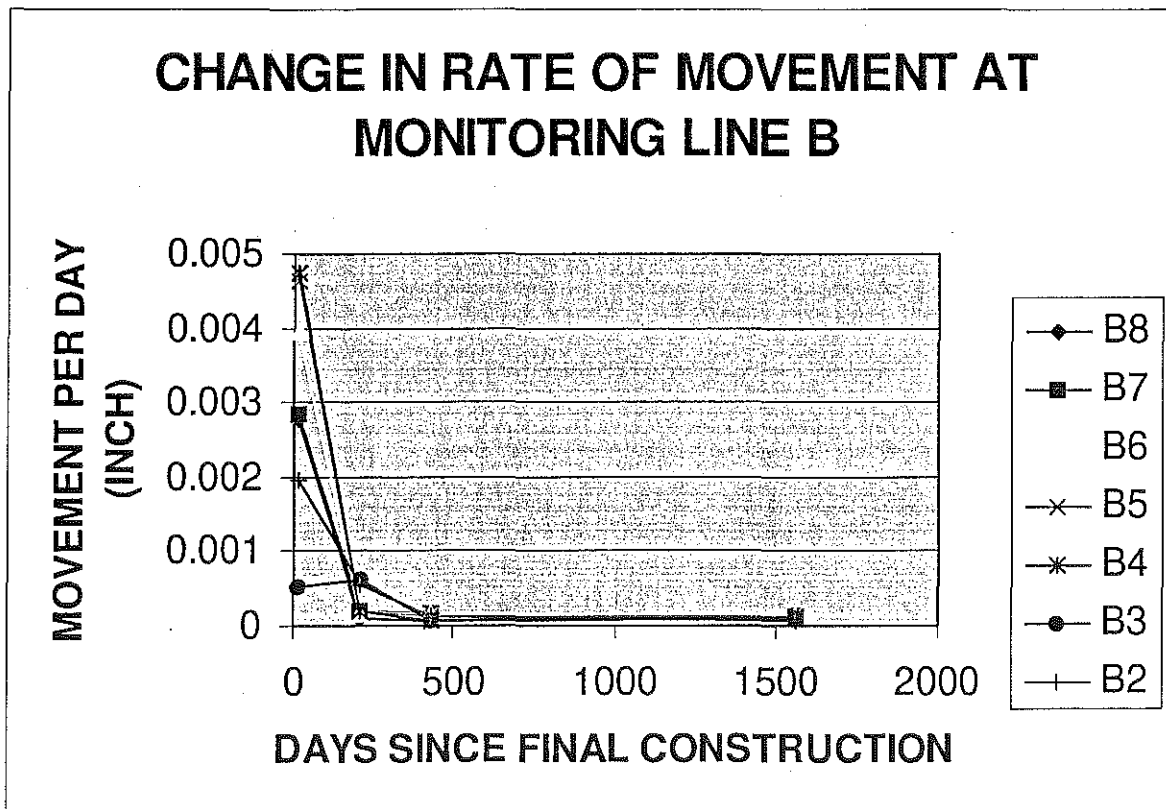
Figure 5. Monitoring Line B

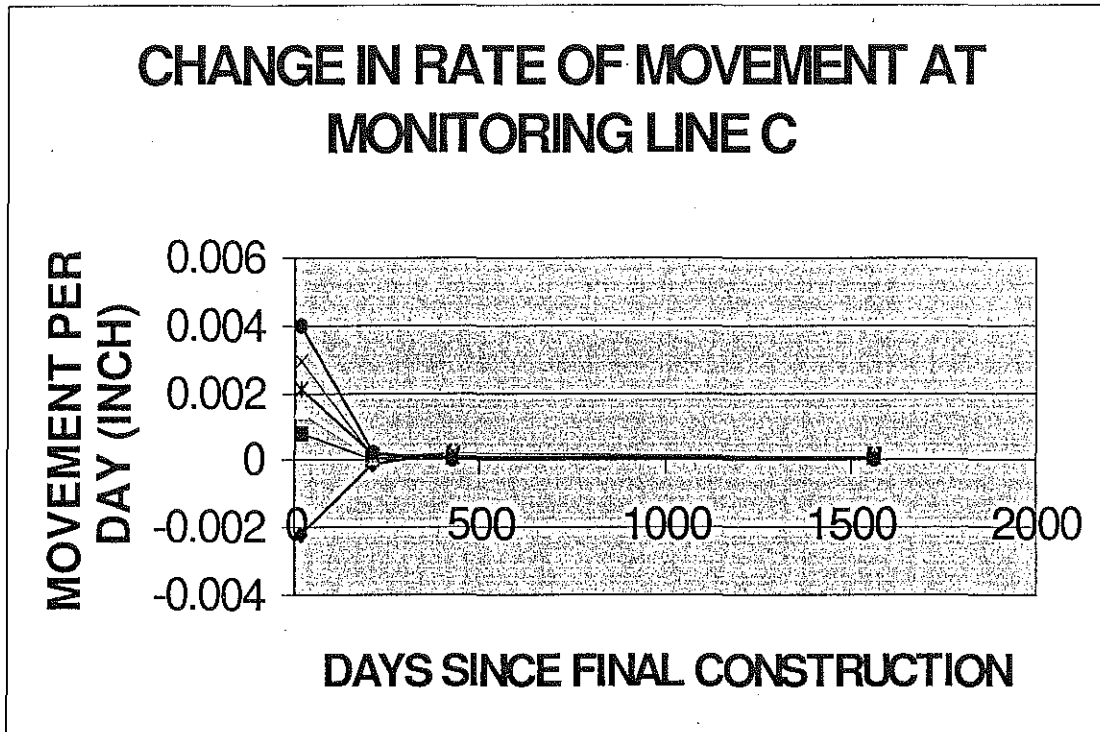
Figure 6. Monitoring Line C

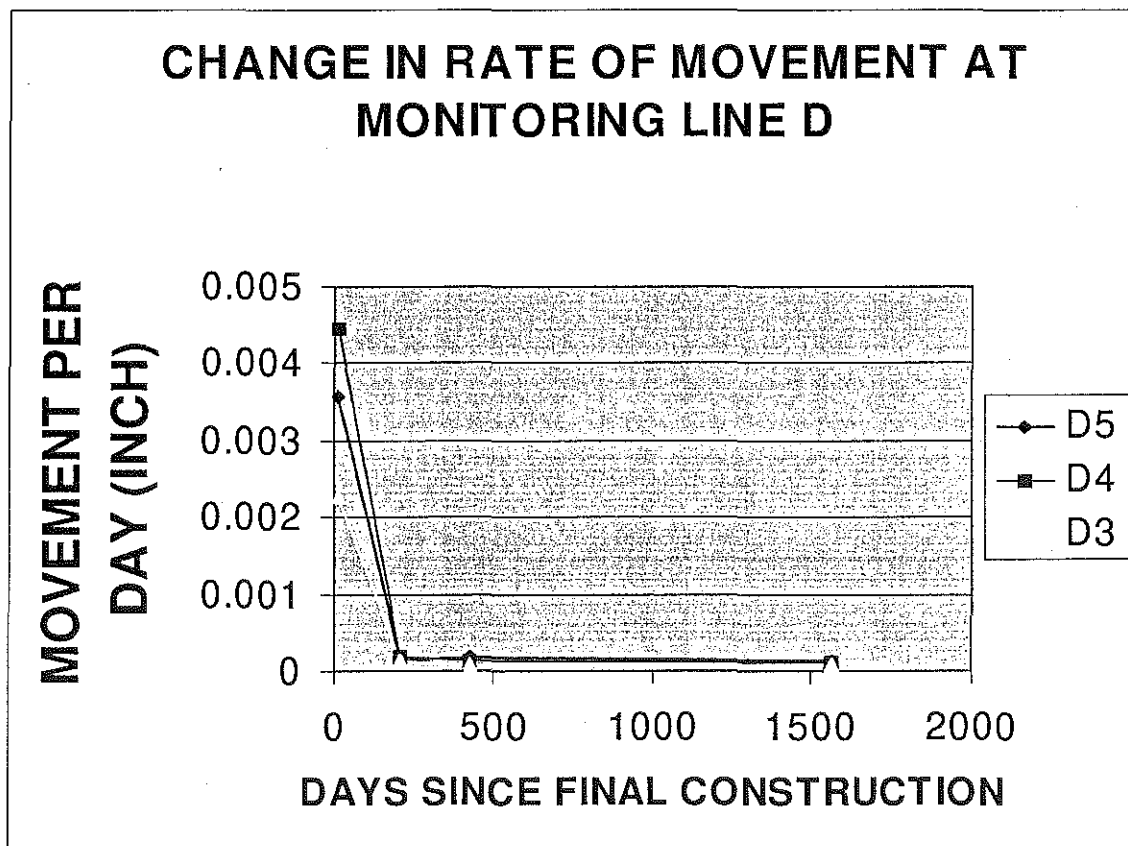
Figure 7. Monitoring Line D

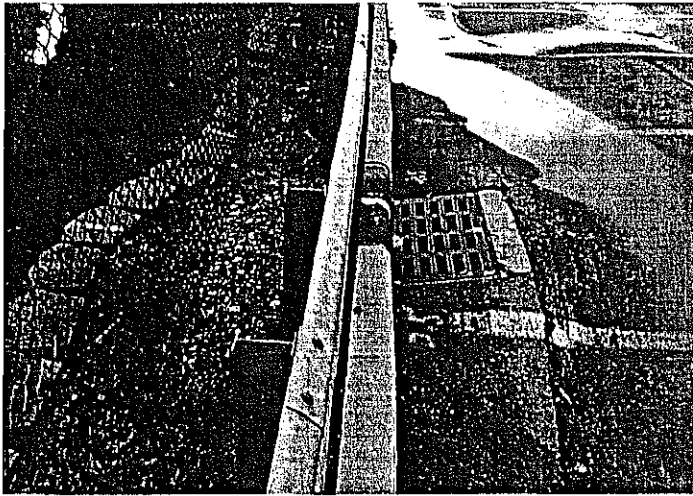
From visual observations, it is apparent that forward displacement has occurred just north of monitoring line C, directly behind vertical catch basin No. SD4 (Storm Drain No. 4) (see location in Appendix B). Figures 8 and 9 show the displacement in the Keystone Wall around SD4. It is apparent that settlement in the fill around the catch basin has caused some forward displacement in the face of the wall structure. It was apparent, at the time of the last survey of the wall face, that monitoring line C was not close enough to record any of this movement. An additional monitoring line was installed at this location on September 24, 1997. Additional monitoring will provide better information on current rates of movement in the various wall segments.

Figure 8. Showing change in wall alignment behind SD4.

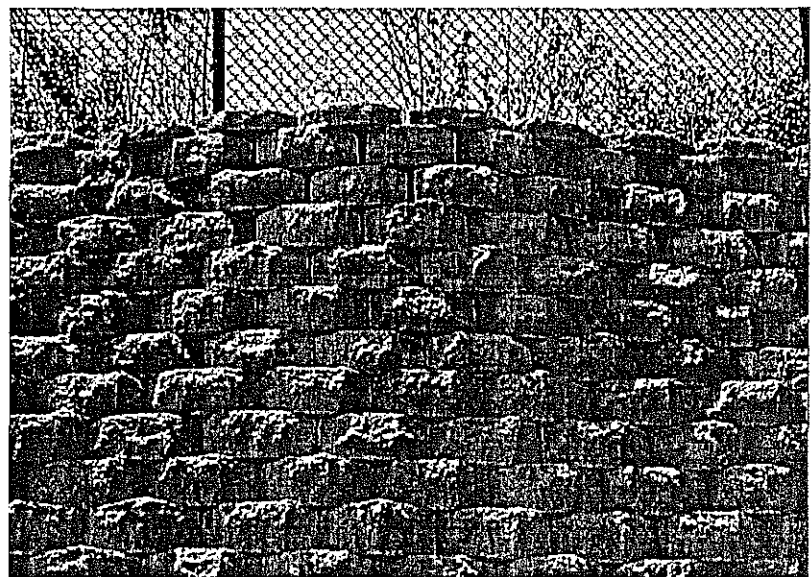
Figure 9. Forward Displacement in Keystone Wall occurring behind SD4.

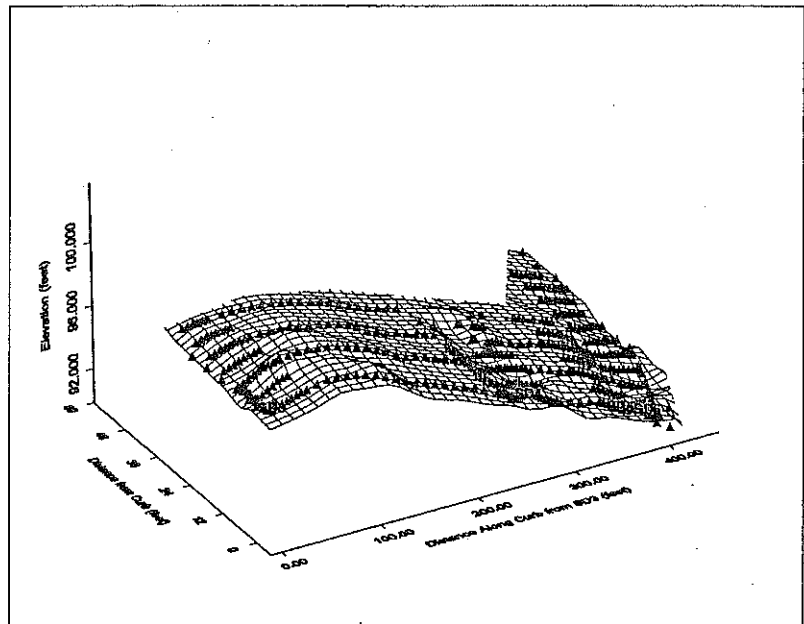
As mentioned in the initial report, vertical settlement of the asphalt pavement was apparent around the catch basins. A level survey of the parking area behind the retaining structure was conducted in 1997 (Figure 10). Settlement around SD3 (Figure 11) appears to be due to a significant amount of water infiltrating the risers in the drop box. In addition, material is also being lost on the backside of SD3 due to the earth embankment slide.

Figure 10. 3D Surface Plot of Parking Area Behind Keystone Block Wall.

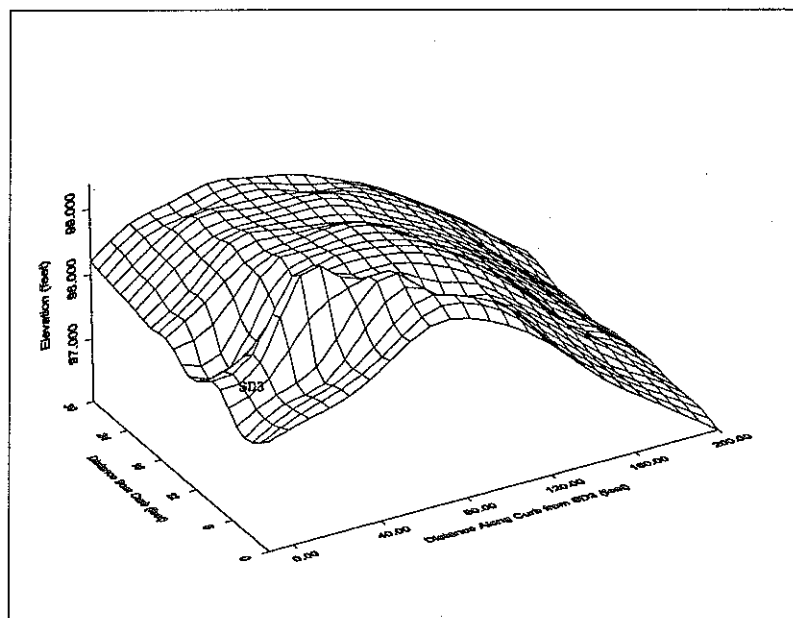
Water infiltrating into the riser of SD3 was sampled on July 1 and July 10, 1997. The water samples were taken to Kentucky American Water Company (KAWC) for testing. The fluoride levels tested were 0.3 and 0.4. KAWC concluded that the water was not treated water. KAWC indicated the source was likely ground water that has been running through limestone. KAWC indicated that limestone will increase the levels of fluoride by a couple of tenths.

Figure 11. Settlement Observed Near SD3.

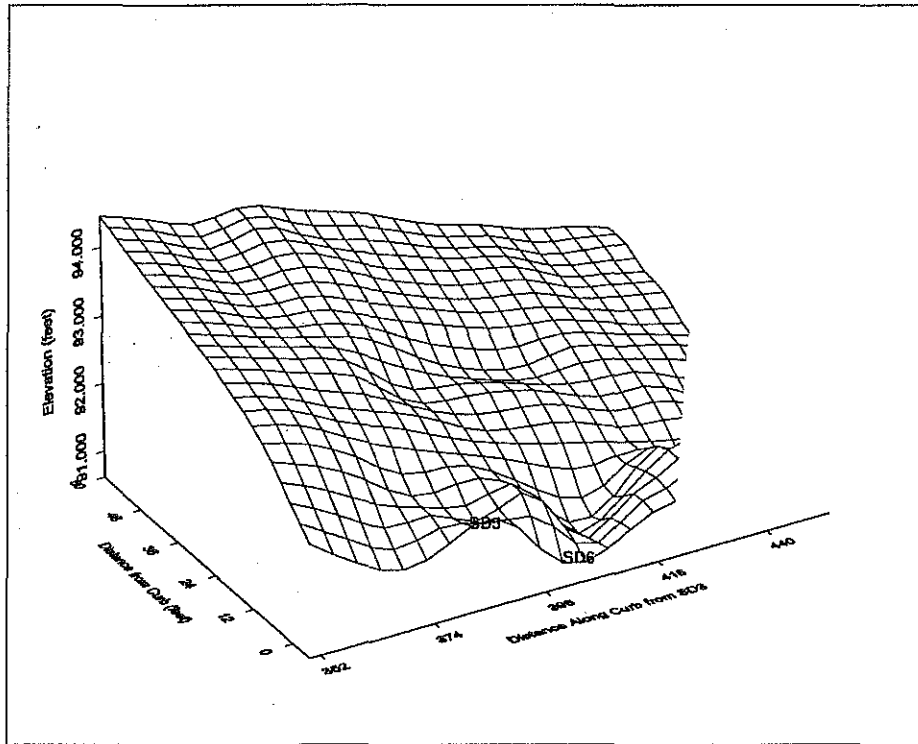
The most significant settlement is occurring around SD4. As shown in Figure 12, significant amounts of settlement have occurred directly in front of the catch basin. A large sunken area also extends back approximately 30 feet just left of the basin. This sunken area does not appear to follow any of the storm drains discharging into the basin. A portion of the material appears to be coming through the face of the wall.

Figure 12. Settlement Observed Around SD5 and SD6.

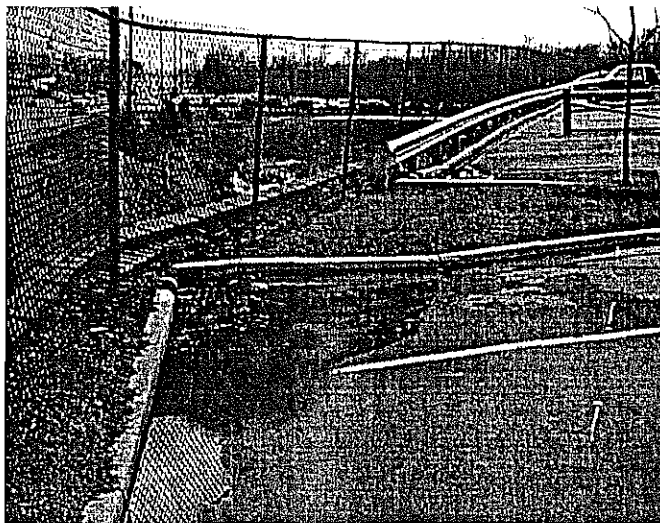
A significant amount of settlement also appears to be occurring on the north end of the wall at SD5 and SD6. This is shown in Figure 13 and Figure 14.

Figure 13. Settlement Observed Around SD6.

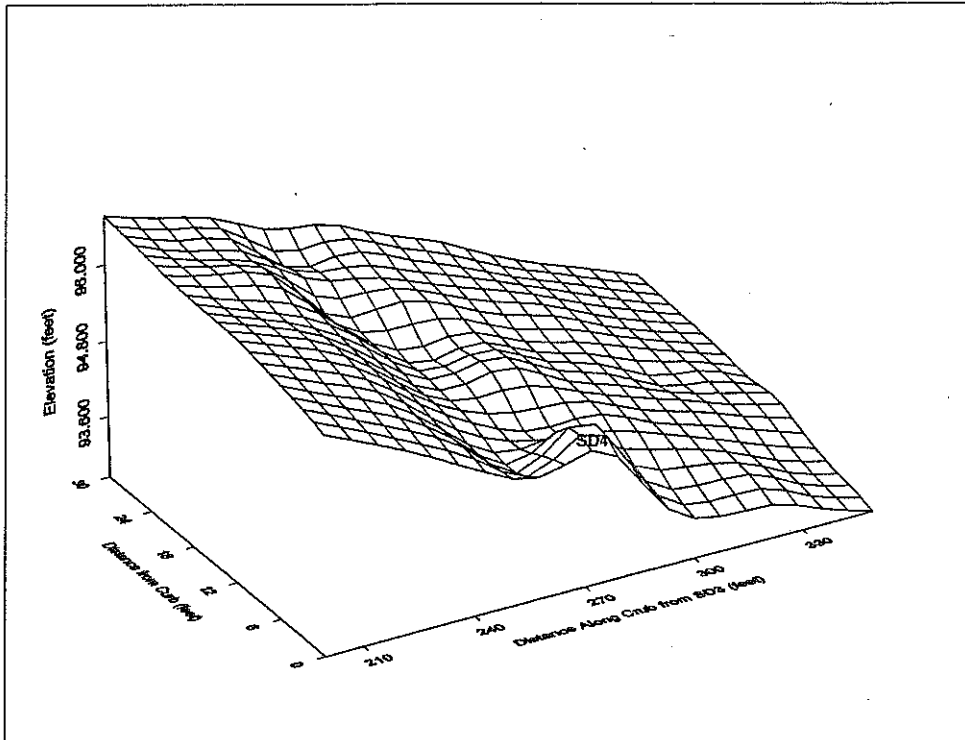
Figure 14. Observed Around SD4.

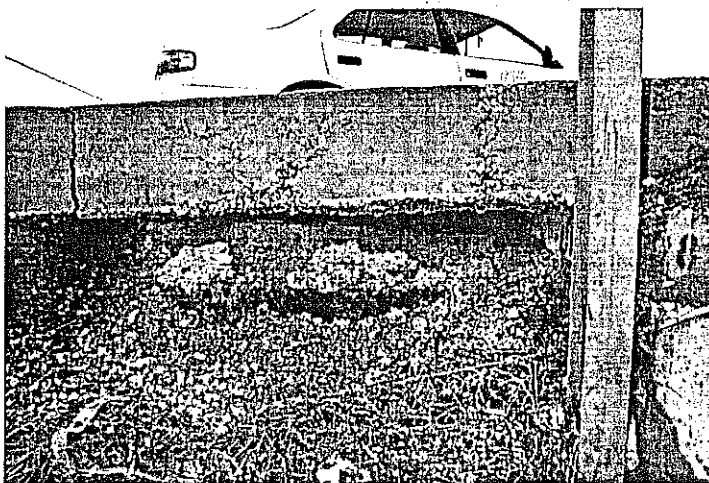
Since the initial report, additional settlement has occurred around all the storm drains (catch basins). Separation of the concrete curb and the asphalt has increased near the earth embankment. Additional sliding of the embankment has occurred around the SD3 (Figure 15). The slide is starting to undermine the edge of the pavement (Figure 16).

Figure 15. Edge of Pavement Undermined

The parking lot along the wall and the access road behind the store should also be repaved. Breaks in the concrete curb should be repaired. In addition, it is recommended that a french drain be installed to collect the water being discharged along the back of the store from the roof gutters. The embankment should be repaired as soon as possible to eliminate any further damage to the retaining structure and the parking lot. Some form of slope reinforcement is recommended for the slide rather than simply regrading and sodding. The surface water infiltrating the drop box inlets and the slide should be isolated. If this water is found to be flowing from the cut and fill, it is recommended that a cutoff trench be installed to intercept the water before it reaches the embankment and the retaining structure. Any cracks or separations in the pavement and curb should be sealed prior to placement of the overlay.

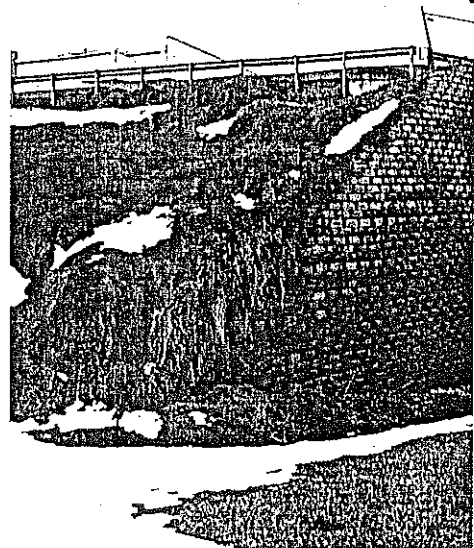
Figure 16. Embankment Slide

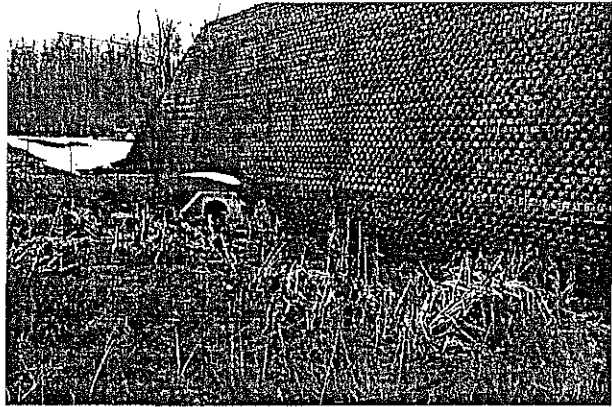
Staining on the base of the wall and erosion on top of the brim of the basin wall indicate that the water has flowed over the basin wall.

Figure 17. Retention Basis and Staining on the Keystone Wall, indicating High Water Levels.
