Research Report
KTC-89-45

CONSTRUCTION AND INSPECTION
REPORT ON CORRUGATED
POLYETHYLENE PIPE, N-12

October 1989

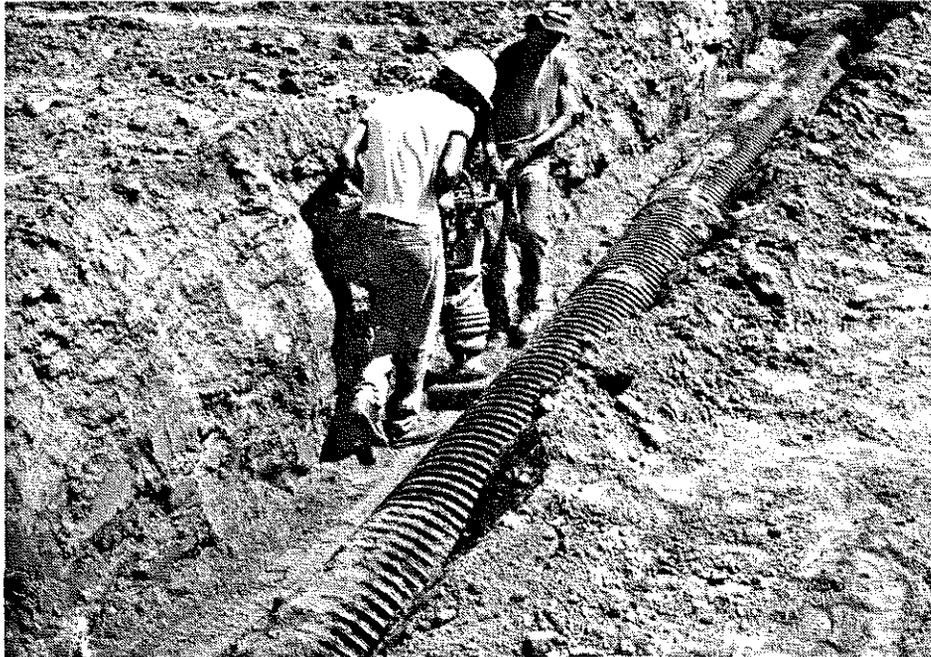
The project begins at Station 93+81.17 and ends at Station 152+00. The first section of N-12 pipe was placed May 18, 1988, at Station 137+88. Approximately 104 feet of 18-inch N-12 were placed at that location. The trench was backfilled with a coarse, clean sand approximately midway up the pipe, and compacted with a vibratory tamper. The remainder of the trench was backfilled with excavated material (Photo 1).

Photo 1. Compacting sand backfill around 18-inch N-12 pipe in Daviess County.

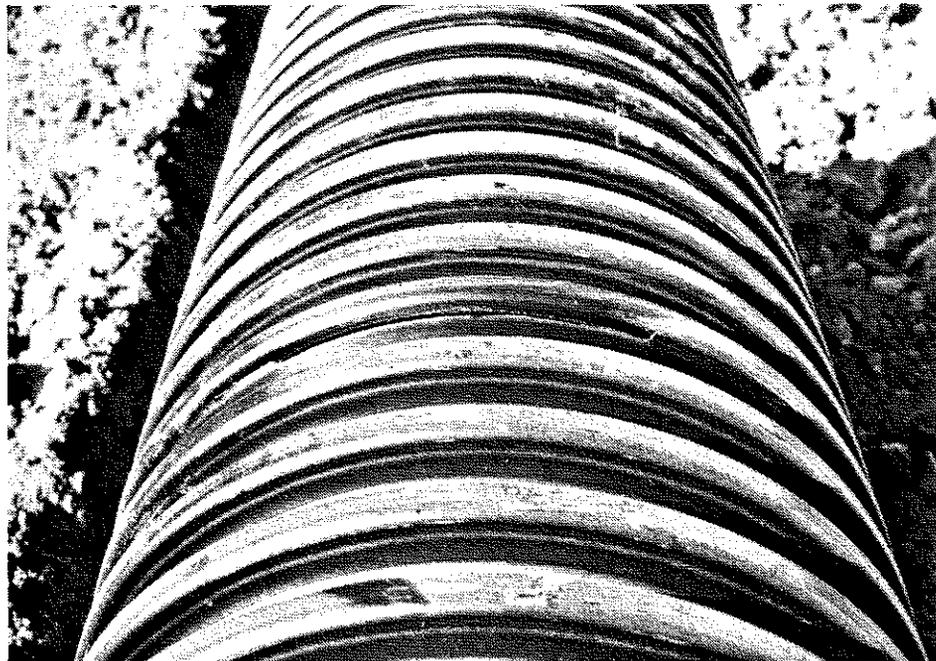
Prior to installation, it was observed that a number of the pipe sections had been cut during construction. It appeared that the sections had been damaged during transport with a backhoe. The damaged sections were returned to the manufacturer for inspection (Photo 2).

Photo 2. Damaged 18 inch N-12 pipe.

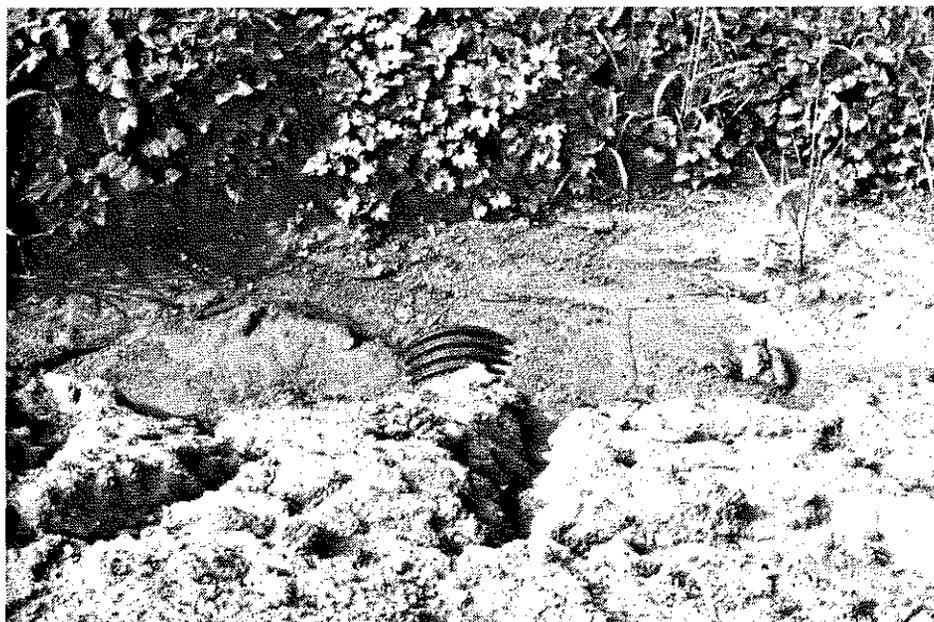
During construction inspection, it was apparent the pipes were becoming clogged due to the time interval between placement of the pipe and the headwall (Photo 3).

Photo 3. Silted pipe in Owensboro.

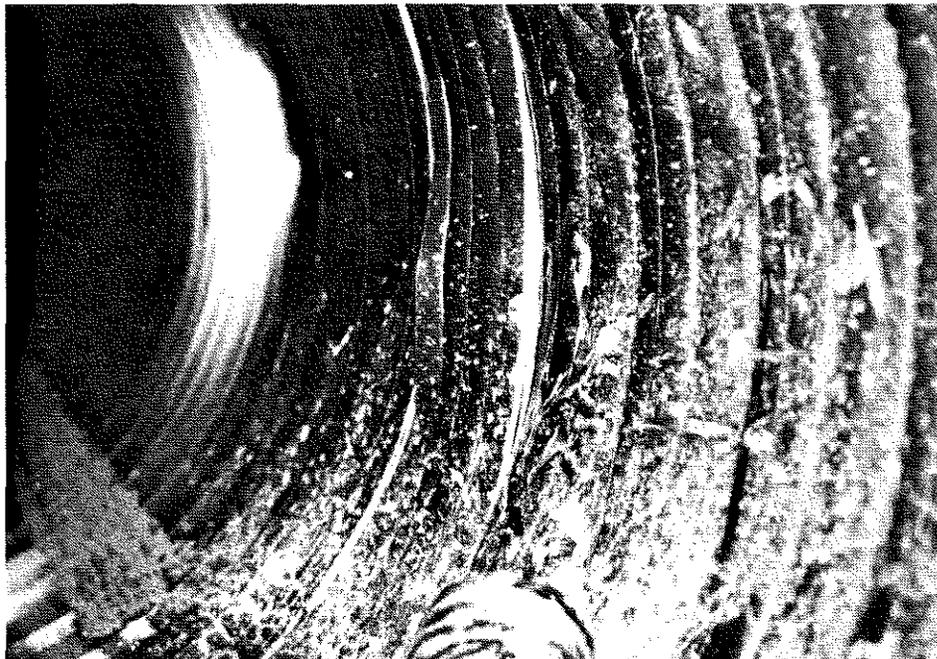
All pipes, including the 18-inch and 15-inch were inspected and photographed. All appeared to be symmetrical. On June 18, 1988 during the inspection of the 104-foot, 18-inch pipe at Station 137+88, a rip or cut was noted in the smooth interior lining of the pipe. The rip follows one of the corrugations and is approximately seven inches in length (Photo 4). The rip was closely inspected again on September 18, 1989. The rip appeared to be approximately the same length and had bulged approximately a one half-inch.

Photo 4. Rip or cut inside an 18 inch pipe.

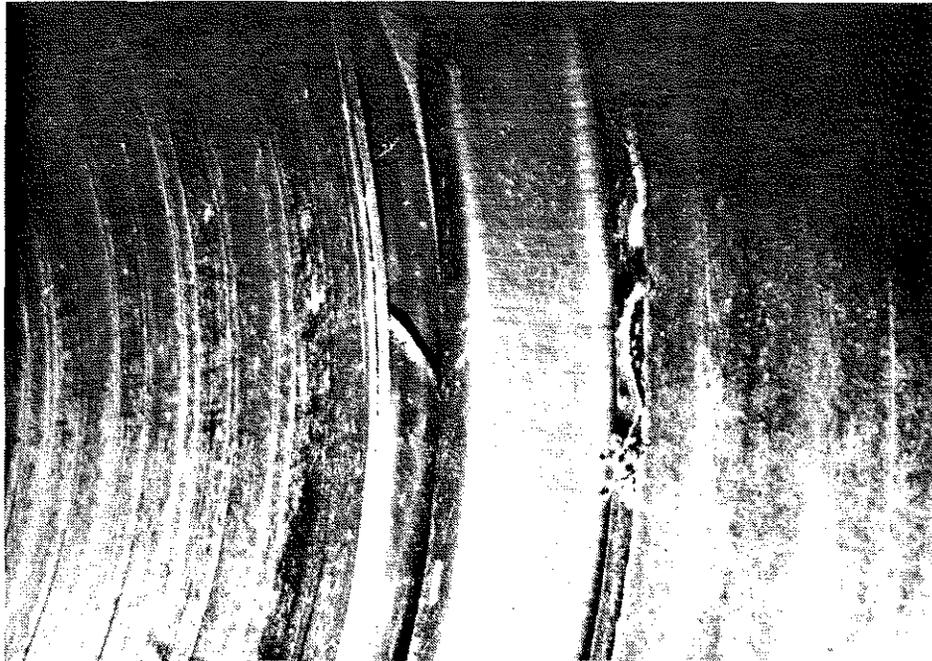
The interior of a 216-foot 18-inch pipe was inspected in detail on September 19, 1989, from Station 126+00 to 128+20. Each 20-foot section was photographed and visually inspected. The pipe appeared to be clean and symmetrical. A four-inch gap was discovered between the first and second joint south of Station 128+20 (Photo No. 5). It was apparent that the sections were not completely butted together at the time of installation. All other joints were inspected and their conditions were recorded. The next largest separation was one inch. A one half-inch separation was fairly common throughout the pipe section.

Photo 5. Four-inch separation between the two connecting pipe ends at the coupling.

From visual observations at all three sites, it is apparent the ends of the pipes at the couplings are rarely butted completely together. This permits material to be deposited in this area. Care should be taken during construction not to damage the plastic pipe during transportation.

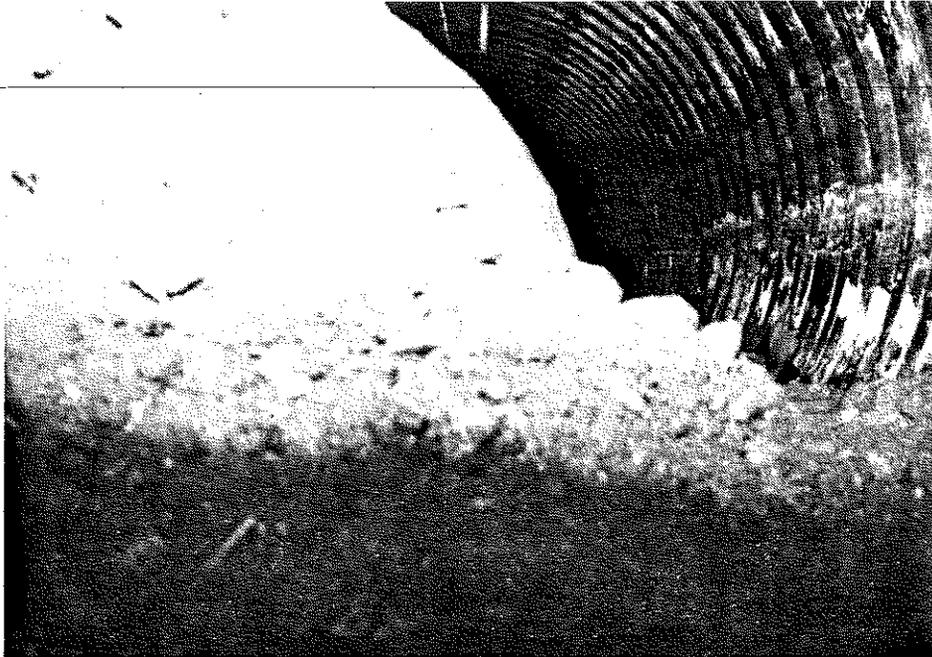
Large amounts of soil and rock had been deposited in two of the pipes leading to the manhole at Station 137+95. It is apparent the material had entered during construction through the grated inlet adjacent to the manhole . Photo No. 6 and Photo No. 7 shows the two partially clogged pipes.

Photo 6. Partially clogged 18-inch pipe.

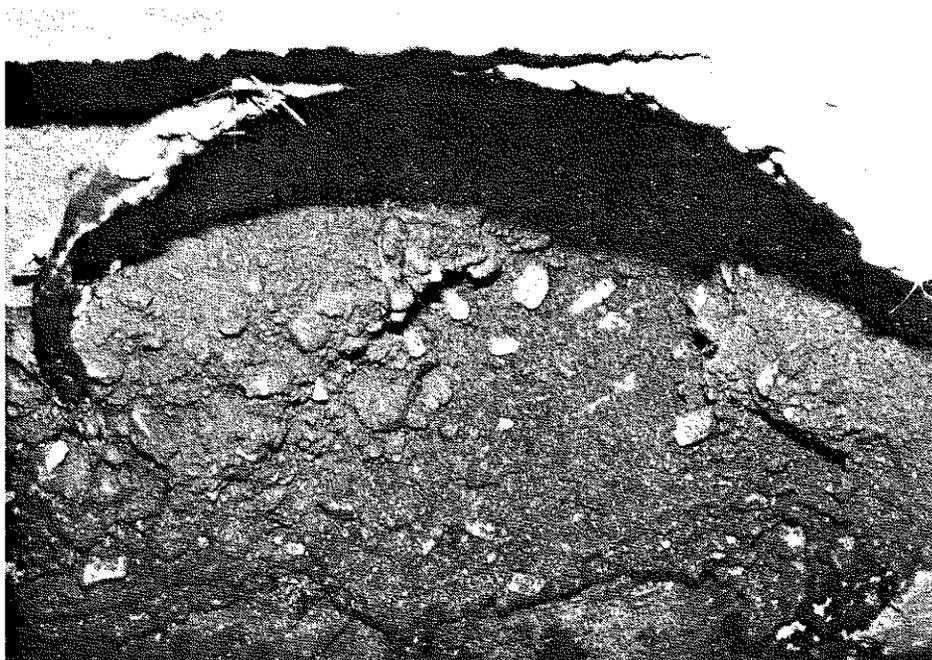
Photo 7. Partially clogged 15-inch pipe.

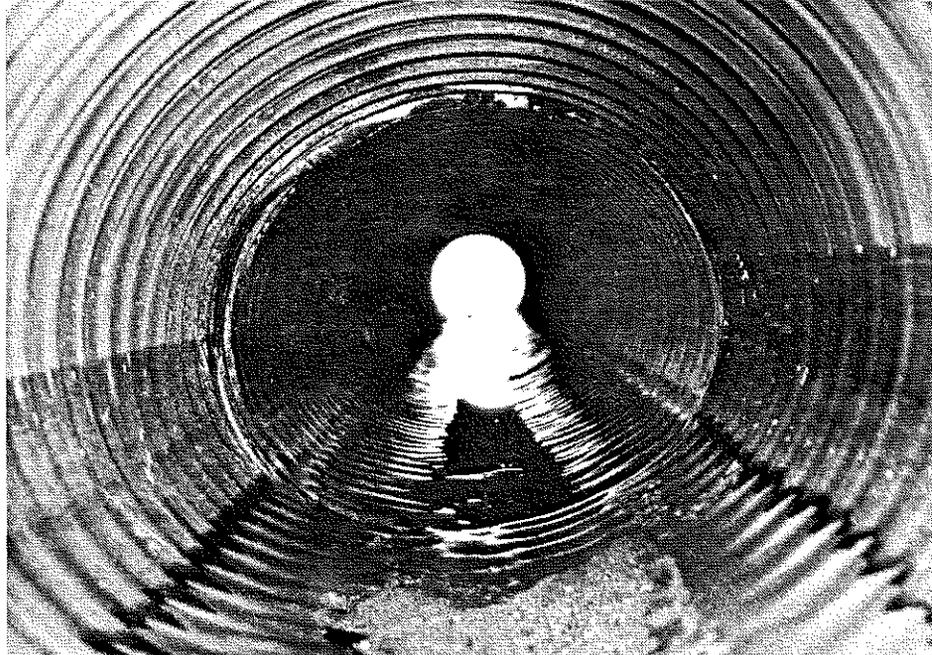
Photo 8. Compression in a 24-inch entrance pipe at Station 174+00.

SITE	DESCRIPTION
No. 1	18-inch entrance pipe slightly irregular
No. 2	24-inch entrance pipe (Station 174+00). Approximately 2.3 inches of deflection at the pipe connection. Some settlement is observed in the gravel drive above the pipe. Approximately 1.5 feet of cover at the south end of the pipe, south side of the gravel drive. The pipe sections are not completely connected.
No. 3	18-inch entrance pipe (Station 167+50). The pipe has approximately 3 inches of cover at 6 feet north of the south end. Approximately 2 inches of compression is noticeable at this point. Inloader tracks are also present on the surface at this point.
No. 4	18-inch entrance pipe (Station 161+50). Slight bow is present at the joint in the pipe. Overall installation looks good. Asphalt surface has been placed within 1 to 2 inches of the top of the pipe.
No. 5	18-inch entrance pipe (Station 151+00-Highland Road). The installation is in good condition.

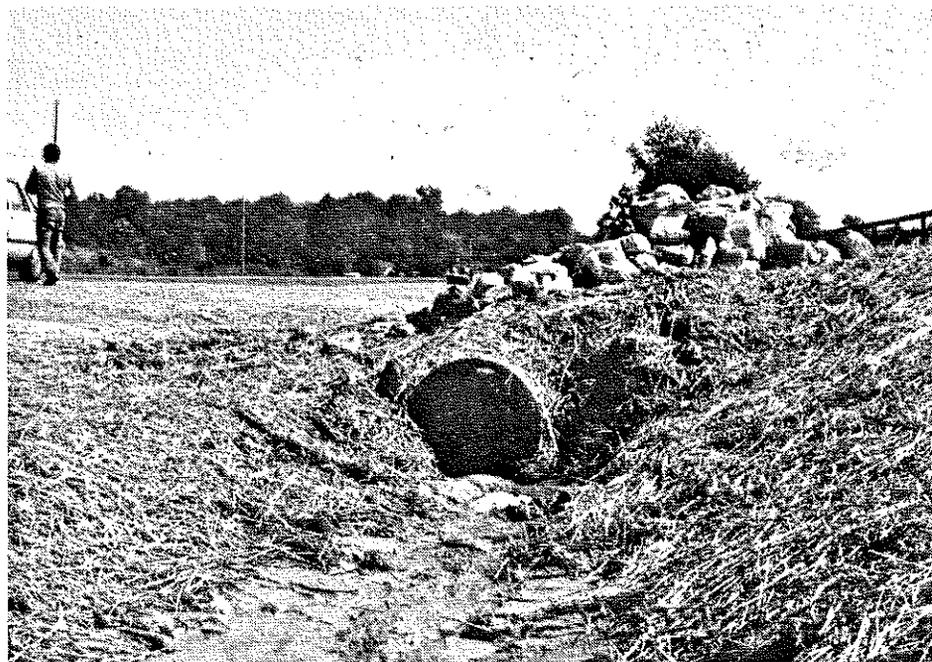
Photo 9. Inloader tracks are present in the thin soil cover above the compressed pipe (Station 167+50).

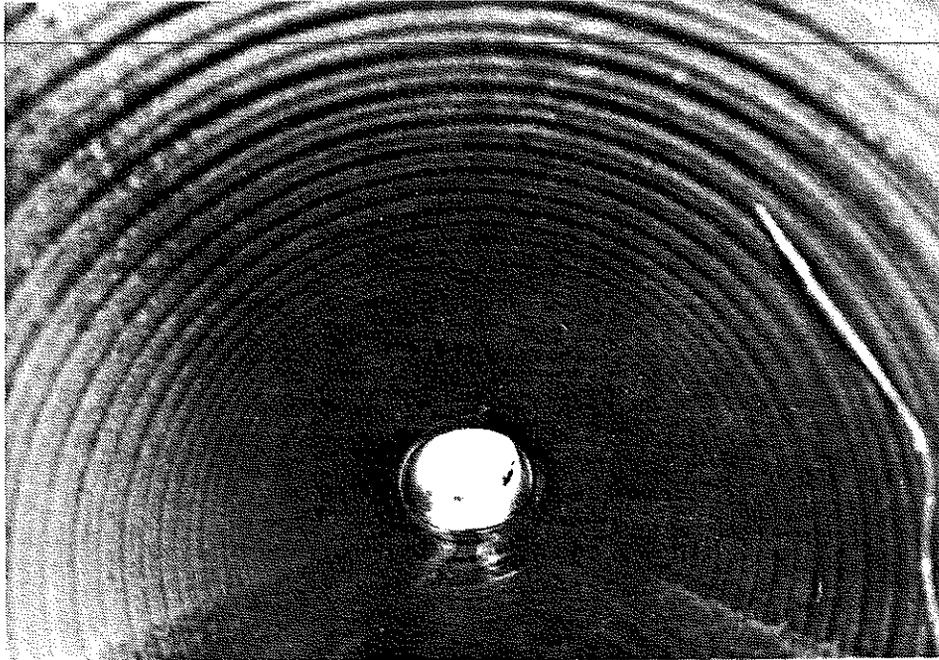
Photo 10. Pipe deflection at Station 167+50
(18-inch pipe).

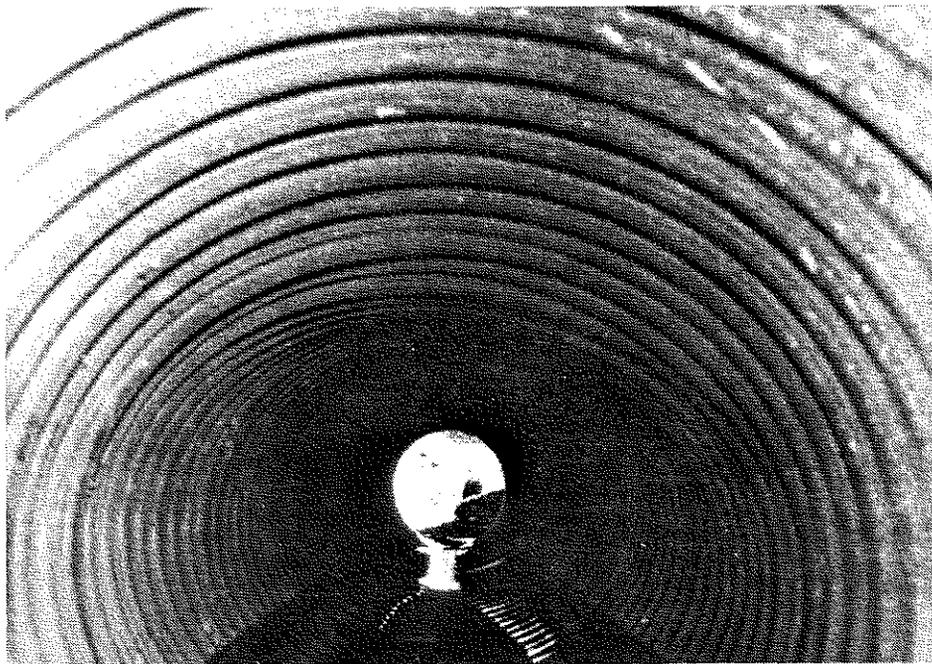
Photo 11. Compression in a 24-inch entrance
pipe at Station 138+50.

No. 6	24-inch entrance pipe (Station 138+50). Approximately 2 inches of compression on the south end. Approximately 4 to 4.5 feet of fill. Pipe does not appear to be bedded on sand or crushed stone.
No. 7	24-inch culvert pipe (Station 134+50). Good installation.
No. 8	30-inch culvert pipe (Station 124+50). Slight vertical deflection approximately 25 inches from the east end. Fairly good shape.
No. 9	15-inch entrance pipe (Station 121+00). Truck entrance for Turner Dairy. Half full of soil. Not much deflection.
No. 10	15-inch entrance pipe (Station 111+00). Half full of soil. Little to no deflection.

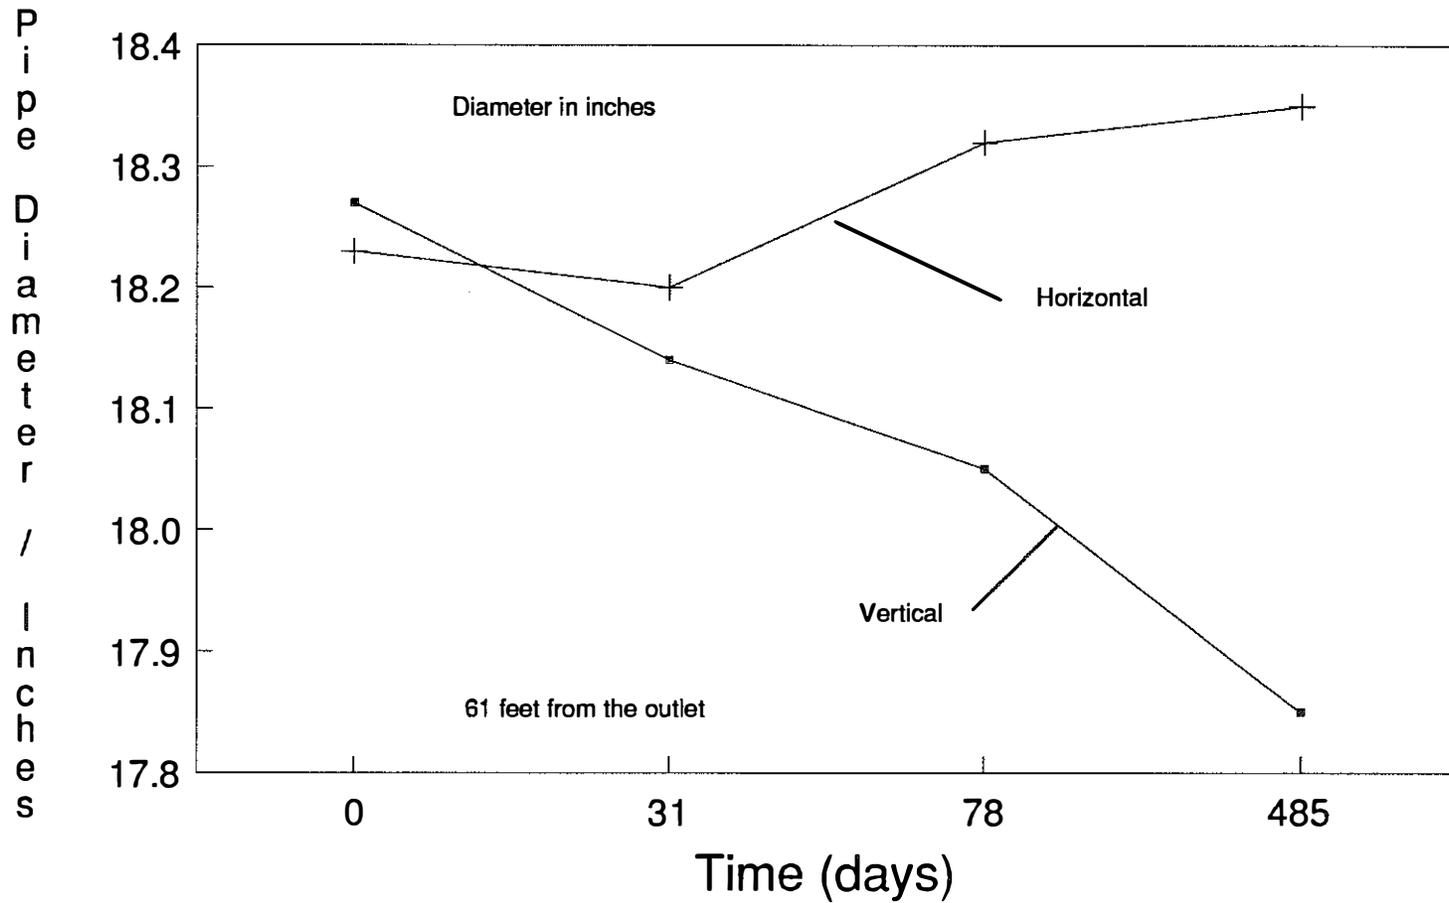
Figure No. 1: 18-Inch N-12 Ky 54, Daviess County, Station 137+88

Two sets of monoritoring points were placed in the pipe at Station 137+88 prior to installation. The monoritoring points were placed at 41 feet and 61 feet from the outlet. The points were monoritored three times in 1988 and on September 18, 1989. Since installation, the interior of the pipe at 61 feet had deflected approximately 0.42 inch, and approximately 0.25 inch at 41 feet (Figures 1 and 2). The fill height above the 61-foot monoritoring point was 6 feet, and the fill height at the 41-foot monoritoring point was 8 feet.

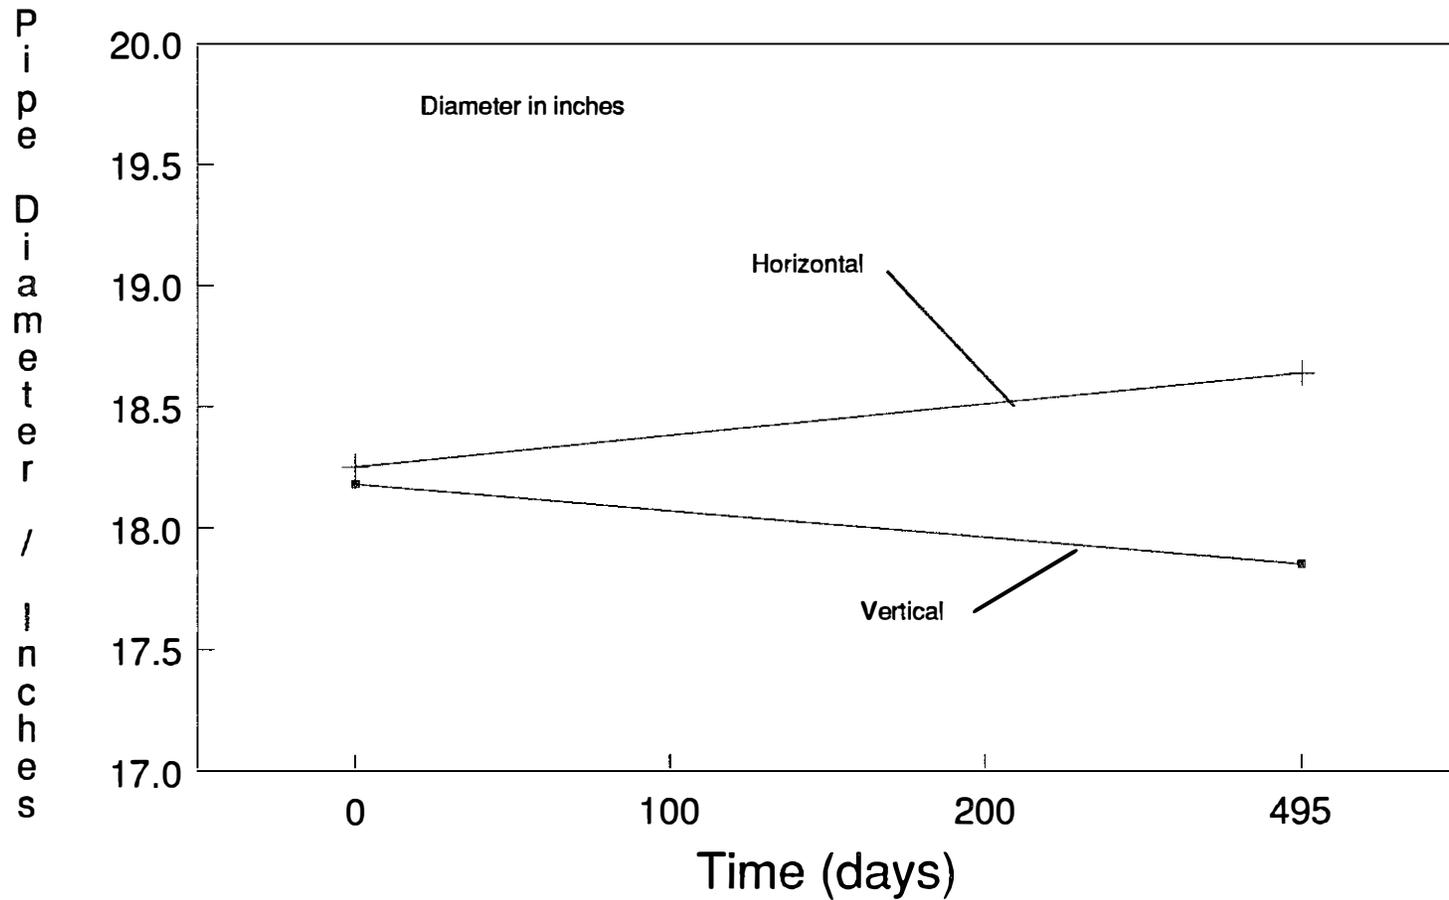
Figure No. 3: 18-Inch N-12 Ky 54, Daviess County, Station 126+00

Monoritoring points were also placed at Station 122+50. Since installation, the interior of the 18-inch pipe has deflected 0.34 inch (Figure 3). Eight additional monoritoring points were placed in the pipes prior to installation. Due to water and mud, the monoritoring points could not be accessed during the last inspection.
