Bulldozer Owner / Operator Dies When Thrown Off Bulldozer Track

Incident Number: 03KY049

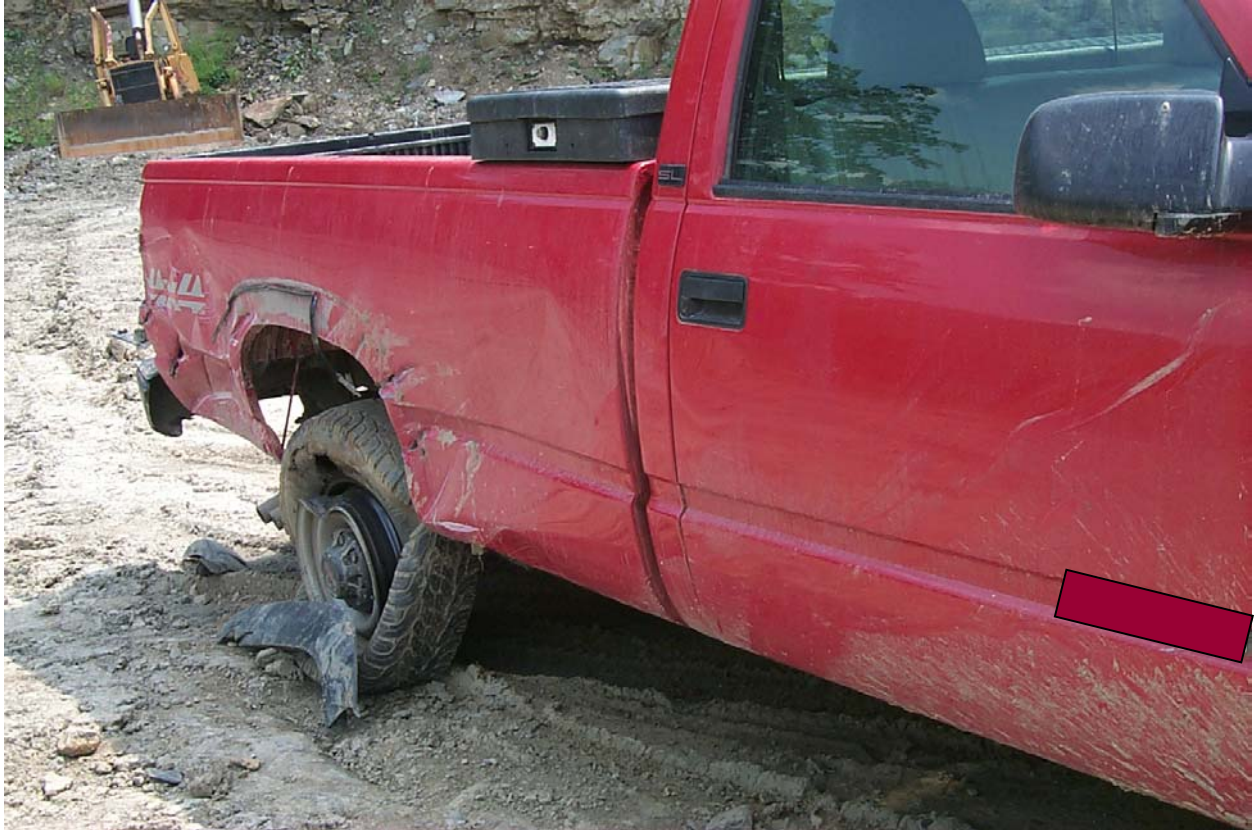
Side of pickup truck where decedent was thrown and the bulldozer in the side of the mountain.
