Research Report
KTC-89-25

EARTHQUAKE HAZARD MITIGATION OF
TRANSPORTATION FACILITIES
FOR CARLISLE COUNTY

June 1989

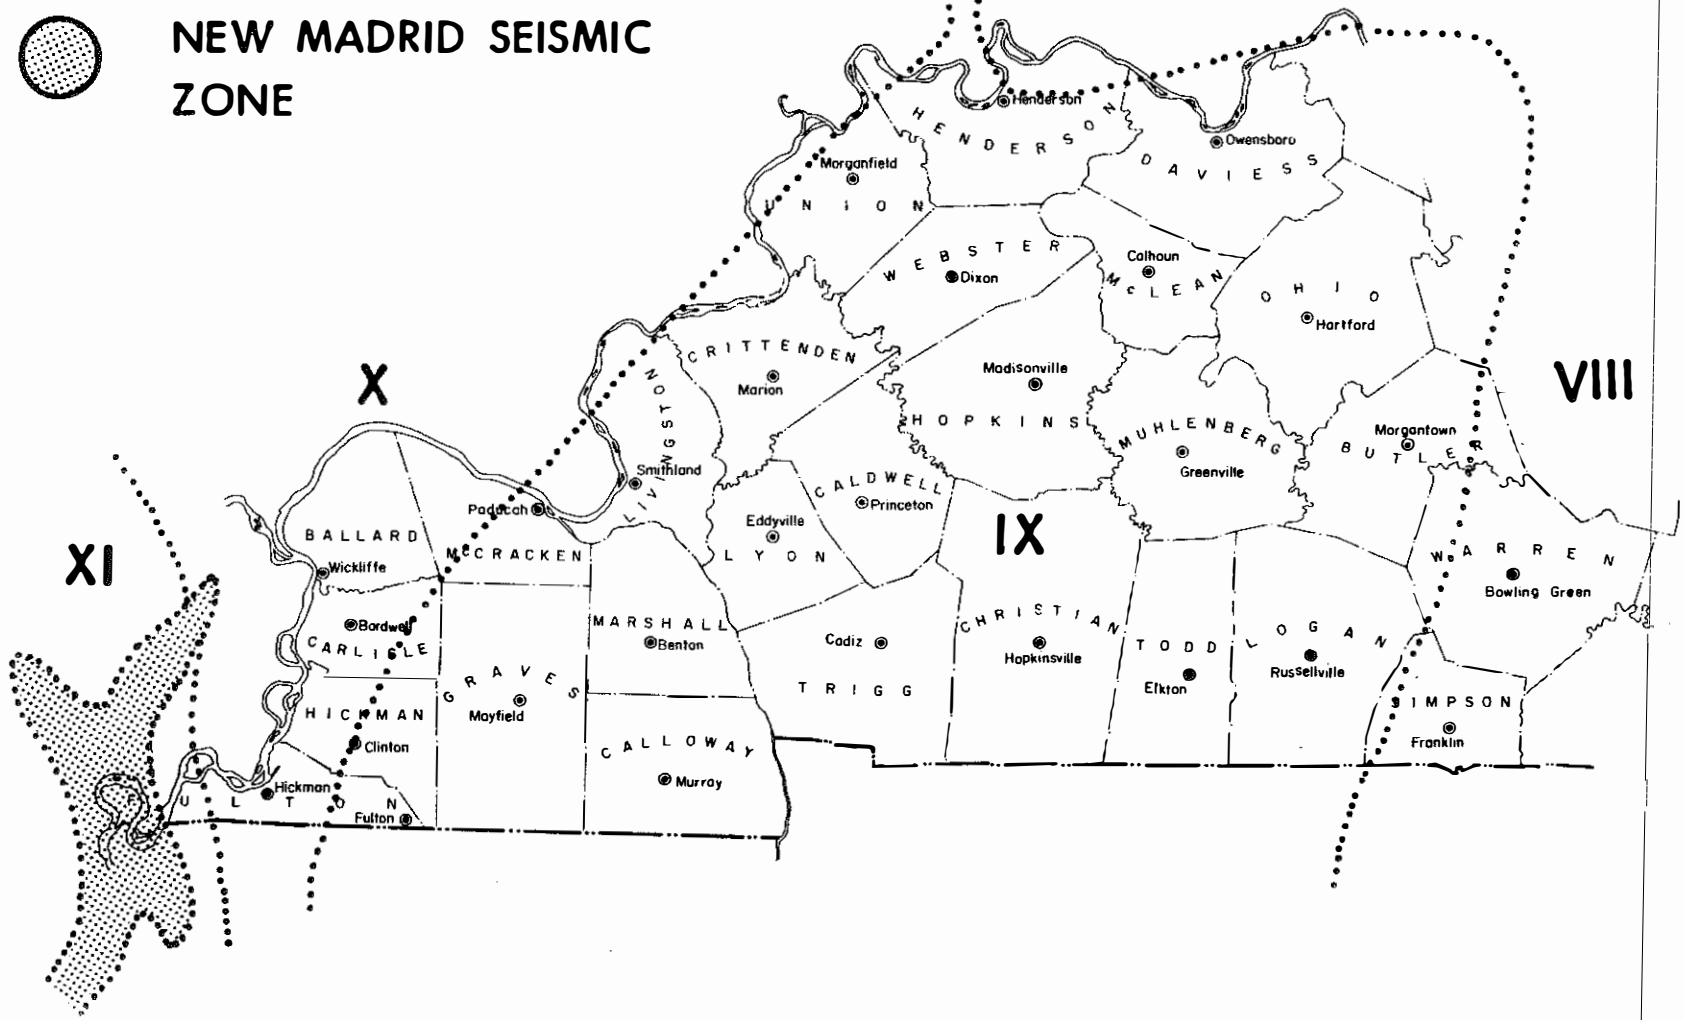
Figure 1: The twenty-six counties included in this study area.

Carlisle County is located approximately 35 miles northeast of the center of the New Madrid Seismic Zone. Figure 1 indicates that approximately 70 percent of Carlisle County is in the X band of the MMI scale with the remainder in the IX band. This indicates considerable damage could occur in Carlisle County in the event of a major earthquake.

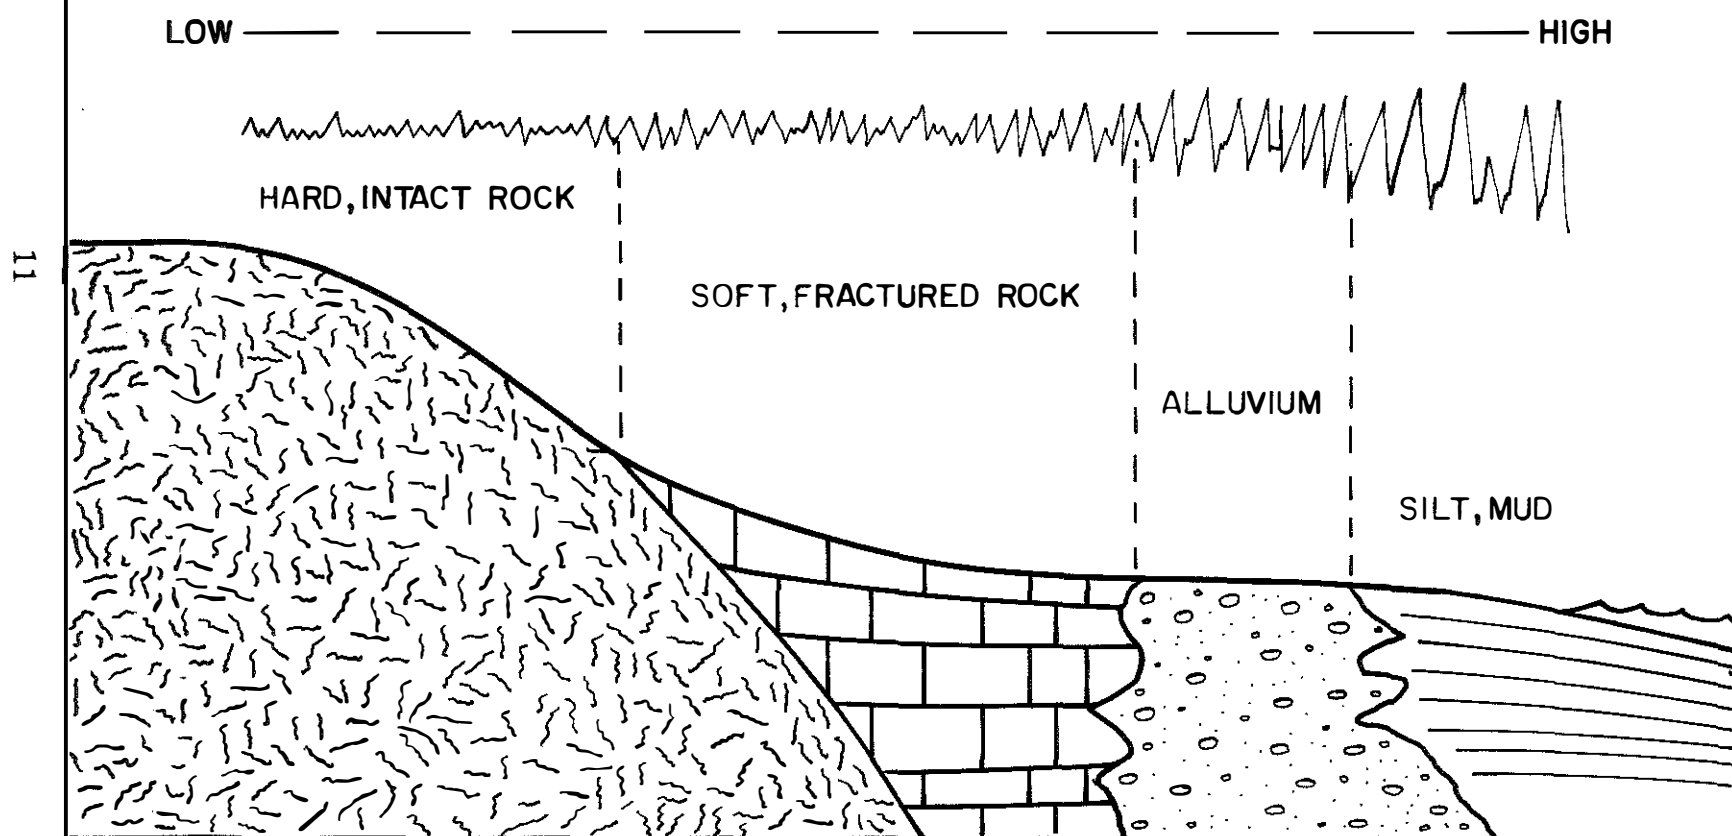
Figure 2 : Amplification of shaking in softer rock & soil during an earthquake.

Soil maps for Carlisle County indicate that there are large amounts of alluvium present throughout the county. Alluvium is a loose, fine-grain soil which is deposited by flowing water such as creeks and rivers. Due to the nature of the alluvium, ground motions at the surface of the soil can be many times greater than those within the underlying bedrock and temporary liquefaction can occur (Figure 2). An alluvium map for Carlisle County is shown in Figure 3.
