Research Report
KTC-89-26

EARTHQUAKE HAZARD MITIGATION OF
TRANSPORTATION FACILITIES
FOR HICKMAN COUNTY

June 1989

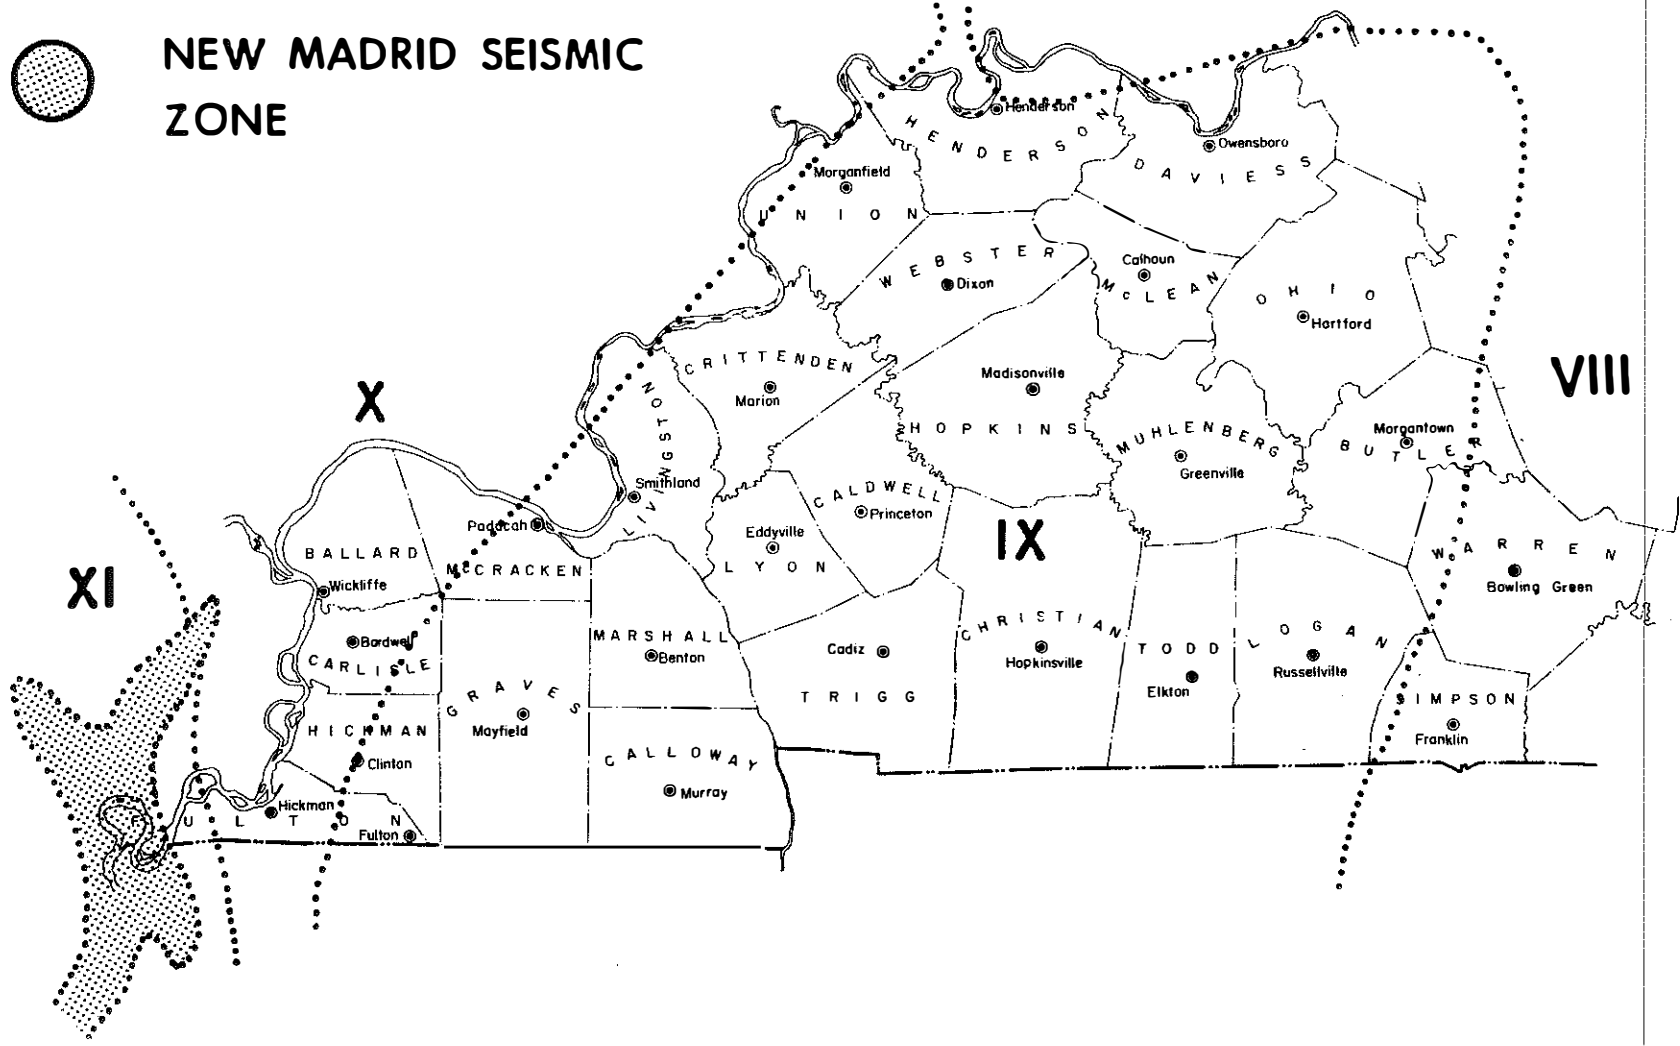
Hickman County is located approximately 30 miles northeast of the center of the New Madrid Seismic Zone. Figure 1 indicates that 50 percent of Hickman County is in the IX band of the MMI scale and 50 percent is in the X band. This indicates considerable damage could occur in Hickman County in the event of a major earthquake.

Figure 1: The twenty-six counties included in this study area.

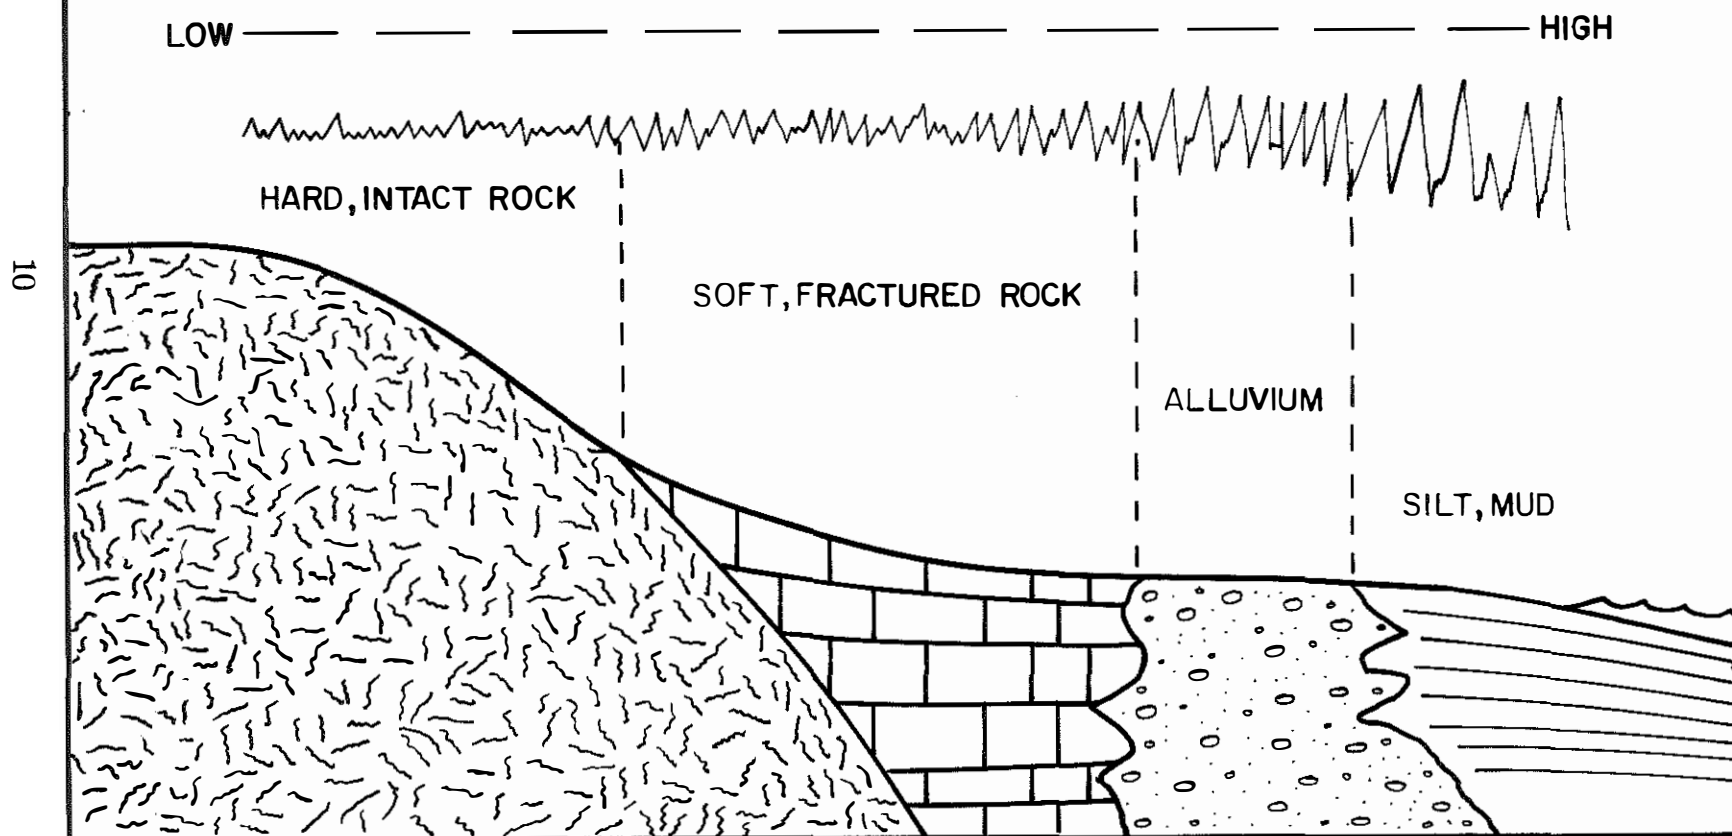
be many times greater than those within the underlying bedrock and temporary liquefaction can occur (Figure 2). An alluvium map for Hickman County is shown in Figure 3.

Figure 2 : Amplification of shaking in softer rock & soil during an earthquake.

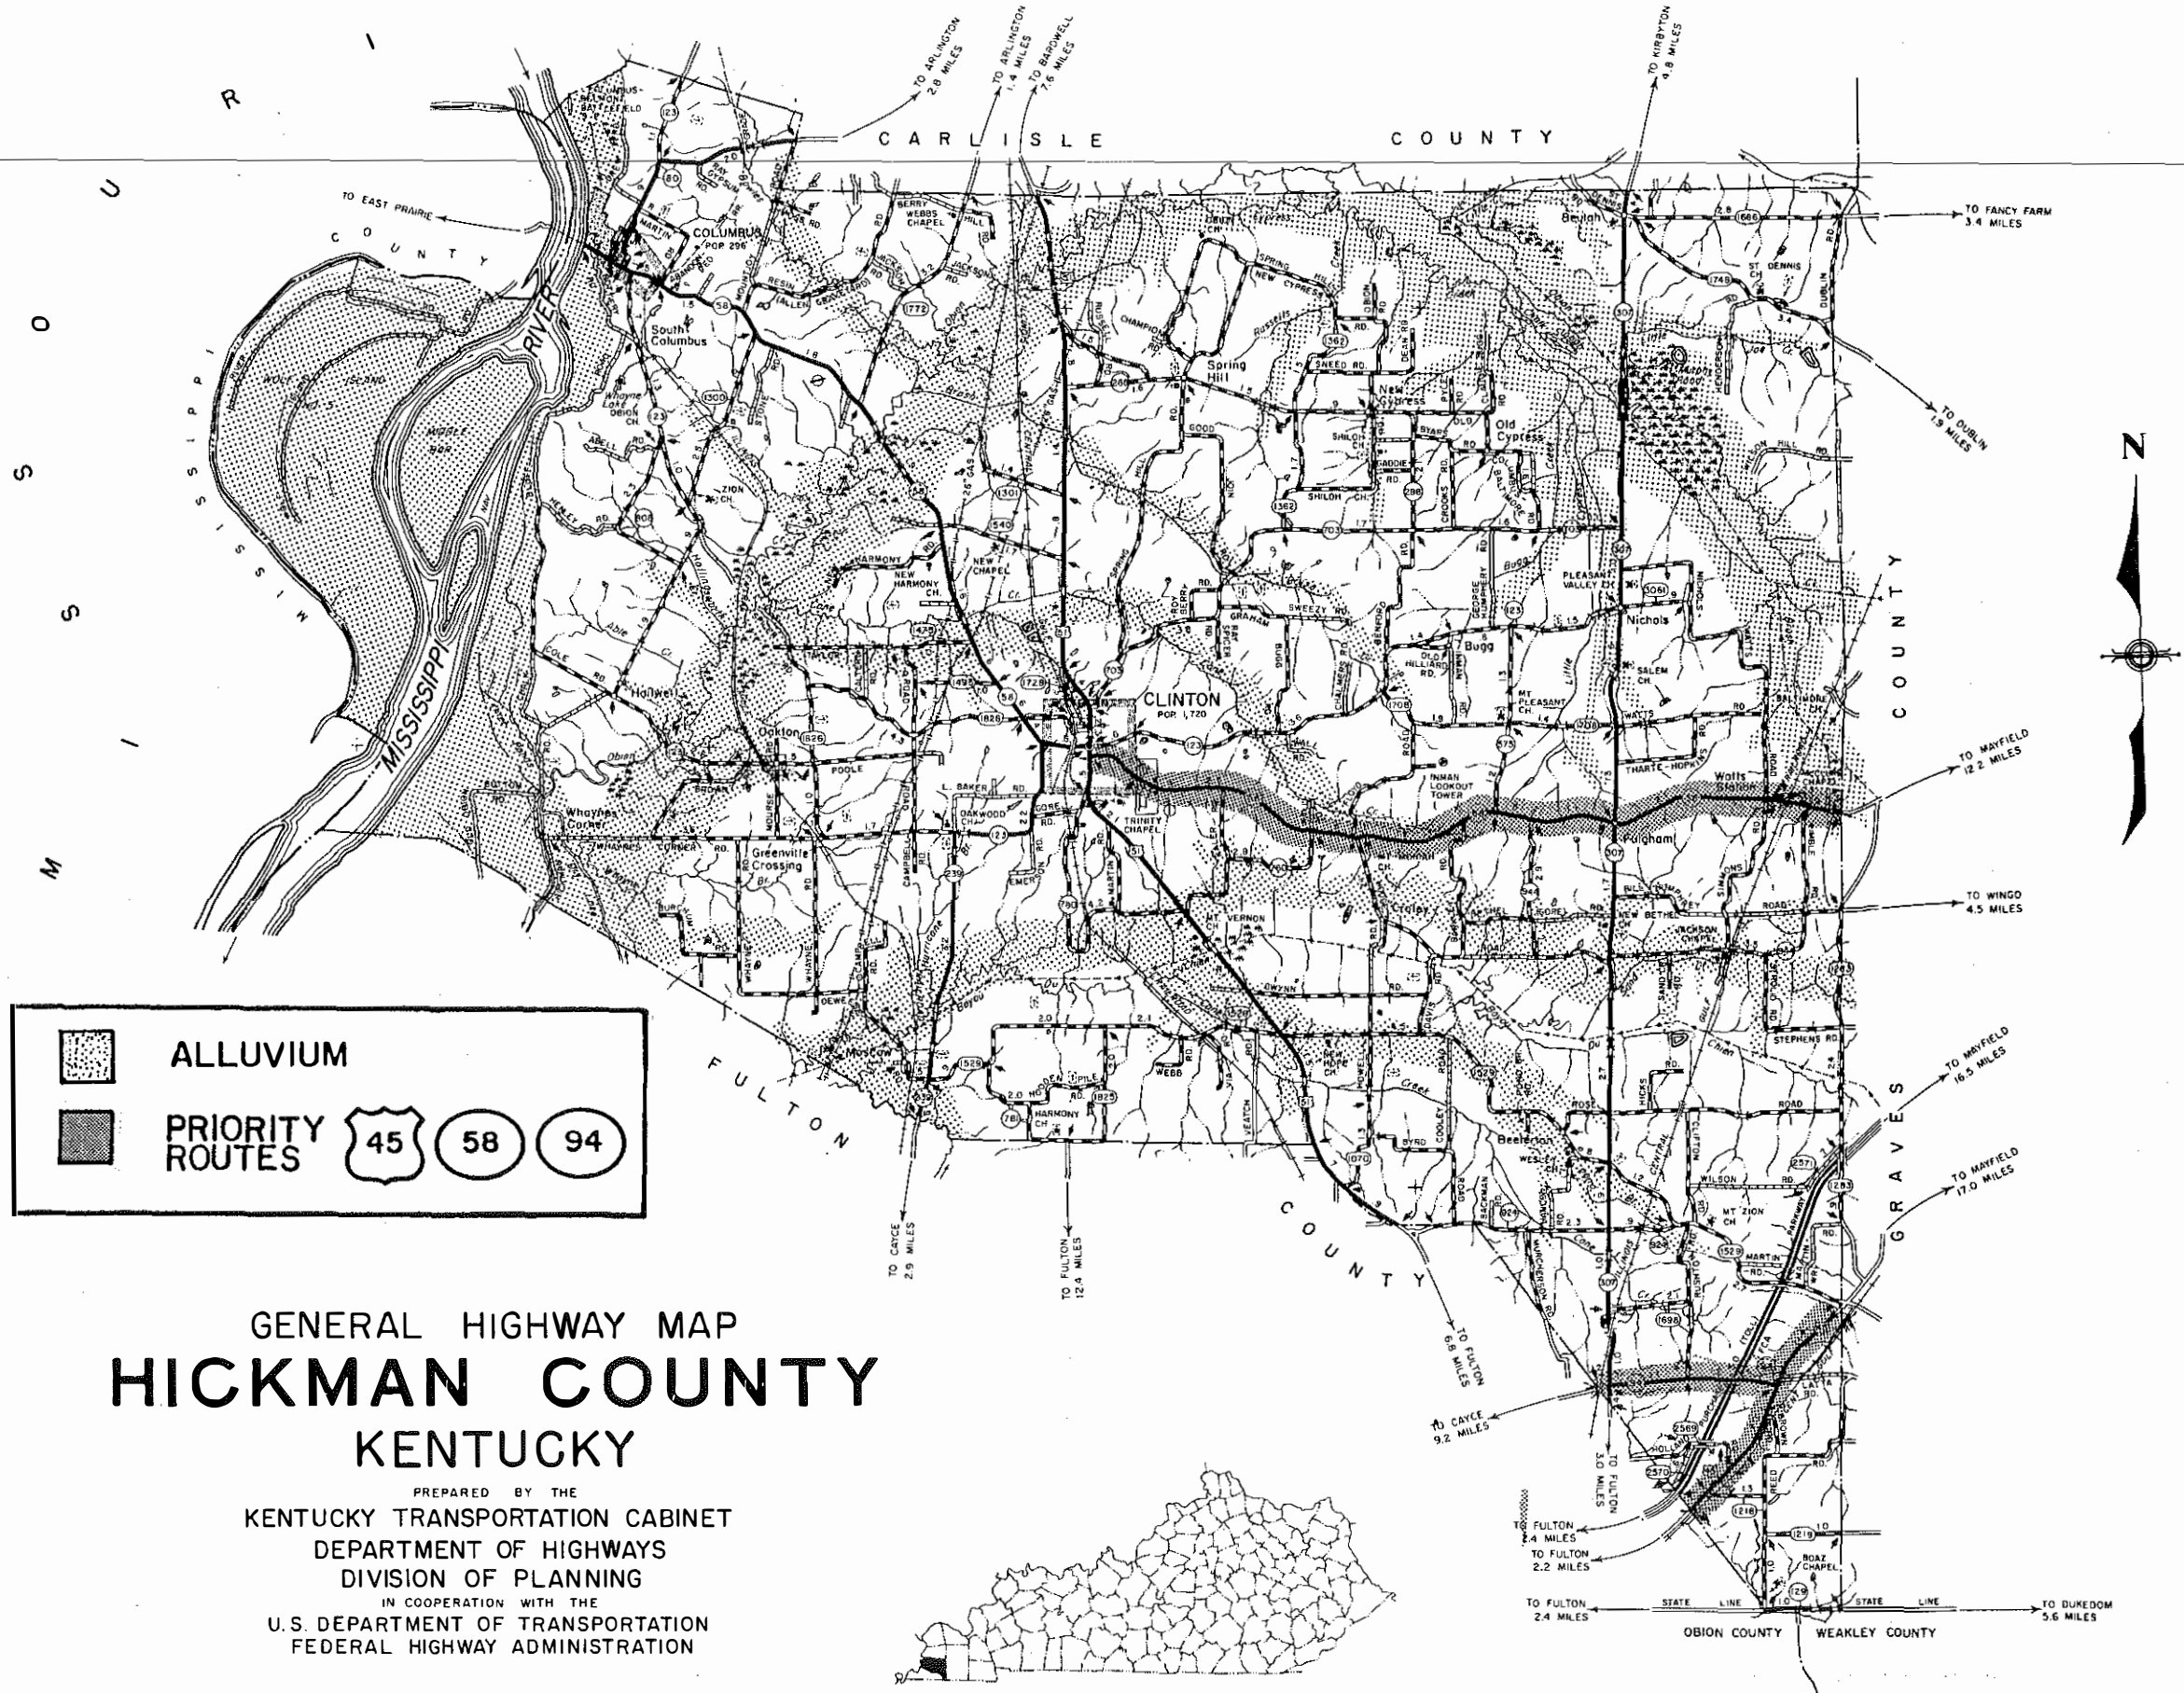
Soil maps for Hickman County indicate that there are large amounts of alluvium present throughout the county. Alluvium is a loose, fine-grain soil which is deposited by flowing water such as creeks and rivers. Due to the nature of the alluvium, ground motions at the surface of the soil can

Figure 3. Alluvium map for Hickman County.
