Research Report  
KTC-89-15

EARTHQUAKE HAZARD MITIGATION OF  
TRANSPORTATION FACILITIES  
FOR TODD COUNTY

APPENDIX A  
STRIP MAP FOR TODD COUNTY  
US 68/KY 80 and US 79

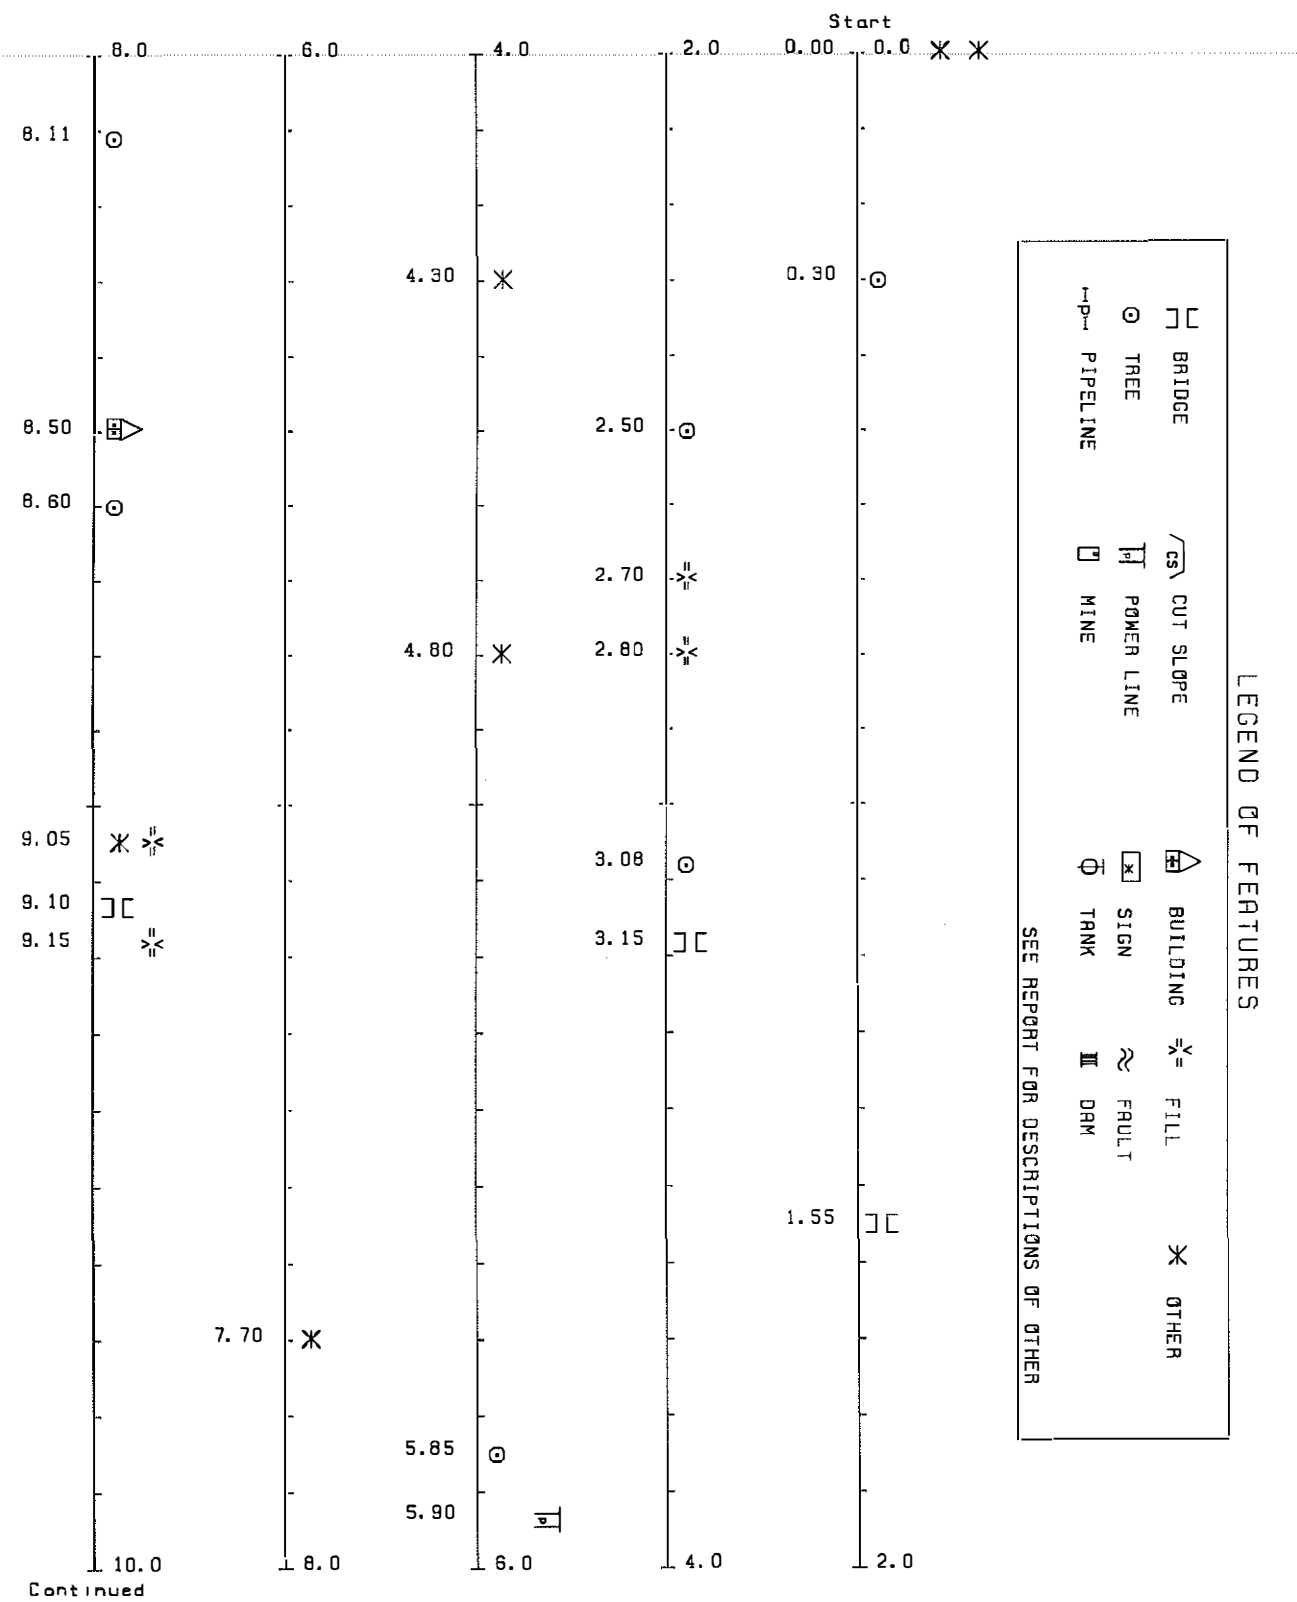
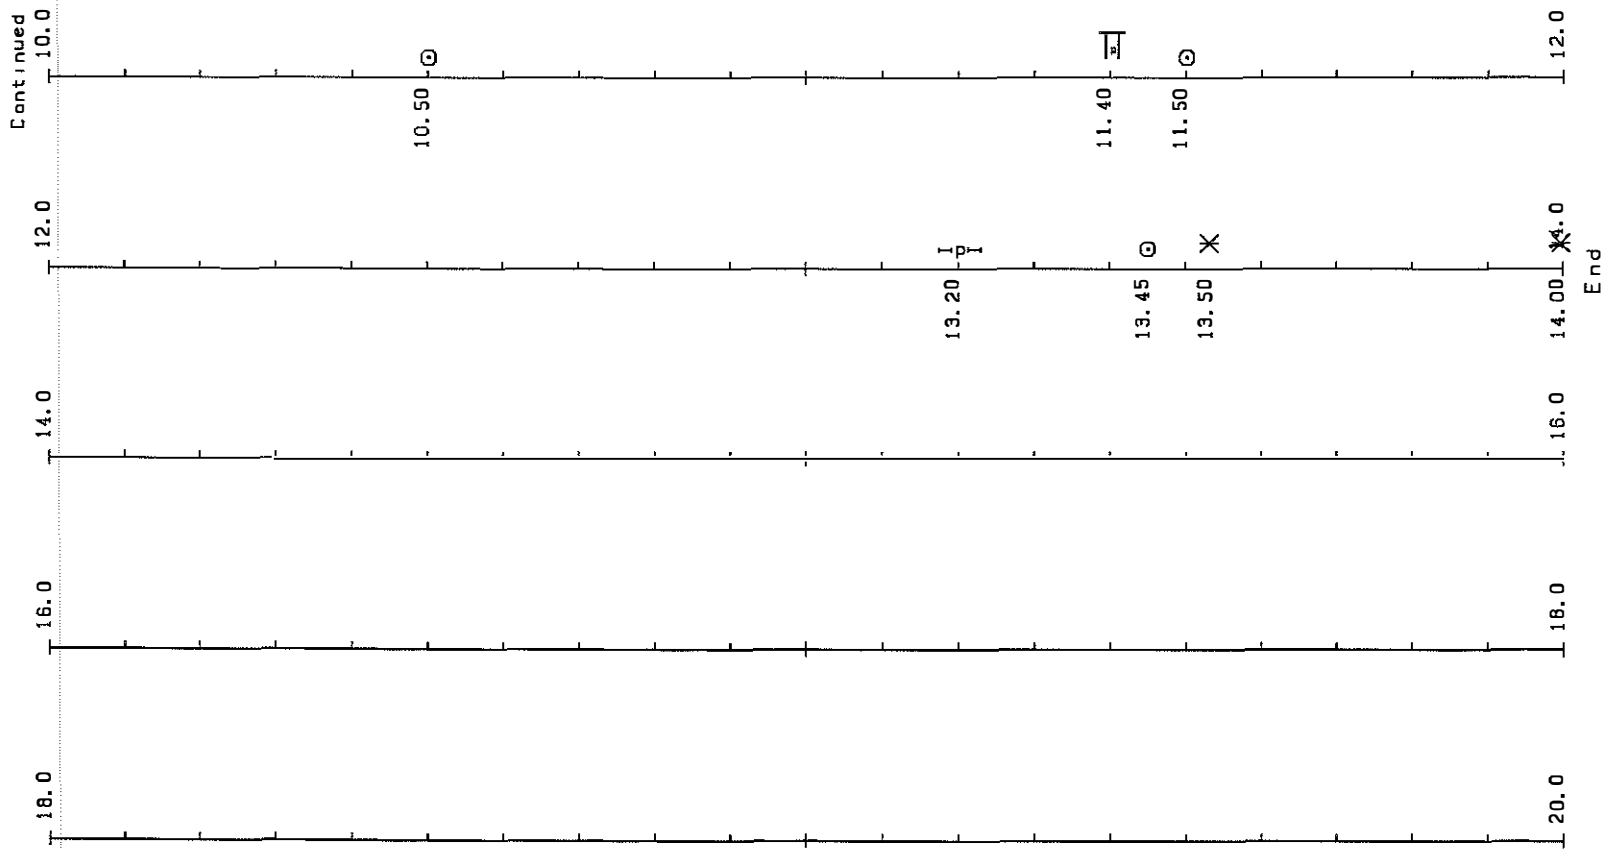
# US68KY80 TODD

A three story masonry structure is located approximately 0.55 mile west of the KY 102 (south) junction. Masonry structures in particular are susceptible to earthquake damage. The priority route could be blocked if this structure collapsed.

There is a quarry 1.15 mile east of the Branch West Fork of Red River bridge on US 68/KY 80. An earthquake could collapse portions of the quarry walls and temporarily

block or destroy a section of the priority route. Further inspection should be conducted to determine if there is a possible threat to the priority route.

1. 0.95 mile east of the West Fork of Red River bridge,
2. 0.07 mile west of the Branch West Fork of the Red River bridge,
3. 0.45 and 0.94 mile west of the KY 102 (south) junction,
4. 0.61 mile south and 1.09 mile north of the Rawhide Creek bridge. and
5. 0.55 mile west of the Todd county - Logan county line.

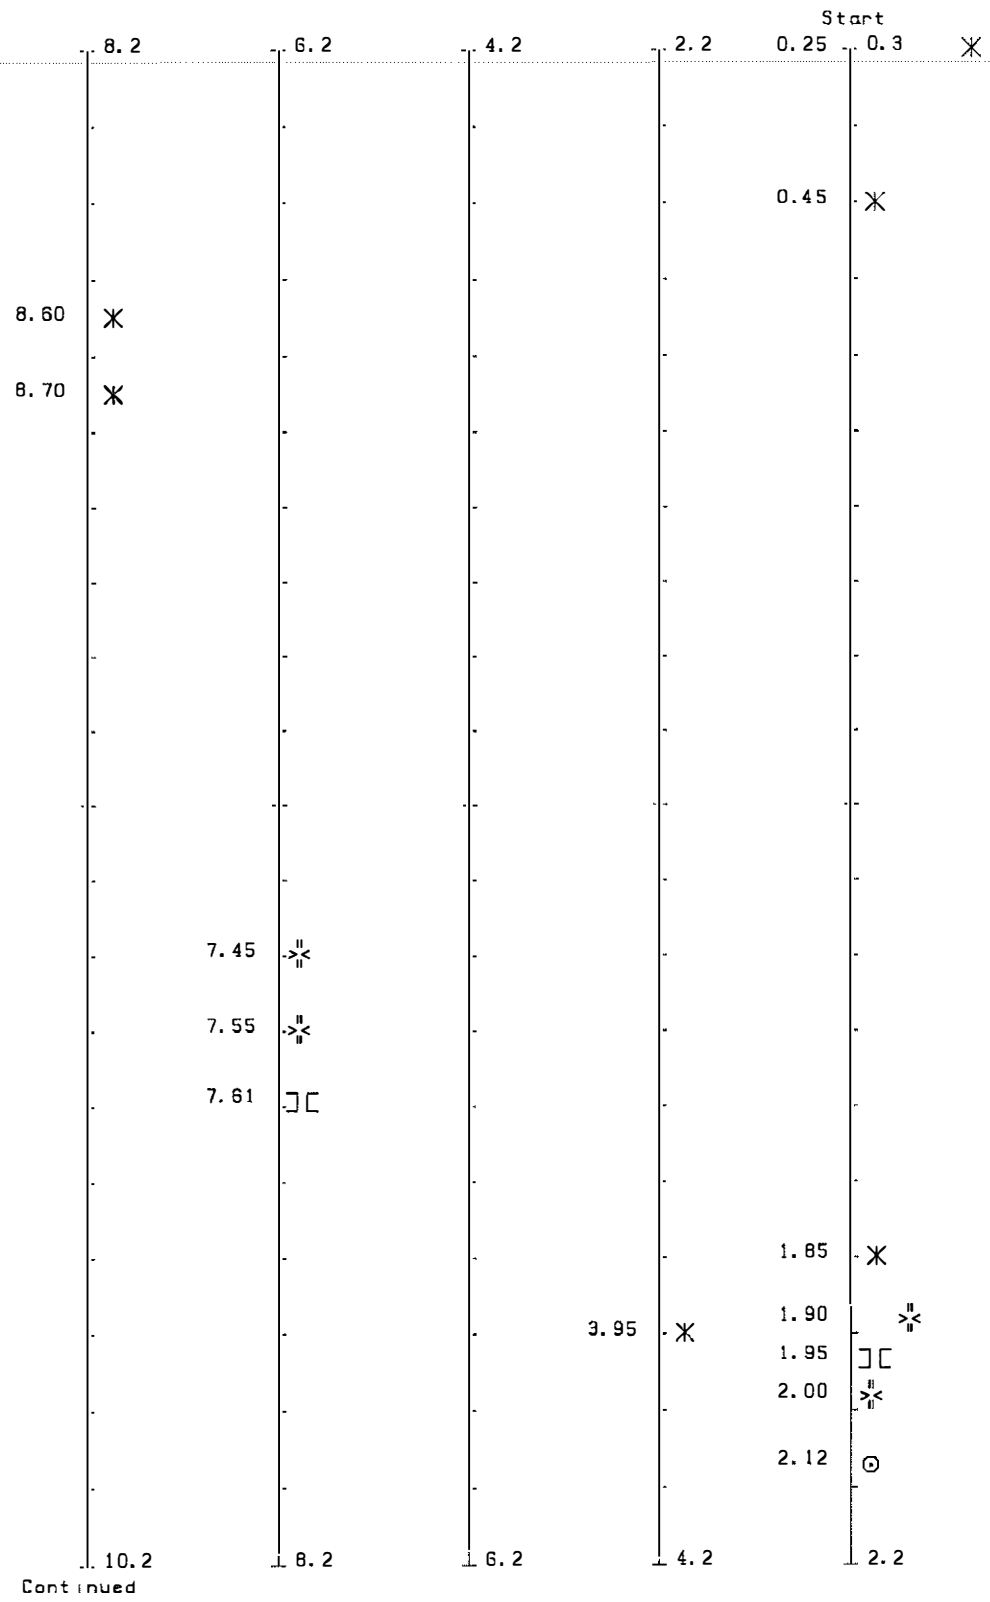
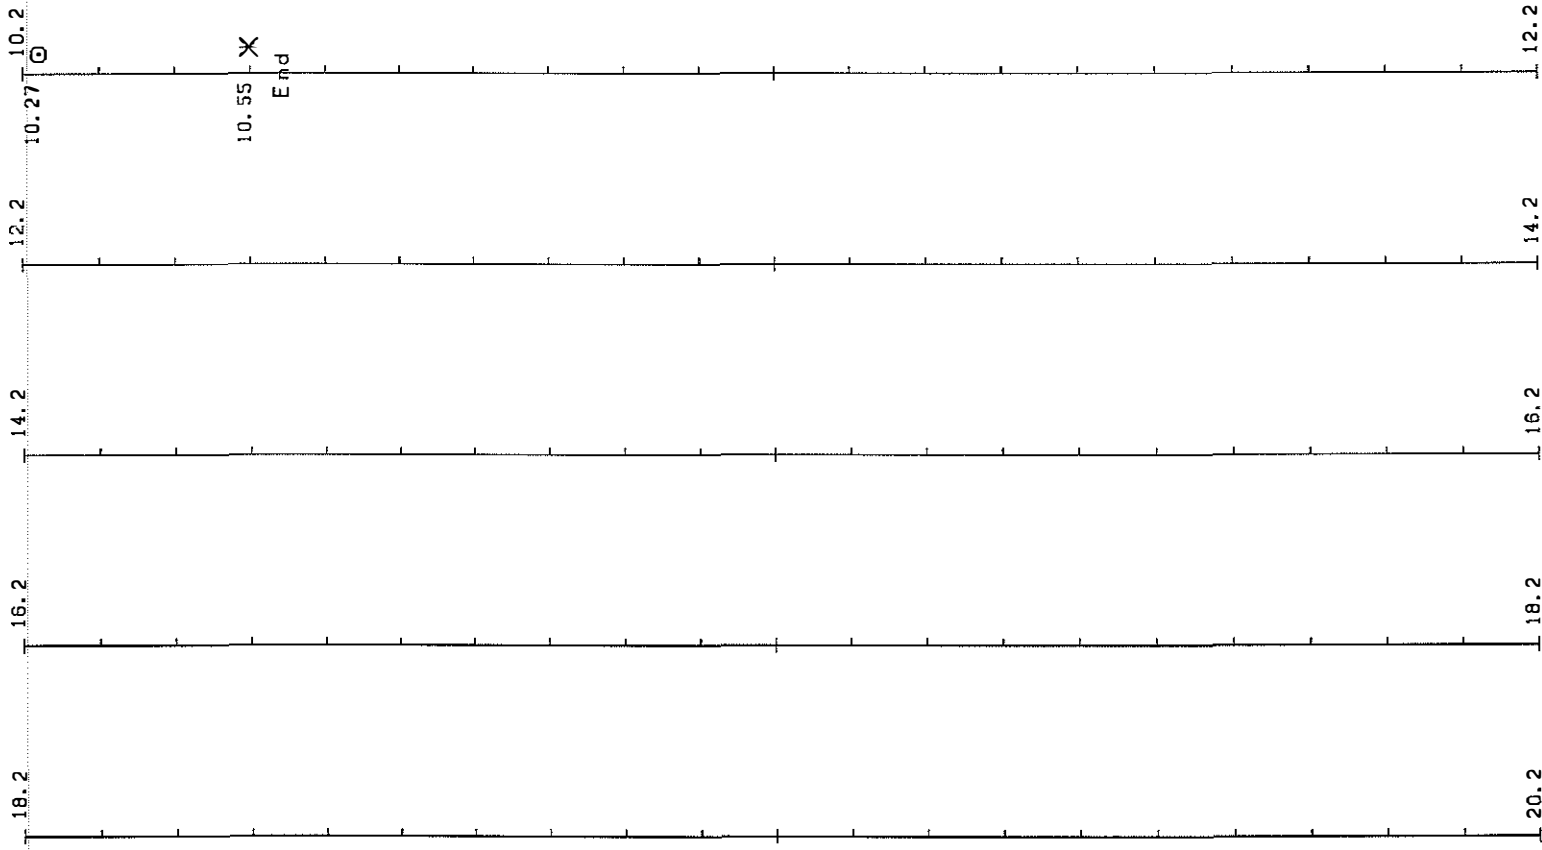
US 79

1. 0.17 mile east of the L & N Railroad bridge, and

2. 0.2850 mile west of the Todd county - Logan county line.

A crop service business is located 0.99 mile east of the Elk Fork Creek bridge near US 79. Further inspection should be conducted to determine if the chemicals stored there would present a problem in the event of container rupture.
