Research Report
KTC-89-16

EARTHQUAKE HAZARD MITIGATION OF
TRANSPORTATION FACILITIES
FOR WEBSTER COUNTY

May 1989

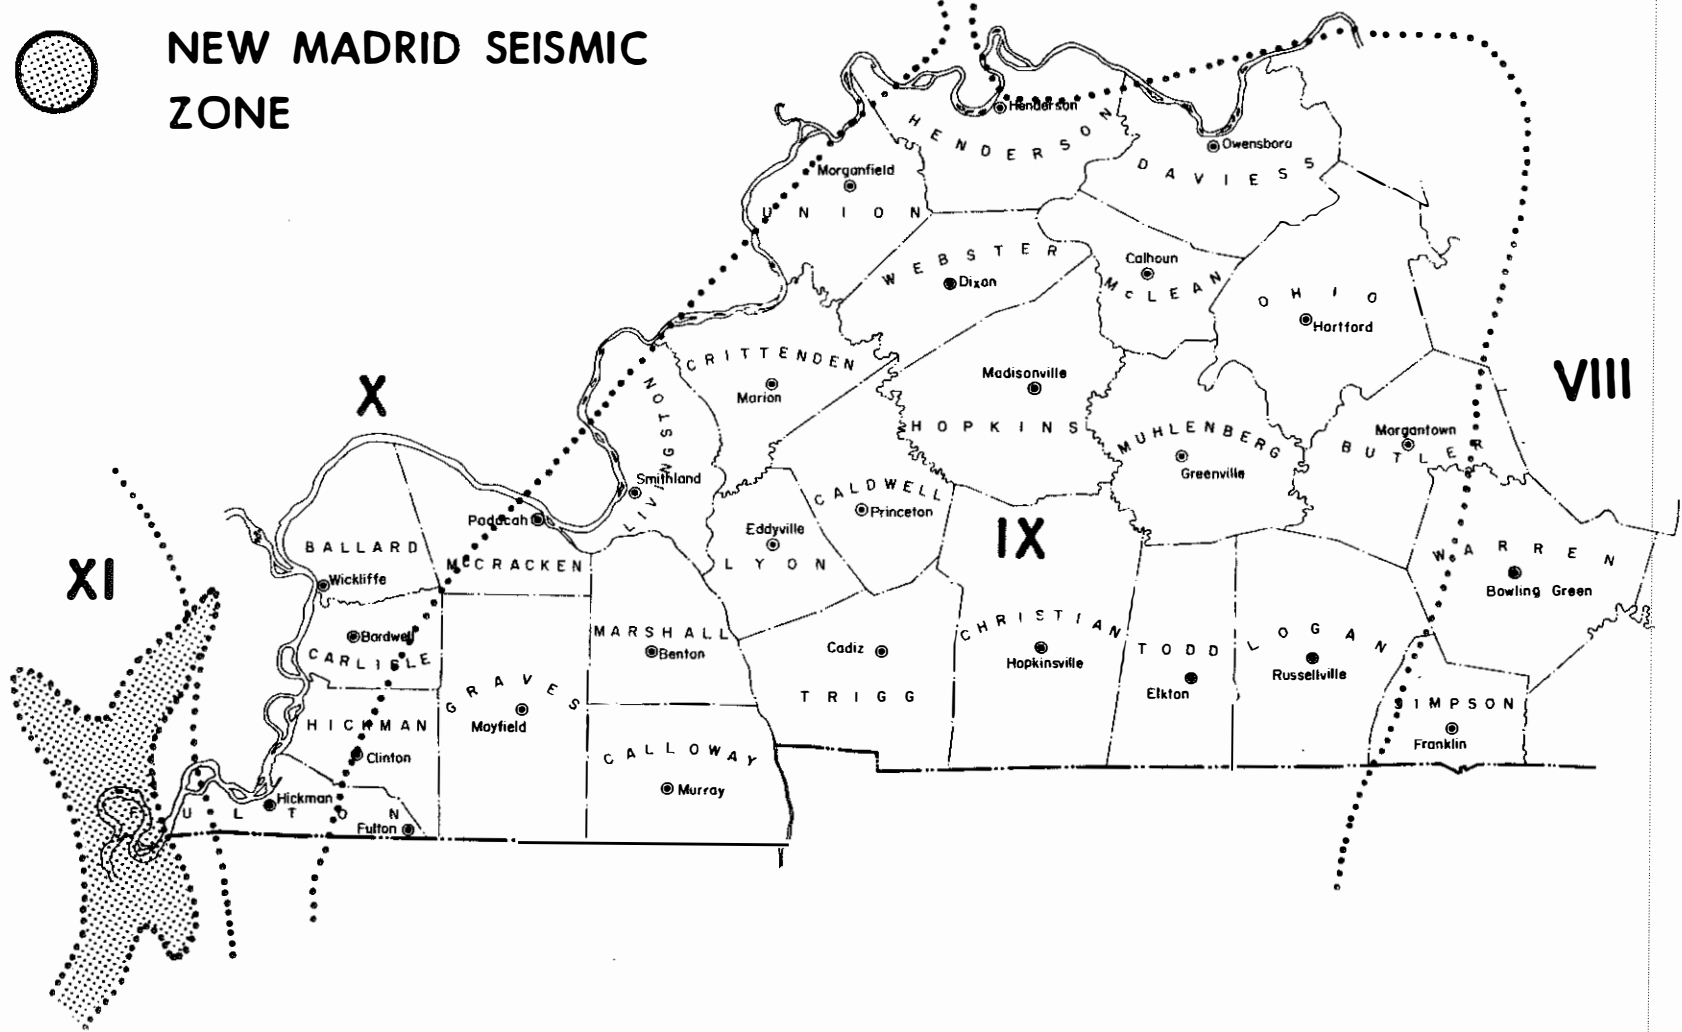
Figure 1: The twenty-six counties included in this study area.

Webster County is located approximately 100 miles northeast of the center of the New Madrid Seismic Zone. Figure 1 indicates that Webster County is in the IX band of the MMI scale. This indicates considerable damage could occur in Webster County in the event of a major earthquake.

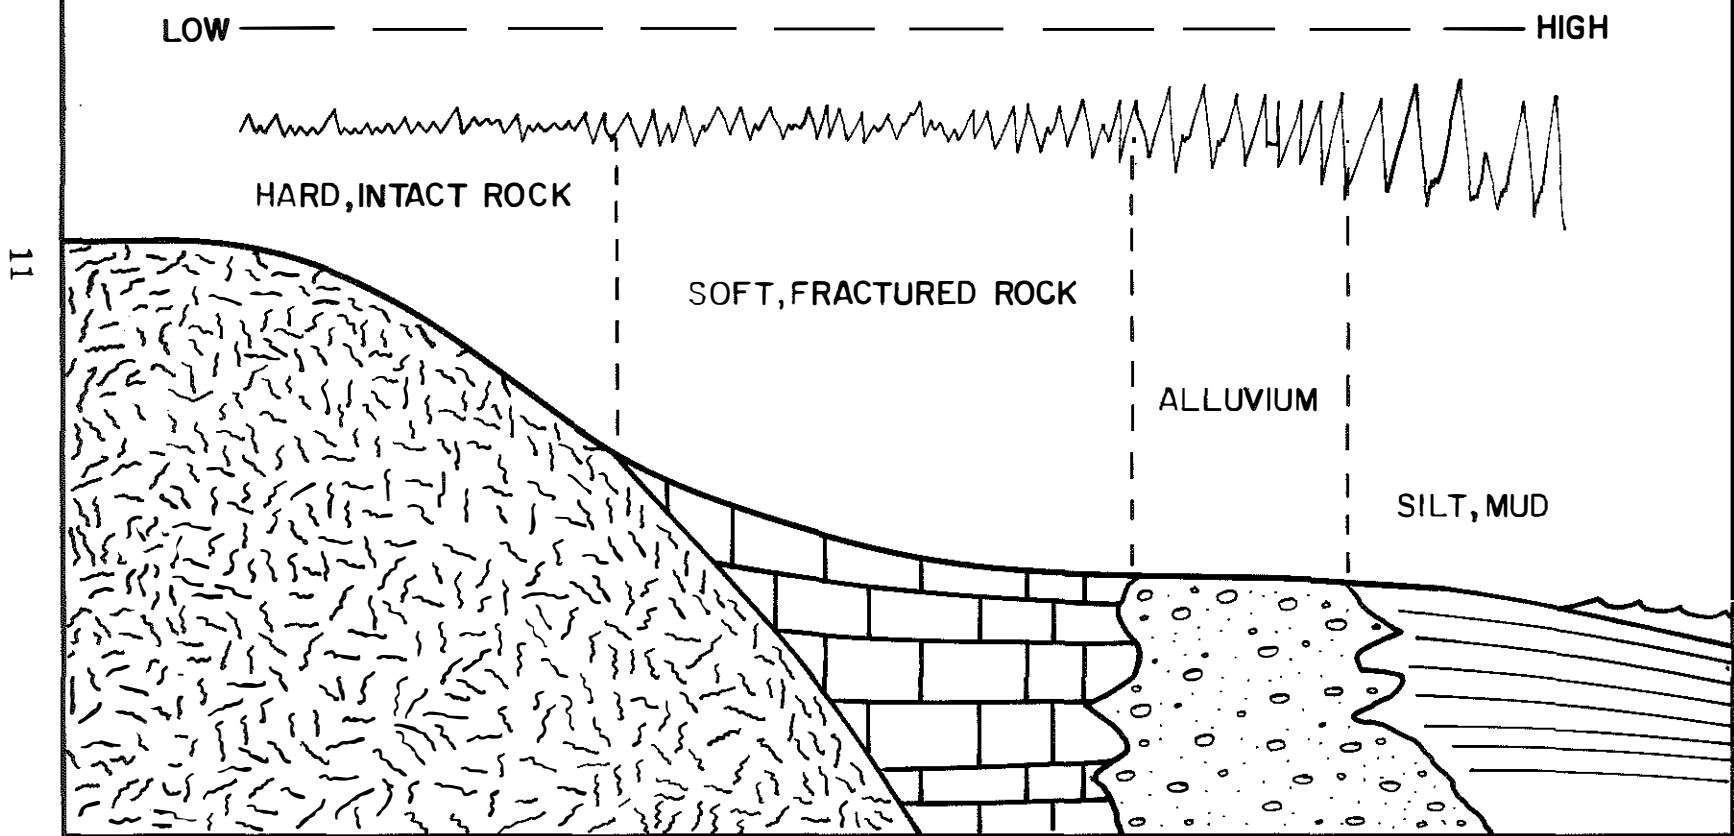
Figure 2 : Amplification of shaking in softer rock & soil during an earthquake.

that there are large amounts of alluvium present throughout the county. Alluvium is a loose, fine-grain soil which is deposited by flowing water such as creeks and rivers. Due to the nature of the alluvium, ground motions at the surface of the soil can be many times greater than those within the underlying bedrock and temporary liquefaction can occur (Figure 2). An alluvium map for Webster County is shown in Figure 3.
