Research Report
KTC-89-9

EARTHQUAKE HAZARD MITIGATION OF
TRANSPORTATION FACILITIES
FOR UNION COUNTY

May 1989

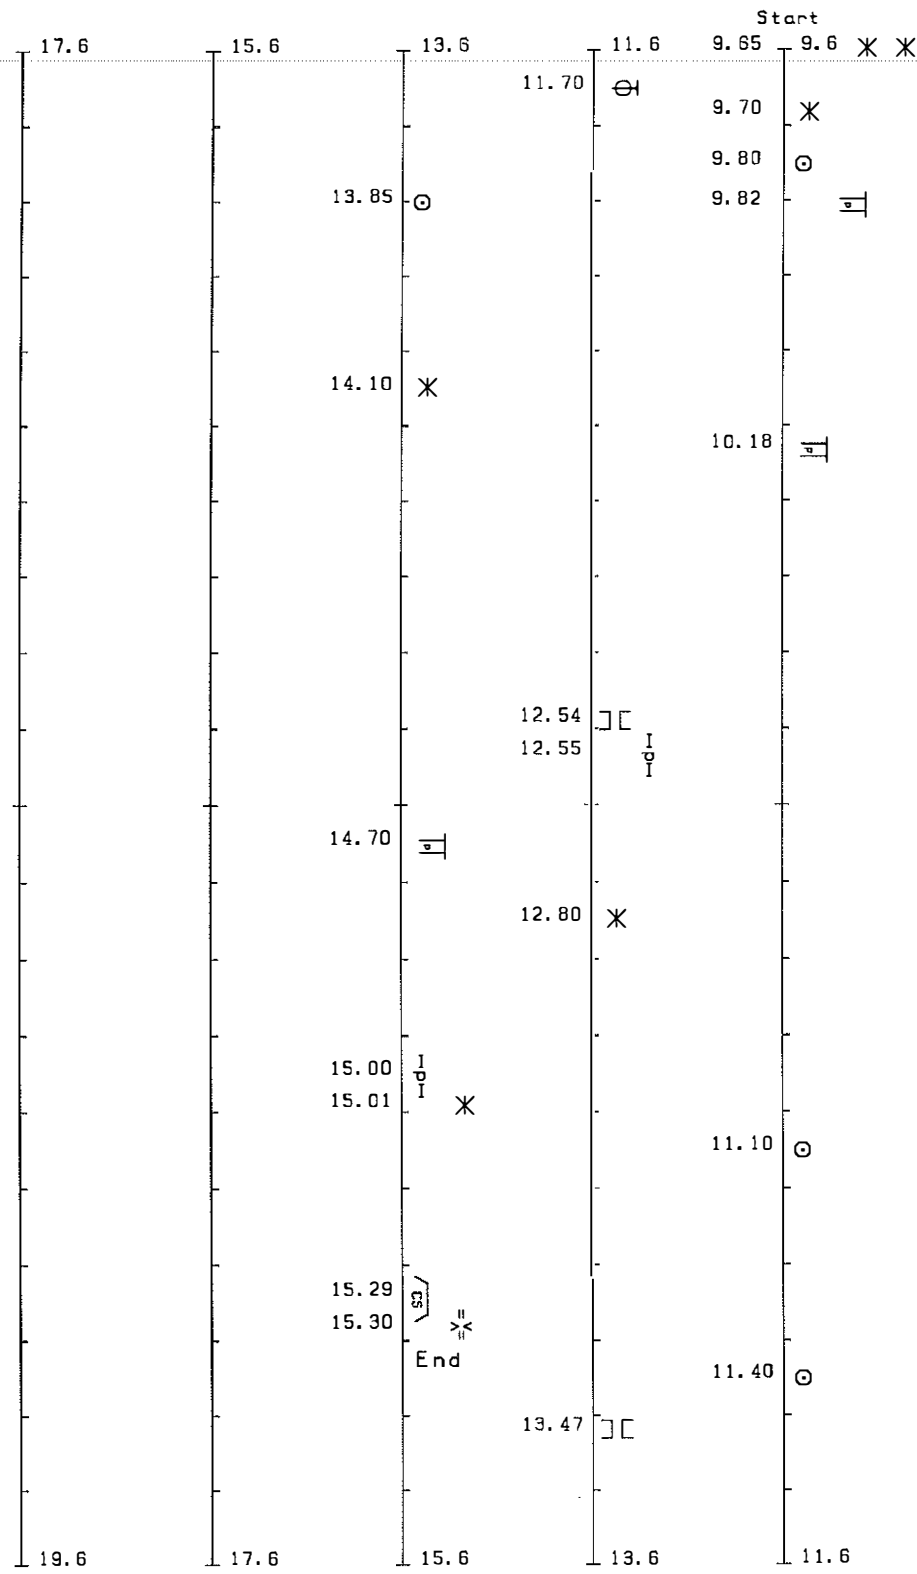
The cut slope is located on KY 130, 0.28 mile into the Uniontown city limits.

Gas pipelines cross under KY 130 at the Wathen Ditch bridge and at the Uniontown city limits. No gas pipelines were logged on the other priority routes in Union County.
