TRUCK ROUTE ACCESS EVALUATION

Industrial Park
Henderson County
Site # 2

Report No. KTC-99-10

“Freight Movement and Intermodal Access in Kentucky”
SPR 98-189

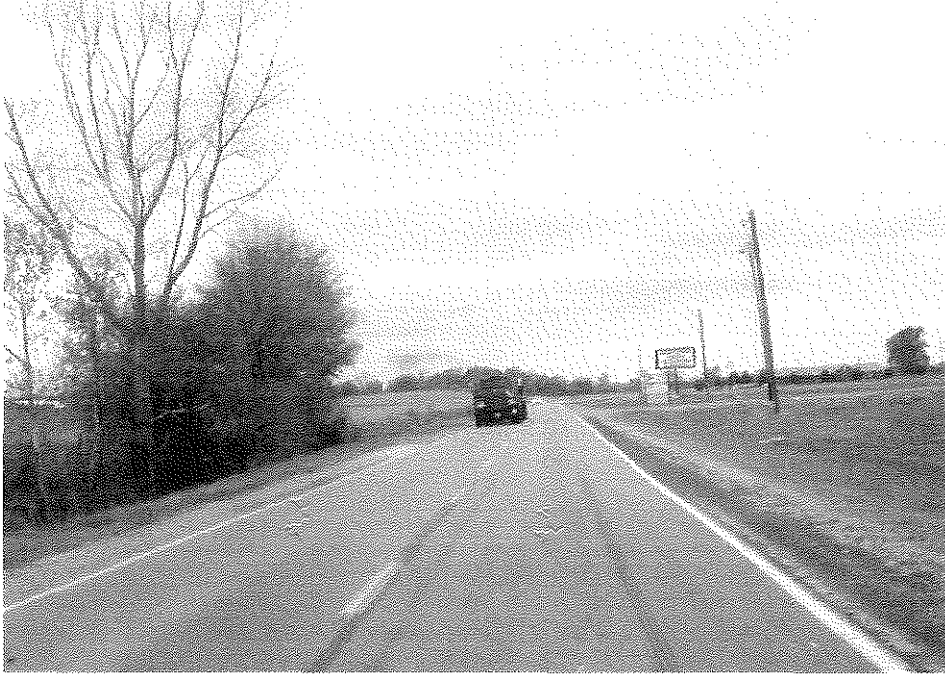
Figure 2. KY 136 (near Riverport Road)

There is one primary route for trucks to reach the National Highway System. The industrial park is located south of Henderson off KY 136. The facilities are located on three side roads off KY 136. Two of these roads are Industrial Park Road which has a length of about 1.3 miles from KY 136 to the last facility and Riverport Road which has a length of about 0.7 miles. Three of the facilities are located on another unnamed side road. The trucks travel a maximum of about one mile on KY 136 from Industrial Park Road to the intersection with KY 425 and US 60 and then follow KY 425 for about 5.5 miles to the Pennyriple Parkway (which is on the National Highway System). The location of the truck generating sites and the route used to travel to the National Highway System is shown in Figure 1. Most of KY 136 is a two lane rural roadway with 10-foot lanes and a two-foot shoulder (Figure 2). The lane and shoulder widths become wider near the US 60/KY425 intersection. KY 425 is a two lane road with 12-foot lanes and a 10-foot shoulder (Figure 3). The sites are located on the side roads such as Industrial Park Road (Figure 4) which are two lane roads with 10 to 11-foot lanes and no shoulder.

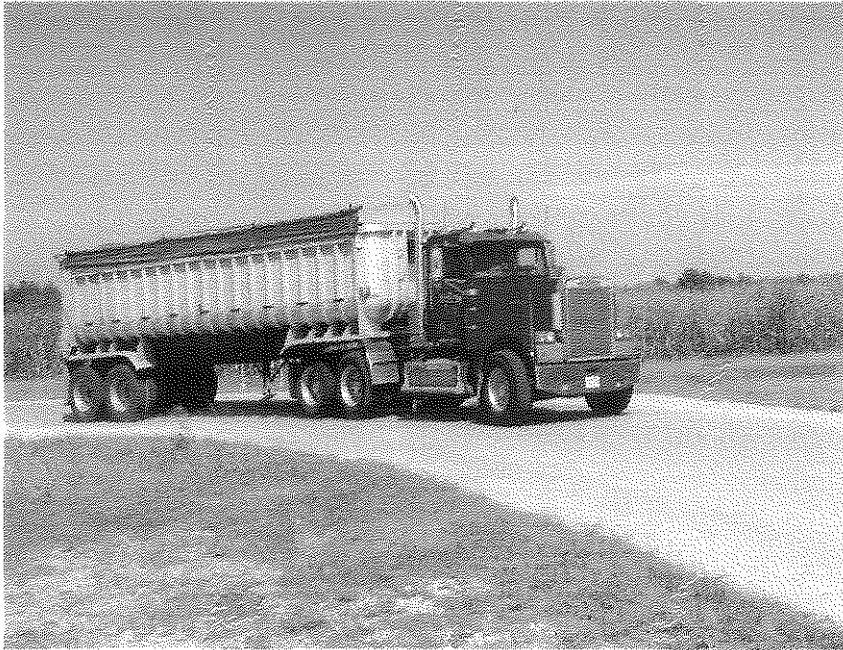
Figure 8: Curve on Industrial Park Road

There were no curves on the major roads in this route (KY 425 and KY 136) which would result in offtracking into the opposing lane. The only sharp curve is on Industrial Park Road (Figure 8) which does result in offtracking into the opposing lane. There is a turn warning sign in advance of this curve with no advisory speed. The speed limit on this road is 35 mph so this curve would have a “less than adequate” rating.

The conclusion was that the roadways provided adequate access with possible minor improvements which could improve the route. The only substantial potential improvement on a state-maintained road was to widen the lanes and shoulders on a section of KY 136 east of US 60 in the area of the side roads. Improvements on the side roads would involve adding shoulders and placing standard signs and pavement markings and performing some surface maintenance. There was also one sharp curve on Industrial Park Road which resulted in offtracking into the opposing lane.
