TRUCK ROUTE ACCESS EVALUATION

Edmonson County
From Western Kentucky Parkway to I-65

Report No. KTC-98-32

September 1998

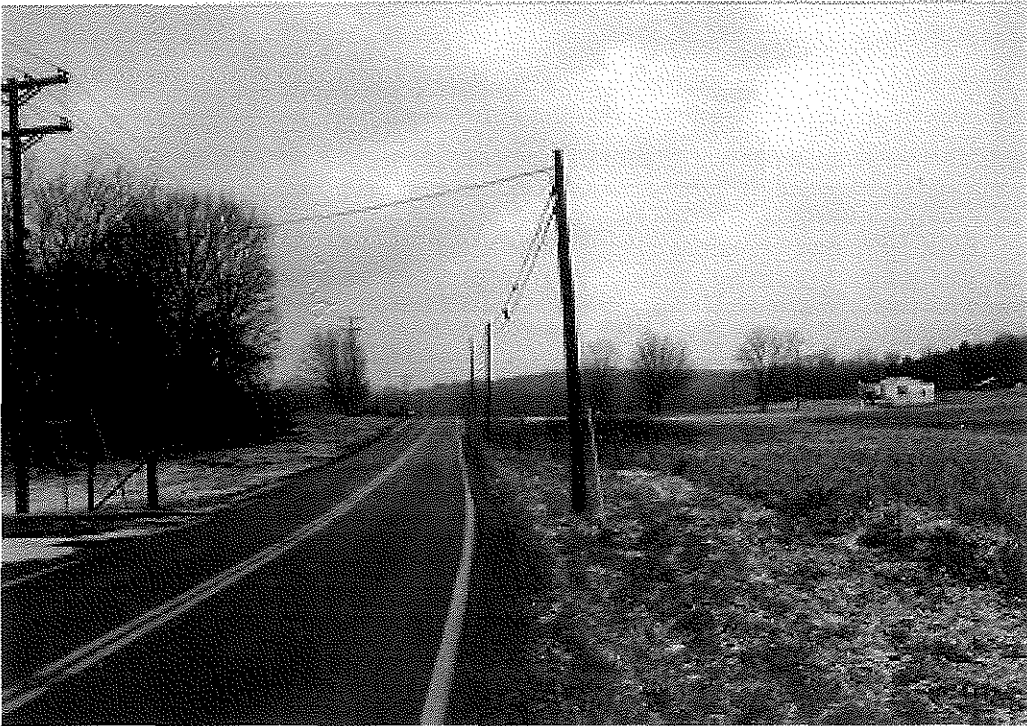
Figure 5: Clear Zone Limitations KY 259 South of Brownsville (MP 9.9)

Clear zone issues existed along many sections of the route. Residences, utility poles, trees, fences, parking and bridge rails were found in several sections within 10 to 15 feet of the road edge. Two such sections are illustrated in Figures 5 and 6. The pavement was good along the whole route. The section of KY 101 south of US 31W had been resurfaced between the June and July site visits.

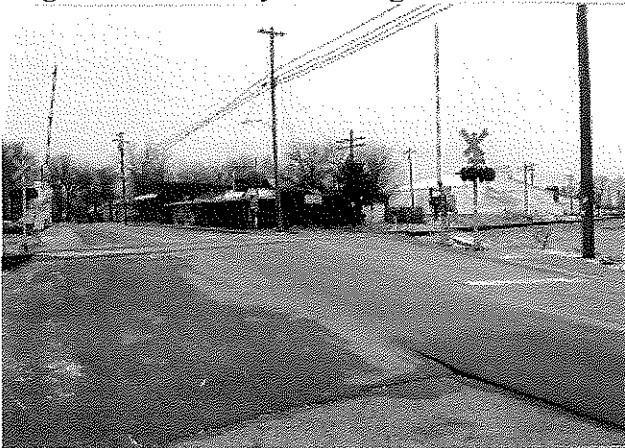
Figure 11: Railway Crossing in Smith’s Grove

There was one at-grade railway crossing (one track) along this route at milepoint 8.562 on KY 101 in Warren county in the town of Smith’s Grove (See Figure 11). There are warning lights and gates. However, the “humped” nature of the crossing makes it inappropriate for some trucks. Therefore, this crossing is rated “less than adequate”.
