TRUCK ROUTE ACCESS EVALUATION

Millard Processing

Site # 1677

“Freight Movement and Intermodal Access in Kentucky”

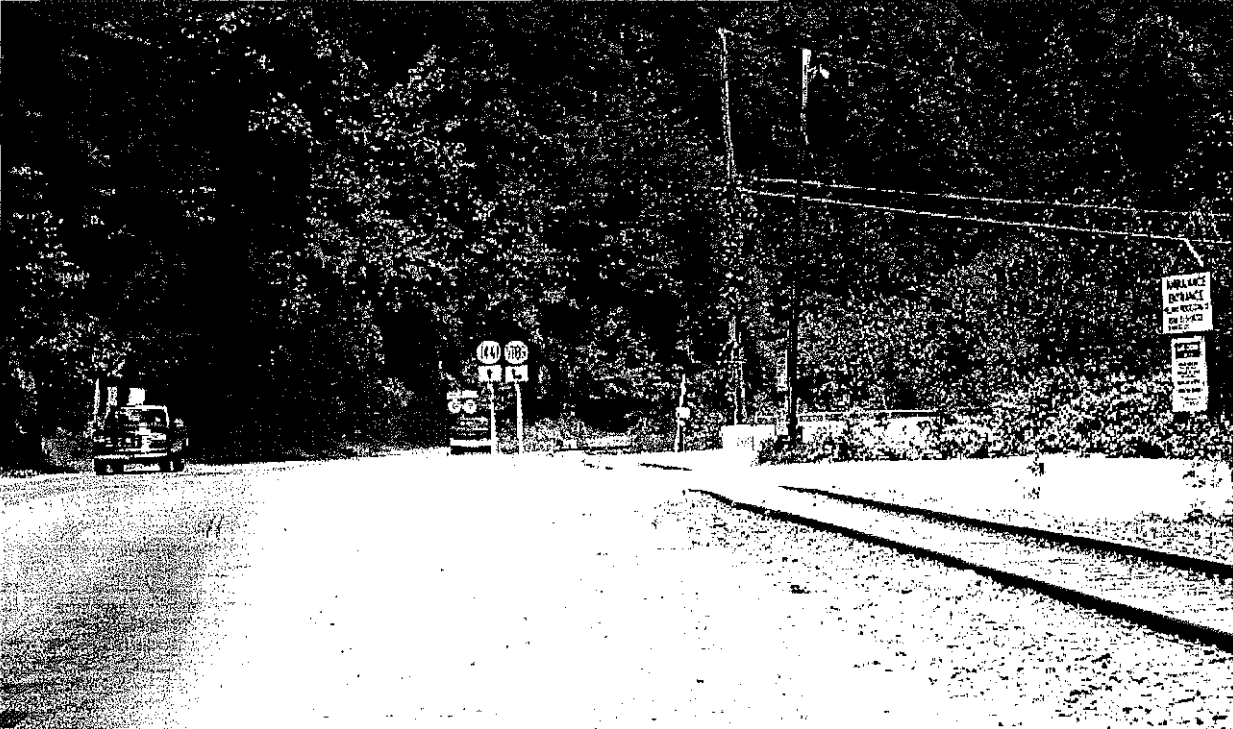
Figure 7: Turning Radius from Nelse Hill Road onto KY 1789 via KY 1441

The turning radius from Nelse Hill Road onto KY 1789 was approximated in the field. A view of this intersection is shown in Figure 7, and the approximate layout of intersections is shown in Figure 8. In Figure 7, the pick-up truck is on KY 1441, Nelse Hill Road crossing the railrail track is in the foreground, and the bridge on KY 1789 can be seen beyond Nelse Road on the right hand side of the picture. Trucks perform a U-turn maneuver and do not make separate turns on and off of KY 1441. The 50-foot radius of this turn was rated “less than adequate” because trucks were observed turning into opposing traffic lanes on both KY 1441 and KY 1789.

The railroad crossings on KY 1789 and Nelse Hill Road near KY 1441 (see Figure 7) were rated “adequate” due to rough crossing surfaces. A crossing on Nelse Hill road approximately 0.4 mile from KY 1441 received a “preferred” rating. The locations of the railroad crossings are shown in Figure 1.

The low traffic volumes on Nelse Hill Road may not justify major improvements along that road. The intersection of Nelse Hill Road, KY 1441 and KY 1789 could be improved to eliminate the problems with turning radius and rough railroad crossings. These problems could also be

addressed through enforcement of existing weight limits on KY 1789. Enforcing the weight limit would encourage trucks to use KY 1441 (on the extended-weight coal haul system) rather than KY 1789.
