TRUCK ROUTE ACCESS EVALUATION

Campbell-Hausfeld
Leitchfield-Grayson County
Site # 2637

Report No. KTC-99-47

“Freight Movement and Intermodal Access in Kentucky”
Project No. SPR 98-189

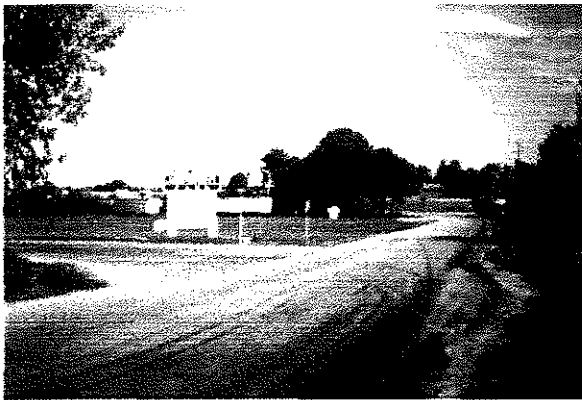
Figure 6: KY 920 at Embry Drive

The turning radii at the intersection of KY 920 and Embry Drive was observed to be “less than adequate” as shown in Figures 6, 7, and 8. Several vehicles were observed encroaching into the opposing lane while making a right turn from Embry Drive onto KY 920. When making left turns into the industrial park from KY 920, vehicles also drove off the pavement either on KY 920 or Embry Drive. The approximate layout of this intersection is shown in Figure 9. The near 45° angle at which Embry Drive joins KY 920, along with the pavement width, increases the required turning radius. The original pavement intersected KY 920 without any widening. The turn from KY 920 onto Embry Drive, which is approximately 45°, was rated “less than adequate” because trucks drive off the pavement to make the turns, as shown in Figures 6, 7 and 8.

The recommended improvement is the reconstruction of the intersection of KY 920 and Embry Drive to eliminate turning radius problem. Other roadways with lane and shoulder width problems could be addressed by rebuilding those sections of highways.

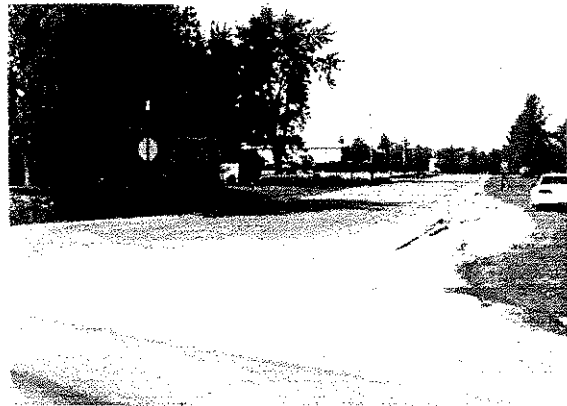
Figure 7: KY 920 at Embry Drive

The turning radii at the intersection of KY 920 and Embry Drive was observed to be “less than adequate” as shown in Figures 6, 7, and 8. Several vehicles were observed encroaching into the opposing lane while making a right turn from Embry Drive onto KY 920. When making left turns into the industrial park from KY 920, vehicles also drove off the pavement either on KY 920 or Embry Drive. The approximate layout of this intersection is shown in Figure 9. The near 45° angle at which Embry Drive joins KY 920, along with the pavement width, increases the required turning radius. The original pavement intersected KY 920 without any widening. The turn from KY 920 onto Embry Drive, which is approximately 45°, was rated “less than adequate” because trucks drive off the pavement to make the turns, as shown in Figures 6, 7 and 8.

The recommended improvement is the reconstruction of the intersection of KY 920 and Embry Drive to eliminate turning radius problem. Other roadways with lane and shoulder width problems could be addressed by rebuilding those sections of highways.

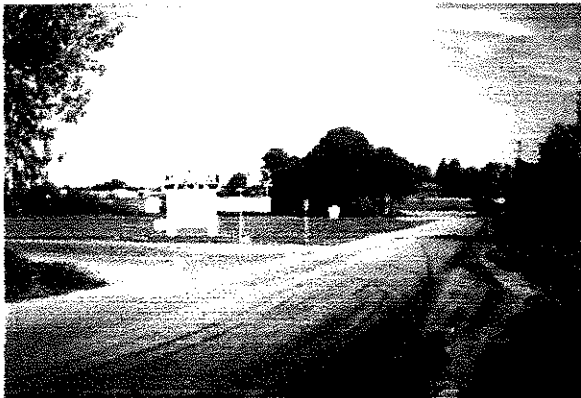
Figure 6: KY 920 at Embry Drive

The turning radii at the intersection of KY 920 and Embry Drive was observed to be “less than adequate” as shown in Figures 6, 7, and 8. Several vehicles were observed encroaching into the opposing lane while making a right turn from Embry Drive onto KY 920. When making left turns into the industrial park from KY 920, vehicles also drove off the pavement either on KY 920 or Embry Drive. The approximate layout of this intersection is shown in Figure 9. The near 45° angle at which Embry Drive joins KY 920, along with the pavement width, increases the required turning radius. The original pavement intersected KY 920 without any widening. The turn from KY 920 onto Embry Drive, which is approximately 45°, was rated “less than adequate” because trucks drive off the pavement to make the turns, as shown in Figures 6, 7 and 8.
